DETECTING WATER LEAKS USING DRONE TECHNOLOGY

Deliverable #5 – Final Report

Report Agreement No. 180894

ManageWater Consulting, Inc.

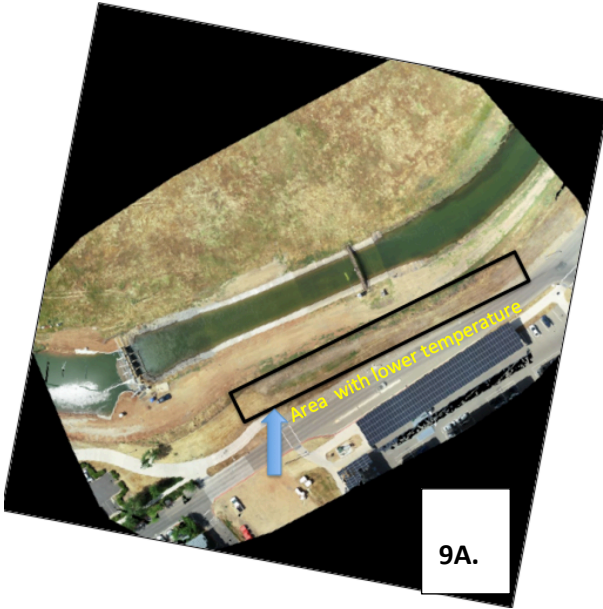
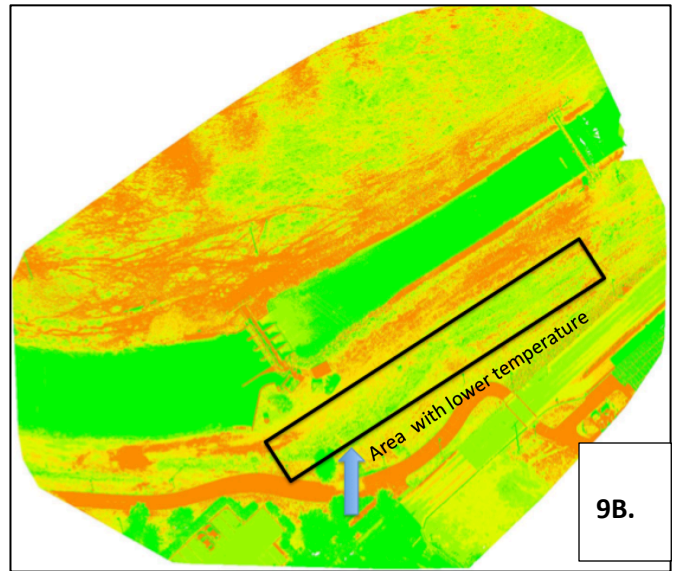
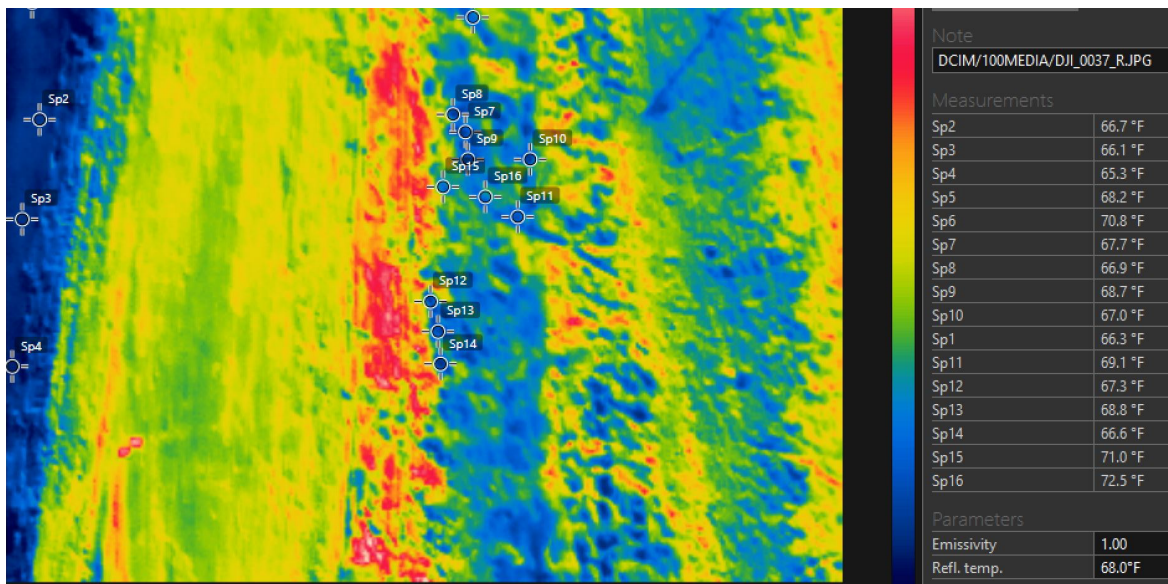
The green vegetation below the levee, in contrast to dry surrounding areas, is an indicator for potential water leaks (Figure 9A). Since vegetation takes time to establish, the area where it is growing was interpreted to have an on-going water leak through the levee. The canal water is interpreted to migrate in the subsurface through the levee and leak out on the road-facing side. The orthomosaic and reflectance index maps (Figures 9B, 9C) were developed from aerial data collected at the end of August 2019. The large contrast in temperatures between the ground (122F) and canal (67F; 55F difference) and low humidity (28.8%) presented excellent conditions for the thermal sensor. The corresponding thermal anomaly showed up strongly on the levee surface (Figure 9C. green - cool, orange- hot).

Figure 9A. Vegetation can be an indicator of water leaks, as seen in this orthomosaic map generated using P4P, with Pix4D Capture and Mapper. Grass and shrubs are visible on the levee side facing the road, approximately 5 feet below the levee top (box area). The orthomosaic map shows an area that corresponds to thermal anomalies shown in the reflectance index map, figure 9B. The area in the box exhibited lower temperatures (green) than the bare ground on the top and side of the levee (orange) and is interpreted as a leak. In Figure 9C, the blue area on the far left is the canal (cooler temperature points Sp2, Sp3, Sp4,), the green and yellow area is the levee top (warm), and the red-yellow area is the levee side (warmest). Below this area, the area shown in dark blue patches is interpreted to be the area of water leakage (e.g., temperature points Sp5, Sp7, Sp8).

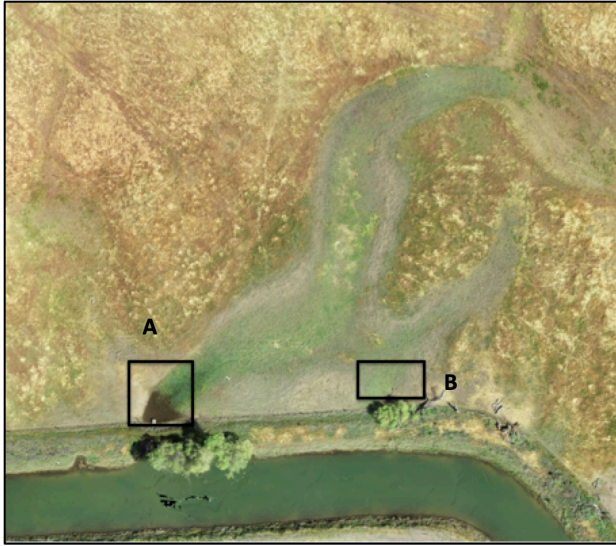
11A

At the UCM2 site, two large outflows through the earthen levee were observed in both the orthomosaic and reflectance index maps. The canal water surface is approximately 5 feet below the top of the levee. The aerial map developed from P4P images (Figure 11A) shows two main water leaks (boxed areas: A, B) through the levee. The reflectance index map (Figure 11B) developed from the M200 images clearly shows the locations of lower temperature anomalies for the canal area (green) compared with the hotter ground (yellow - orange). The areas with boxes A and B are interpreted to be leak areas. Using Flir tools software, we reviewed temperatures on a pixel-detail level in the thermal image. The temperature anomaly is evident – the darkest blue area in Figure 11C identifies the specific area of leak in box A.

Figure 11A. Orthomosaic map developed using P4P drone illustrates 2 main areas of water flowing out of the canal (boxes: A, B). Figure 11B. Reflectance index map for UCM2 with thermal anomalies detected, reflecting the 2 main leaks areas (boxes: A, B).

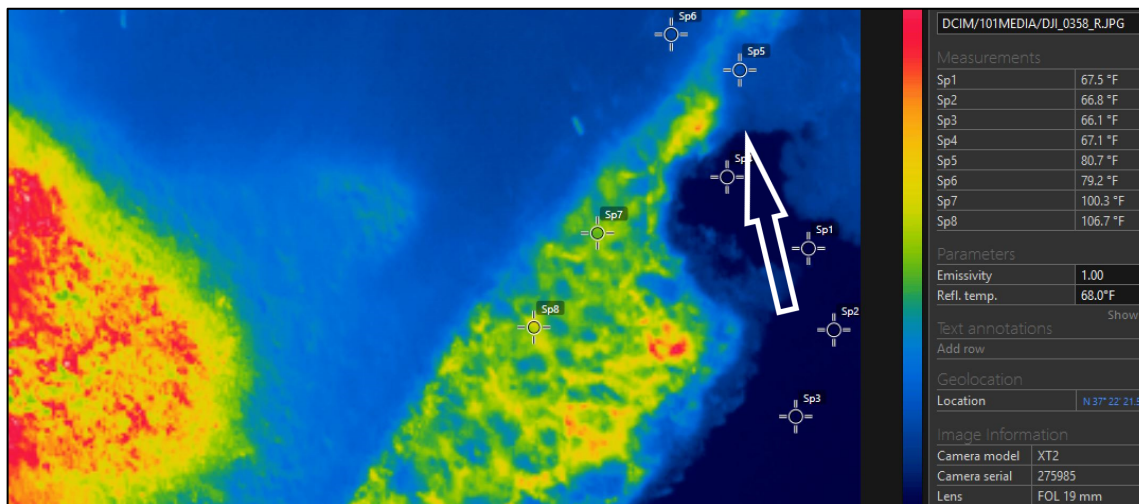
Figure 11C. Close up thermal image of an area of low temperature in box A. Using Flir Tools software the image illustrates specific low temperature locations (dark blue area, Sp1 to Sp4) where water is interpreted to be flowing out through the levee. Green, yellow, orange, and red areas are warmer temperatures, e.g., Sp5 to Sp8).

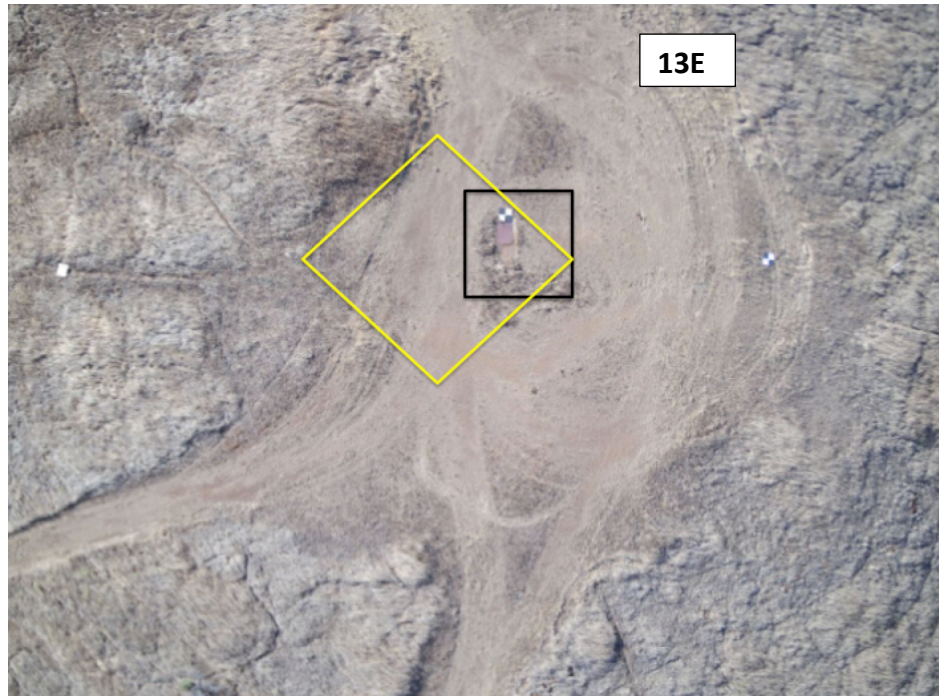
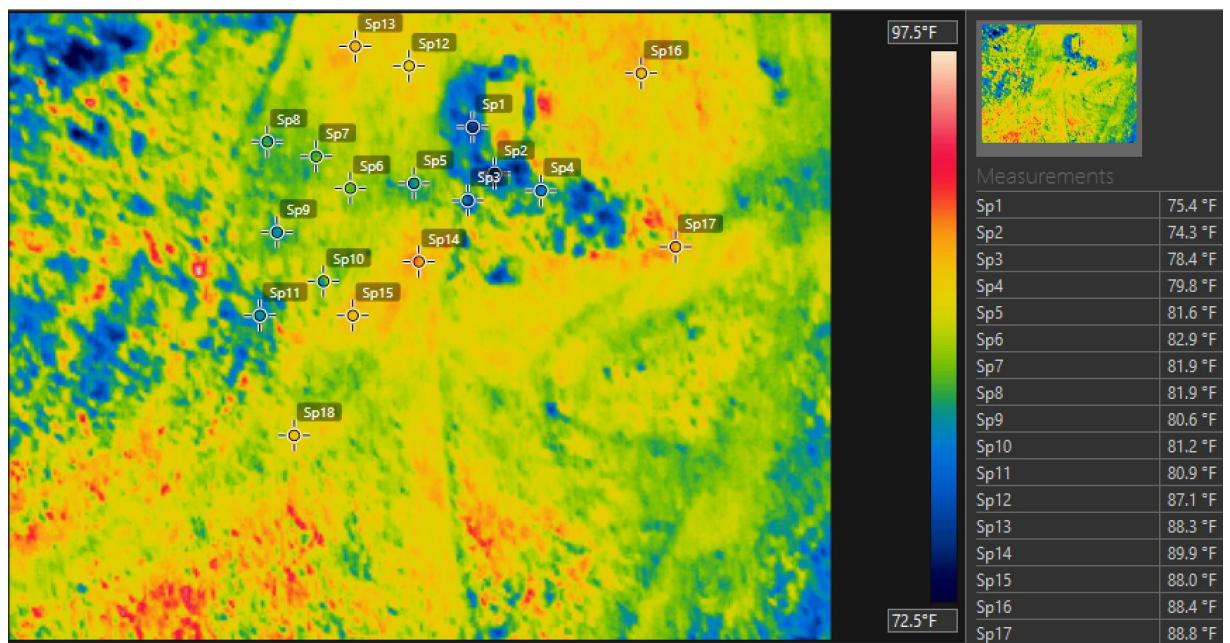
The reflectance index map view is best for initial review before further analysis using individual radiometric images (RJPGs). Figure 13F illustrates the level of detail captured in individual thermal images.

Figure 13E. M200 aerial visual image for reference to Figure 13F, showing the location of the valve box (square box) and approximate location of thermal image showing lower temperatures in figure 13F. This M200 aerial thermal image shows a closer view of the valve box with a metal cover (Sp1, upper center blue area) – the location of the subsurface simulated leak. The greenish mottled area, in the dirt road, to the left

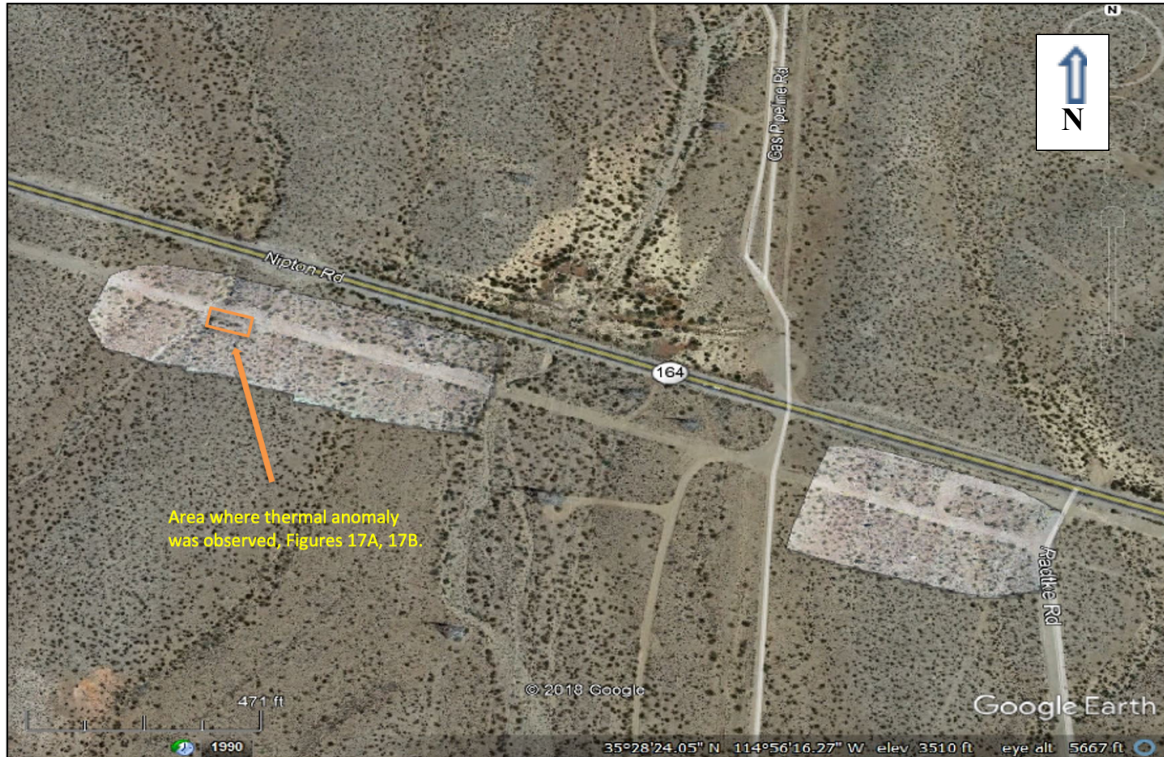
During the May 2019 fieldwork, hundreds of thermal images were collected from drone flights. On May 27 at 6:50 am, the aerial thermal sensor detected a pattern of apparent thermal anomalies. That morning was chilly, with ground temperature in the low to mid-50s F, while water temperature was about 70F. Near the north-west end of 2.1A (Figures 17A, 18A, 18B), the temperature increased consistently about 10F, to mid and high 60s F (Figures 18A, 18B). This apparent thermal anomaly was visible in this area for about 45 minutes.

17B. Aerial orthomosaic map, generated using DJI Phantom 4 Pro and Pix4D Mapper software, for LVVWA S2-1AB, S2-2AB. (Source: MW drone flight, 2019). The water pipeline runs parallel to the south side of the dirt road. Note: orange box shows the location of a thermal anomaly observed on May 27, 2019.

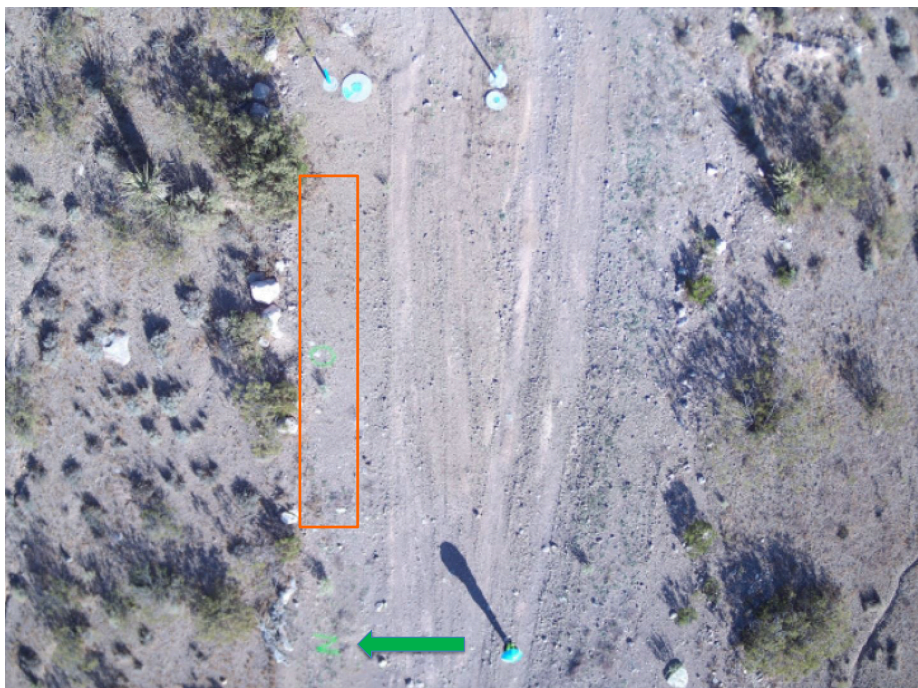
Figure 18A. Visual aerial image showing the location (orange box) of the temperature anomaly observed early morning on May 27, 2019. The water pipeline runs along the left side of dirt road, in the area of the orange box. The arrow points to the green "N" on the ground to help locate the area of interest in the visual and thermal images.

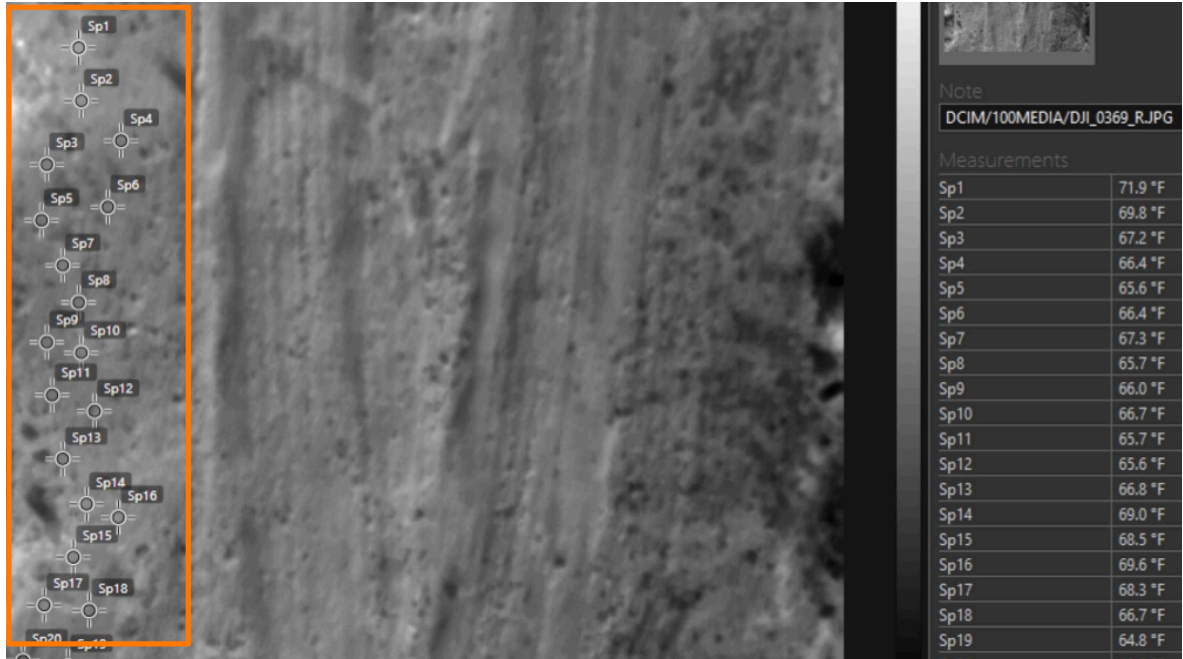
Figure 18B. Thermal aerial image showing the location (orange box) of the temperature anomaly observed early morning on May 27, 2019. The water pipeline runs along the left side of dirt road. The thermal images for LVVWA2 were generated using DJI Matrice 200 with Zenmuse XT2 sensor and DJI Pilot software. Flir Tools software was used to analyze the image and temperature values. As the flight proceeded along the pipeline, approaching the 'N' mark on the ground (Figure 17A. green letter on the ground, bottom center), the Pilot in Command observed temperatures that were consistently 10F higher than the previous leg of the flight. The contrast in temperature appeared as an anomaly due to the flight's early hour and lack of extended exposure to solar radiation.

The MW pilot in command contacted LVVWA staff, but the thermal anomaly in this area was no longer apparent later. The potential causes of the temporary anomaly and lack of clear visibility of the exiting leak(s) are discussed in the Summary and Findings sections below.

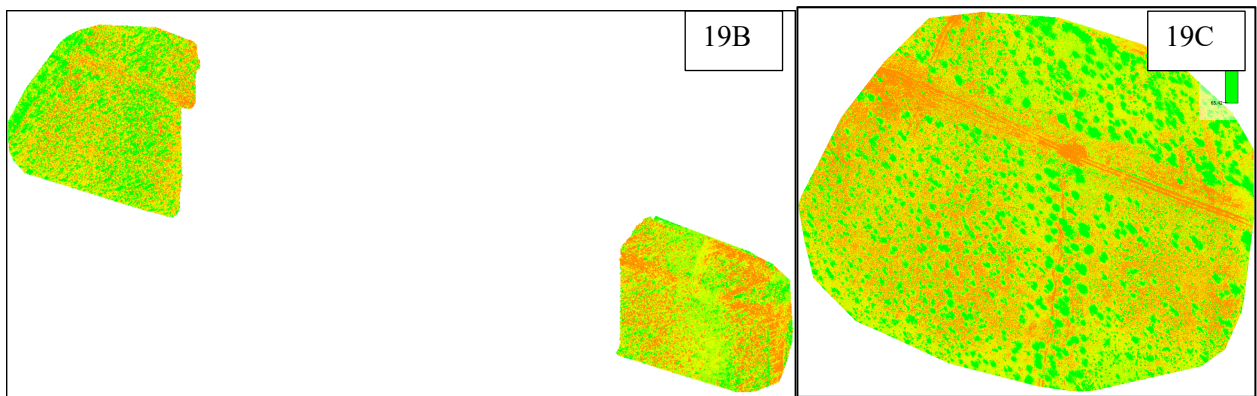
The LVVWA2 site was re-visited between October 29 and 31, 2019. The site representative indicated that the segment of pipeline with the suspected leak was shut down at this time. No other leaks were known. On October 29th and 30th the weather was unusually cold, rainy, and with wind gusts in excess of 30 MPH. Flights were suspended until environmental conditions were safe and suitable (no rain, wind <15mph). The goal of the visit was to develop a reflectance index map and analyze it for thermal anomalies.

Figures 19B, 19C. Reflectance index map from LVVWA2 flight on October 31, 2019, using sUAS DJI M200 with the XT2 sensor and DJI Pilot software. The reflectance index map from this flight illustrates the cooler ground surfaces (orange) and vegetation that indicated warmer temperature (green) compared to the adjacent ground. The reflectance index map on the left (19B) shows both sections 2.1A-B and 2.2A-B. The reflectance map on the right (19C) is from a later flight on October 31st of segment 2.1A-B. No thermal anomalies attributable to water leakage were observed during the flights or in the reflectance index maps. (Source: MW, 2019.)
