## ***DETECTING WATER LEAKS USING DRONE TECHNOLOGY***

Deliverable #5 – Final Report

Report Agreement No. 180894

ManageWater Consulting, Inc.

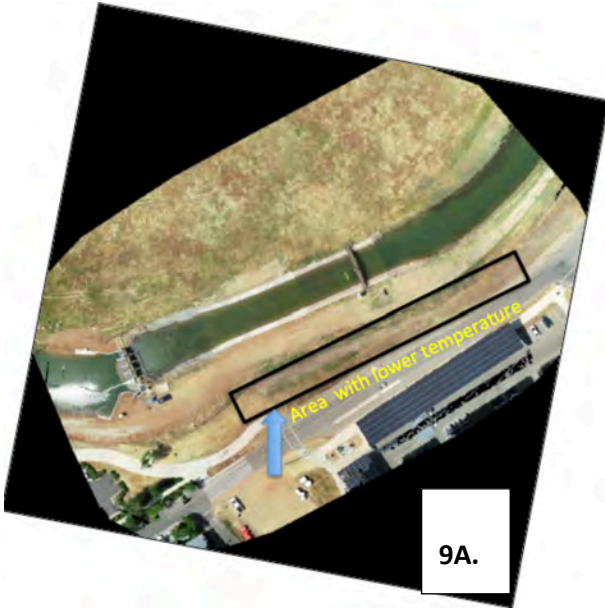
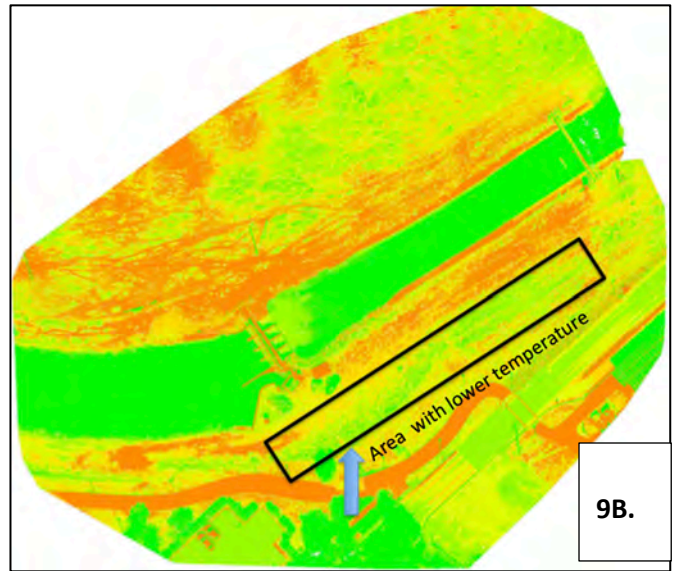
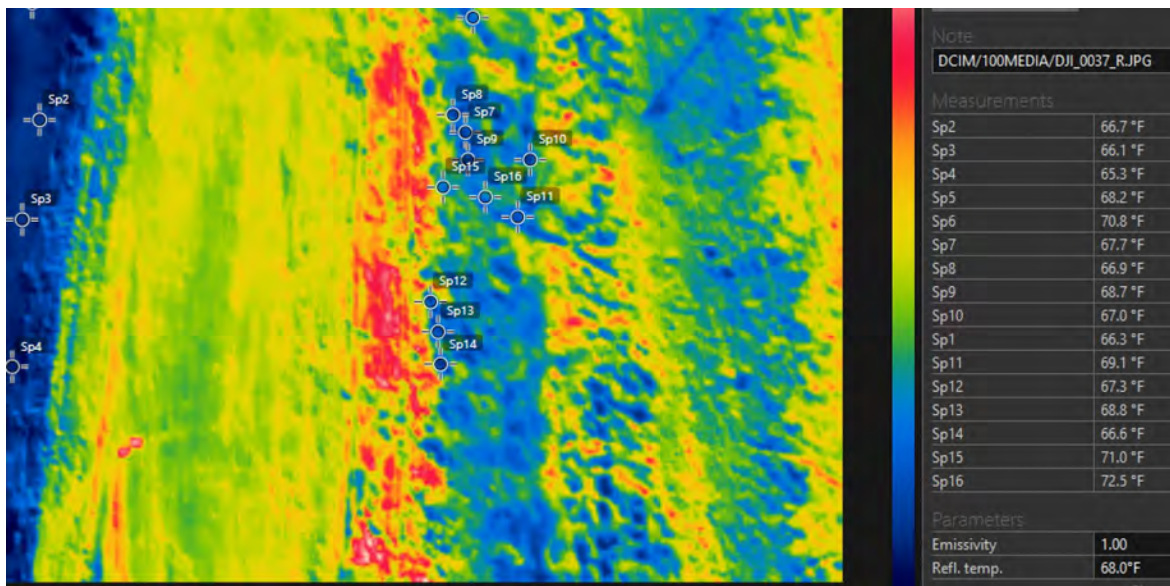
The green vegetation below the levee, in contrast to dry surrounding areas, is an indicator for potential water leaks (Figure 9A). Since vegetation takes time to establish, the area where it is growing was interpreted to have an on-going water leak through the levee. The canal water is interpreted to migrate in the subsurface through the levee and leak out on the road-facing side. The orthomosaic and reflectance index maps (Figures 9B, 9C) were developed from aerial data collected at the end of August 2019. The large contrast in temperatures between the ground (122F) and canal (67F; 55F difference) and low humidity (28.8%) presented excellent conditions for the thermal sensor. The corresponding thermal anomaly showed up strongly on the levee surface (Figure 9C. green - cool, orange- hot).

Figure 9A. Vegetation can be an indicator of water leaks, as seen in this orthomosaic map generated using P4P, with Pix4D Capture and Mapper. Grass and shrubs are visible on the levee side facing the road, approximately 5 feet below the levee top (box area). The orthomosaic map shows an area that corresponds to thermal anomalies shown in the reflectance index map, figure 9B. The area in the box exhibited lower temperatures (green) than the bare ground on the top and side of the levee (orange) and is interpreted as a leak. In Figure 9C, the blue area on the far left is the canal (cooler temperature points Sp2, Sp3, Sp4, ), the green and yellow area is the levee top (warm), and the red-yellow area is the levee side (warmest). Below this area, the area shown in dark blue patches is interpreted to be the area of water leakage (e.g., temperature points Sp5, Sp7, Sp8).

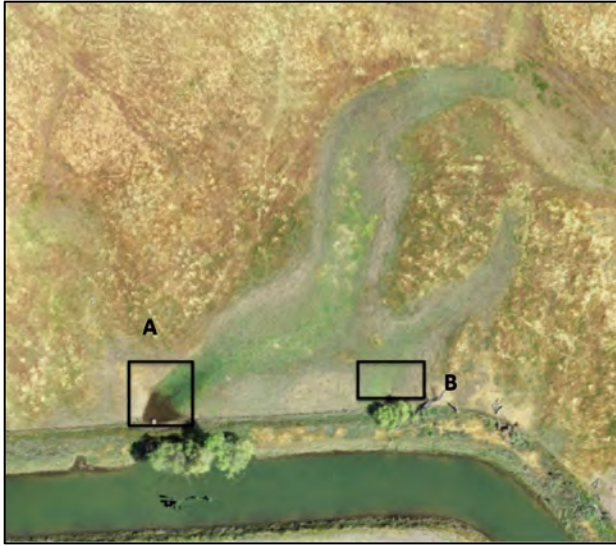
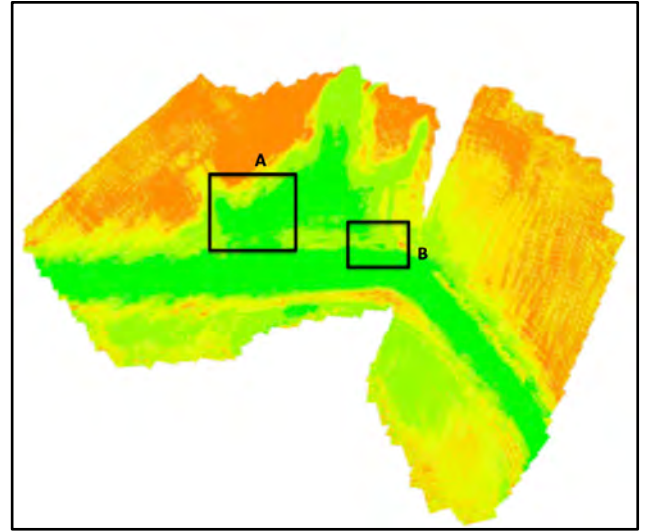
At the UCM2 site, two large outflows through the earthen levee were observed in both the orthomosaic and reflectance index maps. The canal water surface is approximately 5 feet below the top of the levee. The aerial map developed from P4P images (Figure 11A) shows two main water leaks (boxed areas: A, B) through the levee. The reflectance index map (Figure 11B) developed from the M200 images clearly shows the locations of lower temperature anomalies for the canal area (green) compared with the hotter ground (yellow - orange). The areas with boxes A and B are interpreted to be leak areas. Using Flir tools software, we reviewed temperatures on a pixel-detail level in the thermal image. The temperature anomaly is evident – the darkest blue area in Figure 11C identifies the specific area of leak in box A.

Figure 11A. Orthomosaic map developed using P4P drone illustrates 2 main areas of water flowing out of the canal (boxes: A, B). Figure 11B. Reflectance index map for UCM2 with thermal anomalies detected, reflecting the 2 main leaks areas (boxes: A, B).

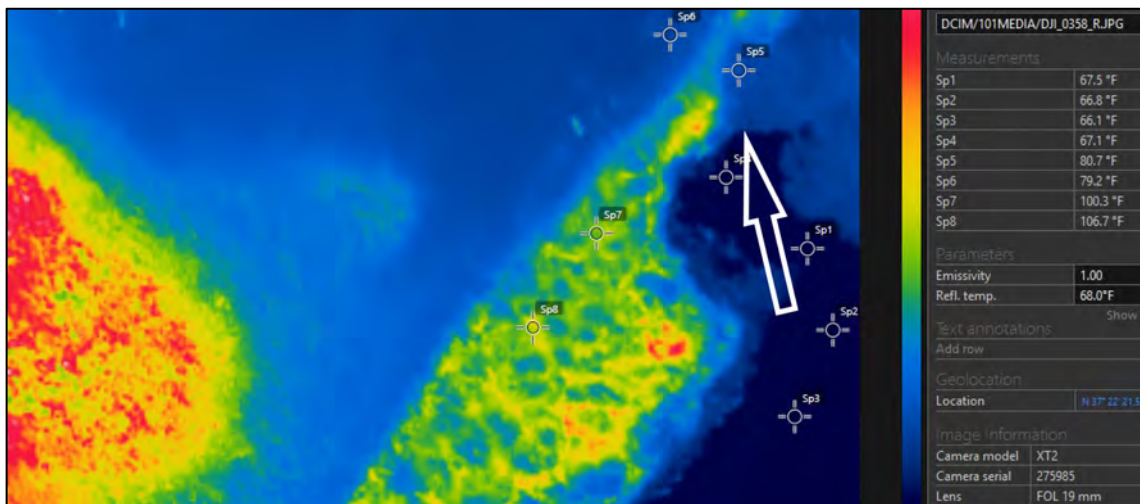
Figure 11C. Close up thermal image of an area of low temperature in box A. Using Flir Tools software the image illustrates specific low temperature locations (dark blue area, Sp1 to Sp4) where water is interpreted to be flowing out through the levee. Green, yellow, orange, and red areas are warmer temperatures, e.g., Sp5 to Sp8).

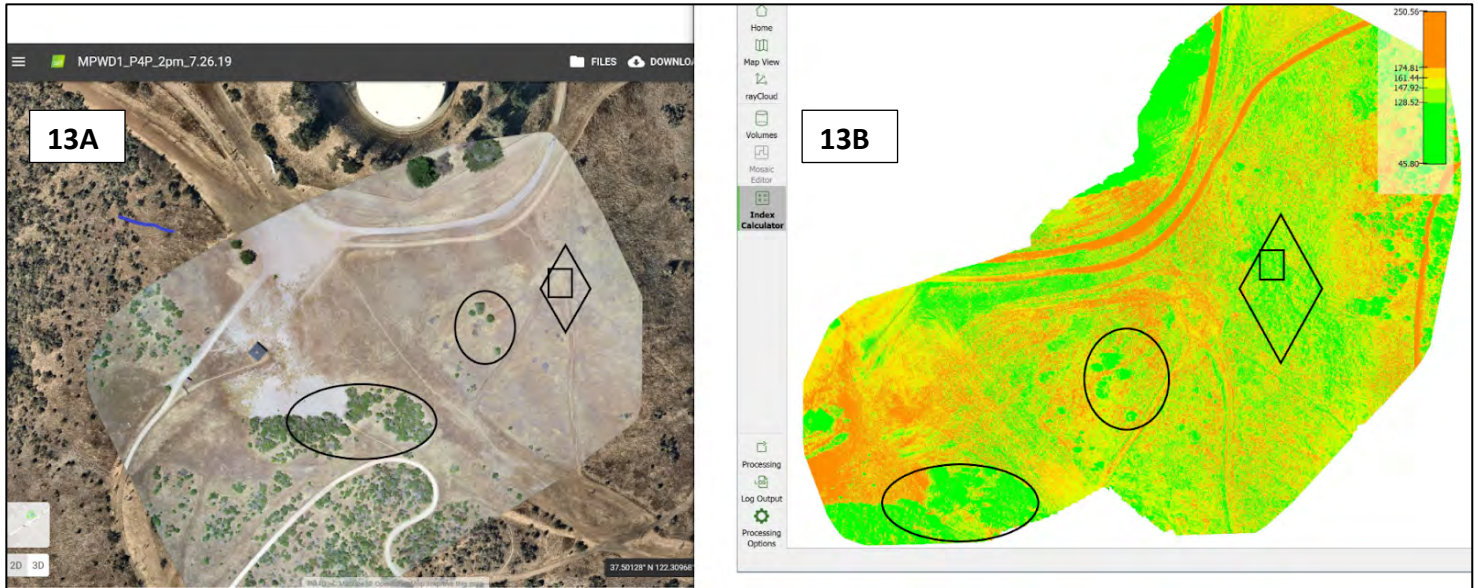
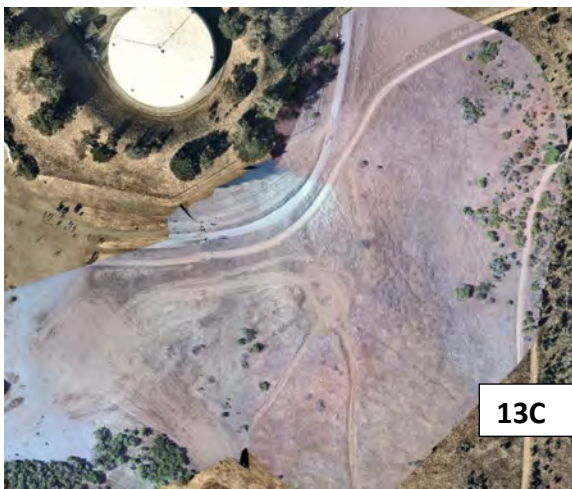
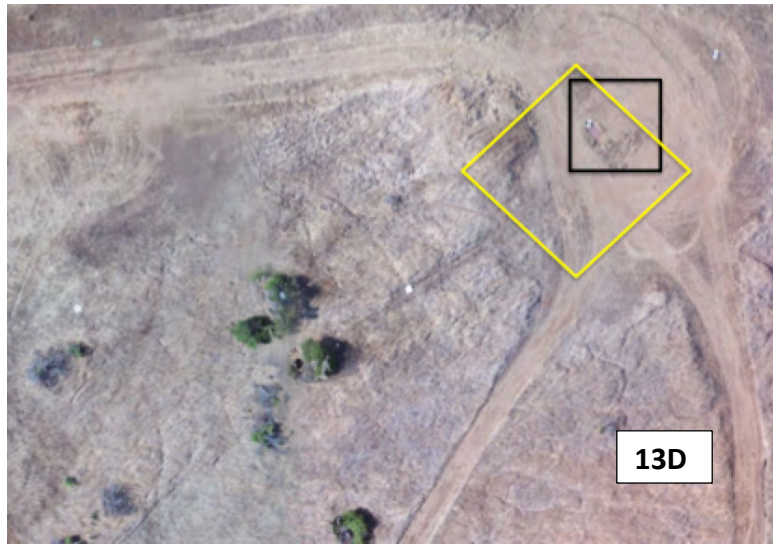
Figure 13A, B, C, D. Figure 13A. Visual (P4P) and Figure B reflectance (M200) aerial maps illustrate the MPWD1 site. The green areas in Figure 13B reflect cooler temperatures, while the yellow-orange areas reflect warmer temperatures. Figure 13 C shows the reference location for the enlarged view in Figure 13D. The square on Figures 13A, 13B, and 13D outlines the general area of the valve box (approximately 4.5 ft. subsurface) – the location of the simulated ‘leak’; the diamond shows the general area with lower temperatures. This area is interpreted as: ‘affected by the simulated leak’ – with temperatures approximately 10F lower than the surrounding ground on the dirt road. By comparison, the ovals (13A, 13B) to the left show how vegetation appears as a temperature anomaly, an artifact on the reflectance map.

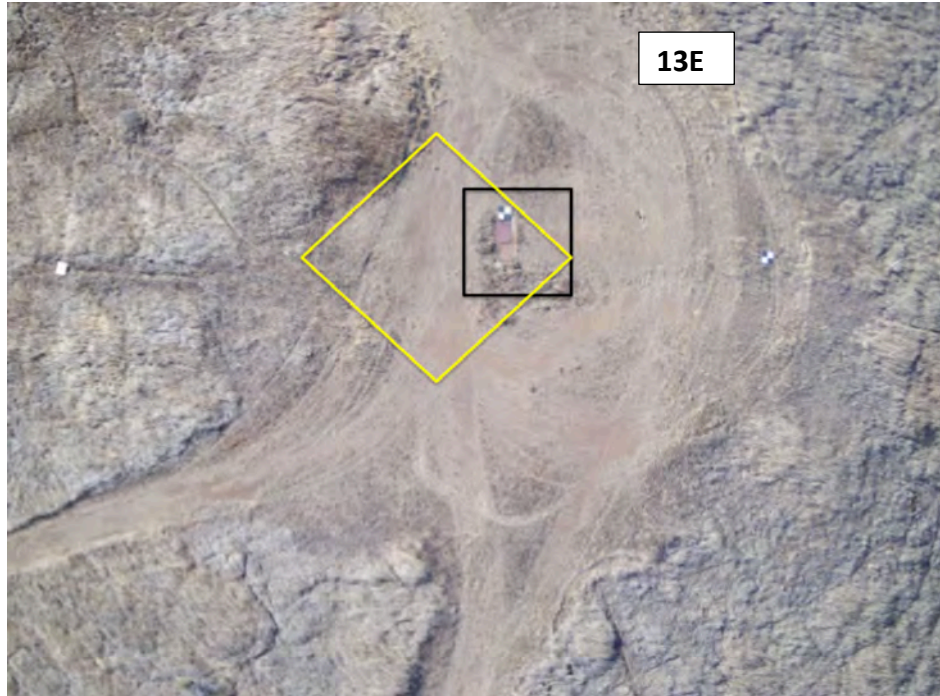
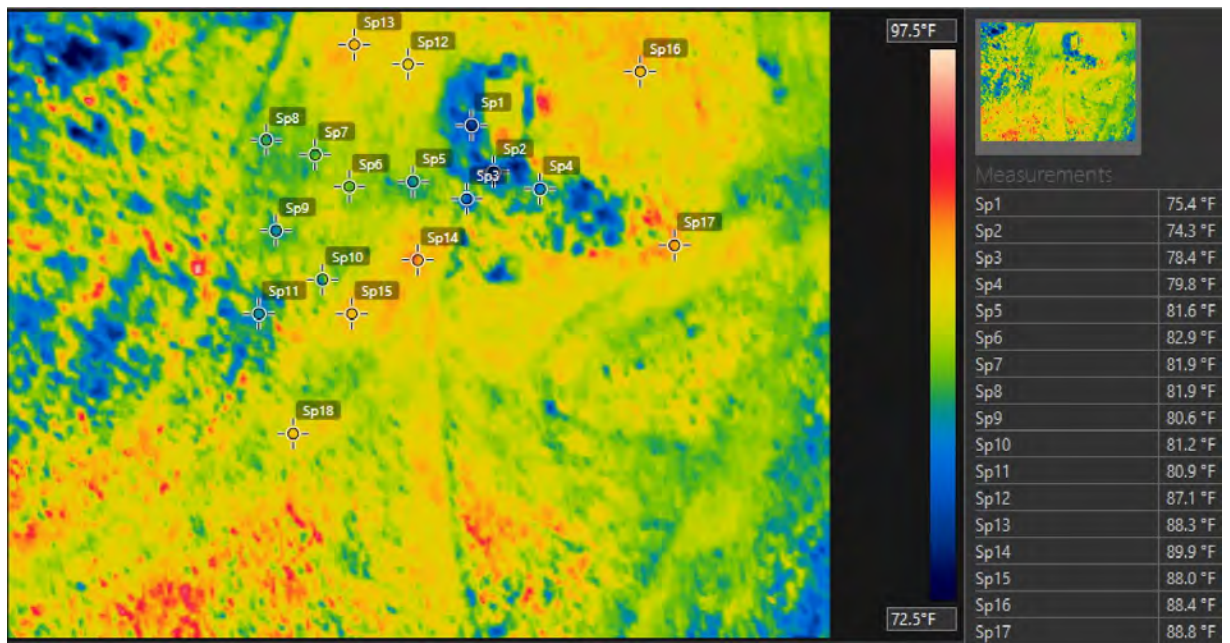
Figure 13E. M200 aerial visual image for reference to Figure 13F, showing the location of the valve box (square box) and approximate location of thermal image showing lower temperatures in figure 13F. This M200 aerial thermal image shows a closer view of the valve box with a metal cover (Sp1, upper center blue area) – the location of the subsurface simulated leak. The greenish mottled area, in the dirt road, to the left

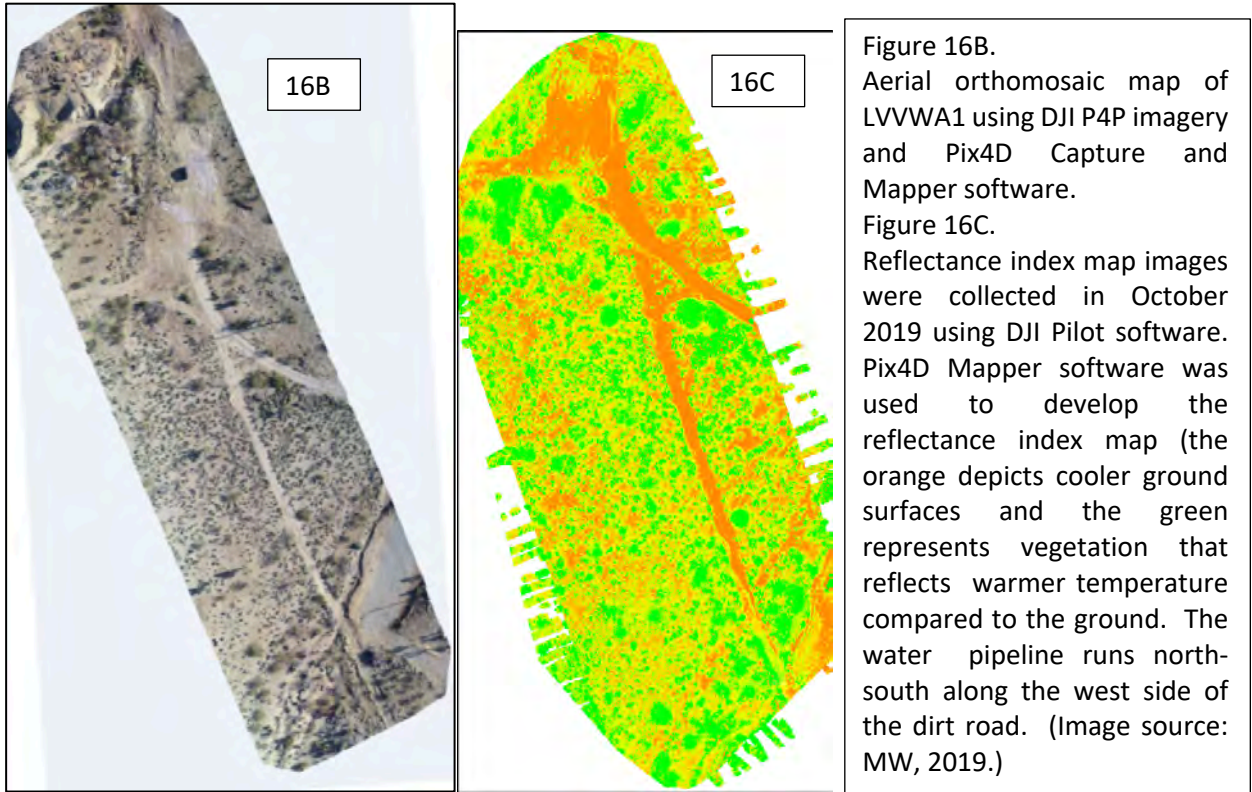
a reflectance index map and analyze it for thermal anomalies. No thermal anomalies were detected that could be interpreted as pipeline water leaks during fieldwork in May and October 2019.

Figure 16B. Aerial orthomosaic map of LVVWA1 using DJI P4P imagery and Pix4D Capture and Mapper software.  
 Figure 16C. Reflectance index map images were collected in October 2019 using DJI Pilot software. Pix4D Mapper software was used to develop the reflectance index map (the orange depicts cooler ground surfaces and the green represents vegetation that reflects warmer temperature compared to the ground. The water pipeline runs north-south along the west side of the dirt road. (Image source: MW, 2019.)

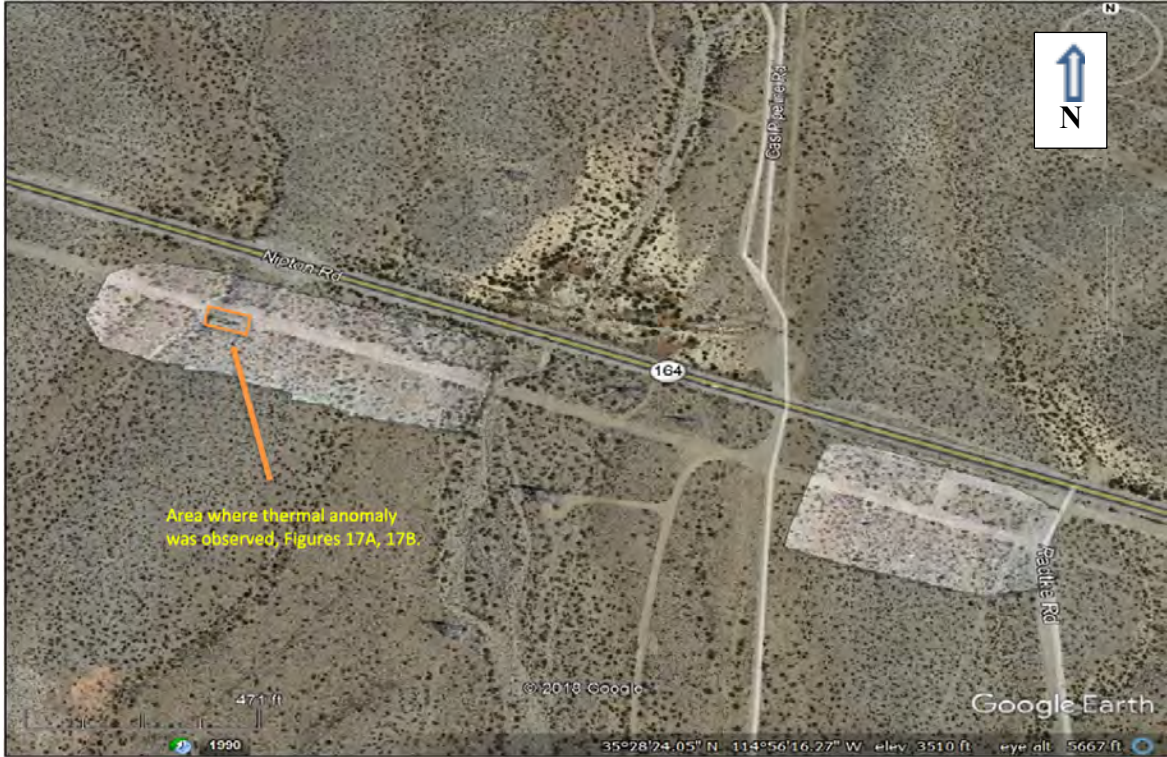
During the May 2019 fieldwork, hundreds of thermal images were collected from drone flights. On May 27 at 6:50 am, the aerial thermal sensor detected a pattern of apparent thermal anomalies. That morning was chilly, with ground temperature in the low to mid-50s F, while water temperature was about 70F. Near the north-west end of 2.1A (Figures 17A, 18A, 18B), the temperature increased consistently about 10F, to mid and high 60s F (Figures 18A, 18B). This apparent thermal anomaly was visible in this area for about 45 minutes.

17B. Aerial orthomosaic map, generated using DJI Phantom 4 Pro and Pix4D Mapper software, for LVVWA S2-1AB, S2-2AB. (Source: MW drone flight, 2019). The water pipeline runs parallel to the south side of the dirt road. Note: orange box shows the location of a thermal anomaly observed on May 27, 2019.

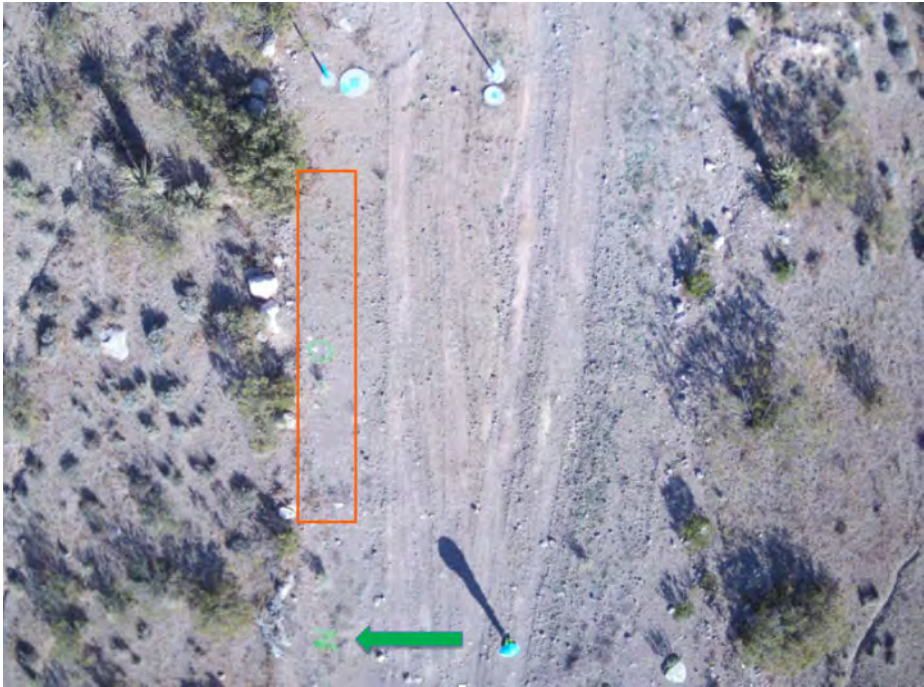
Figure 18A. Visual aerial image showing the location (orange box) of the temperature anomaly observed early morning on May 27, 2019. The water pipeline runs along the left side of dirt road, in the area of the orange box. The arrow points to the green “N” on the ground to help locate the area of interest in the visual and thermal images.

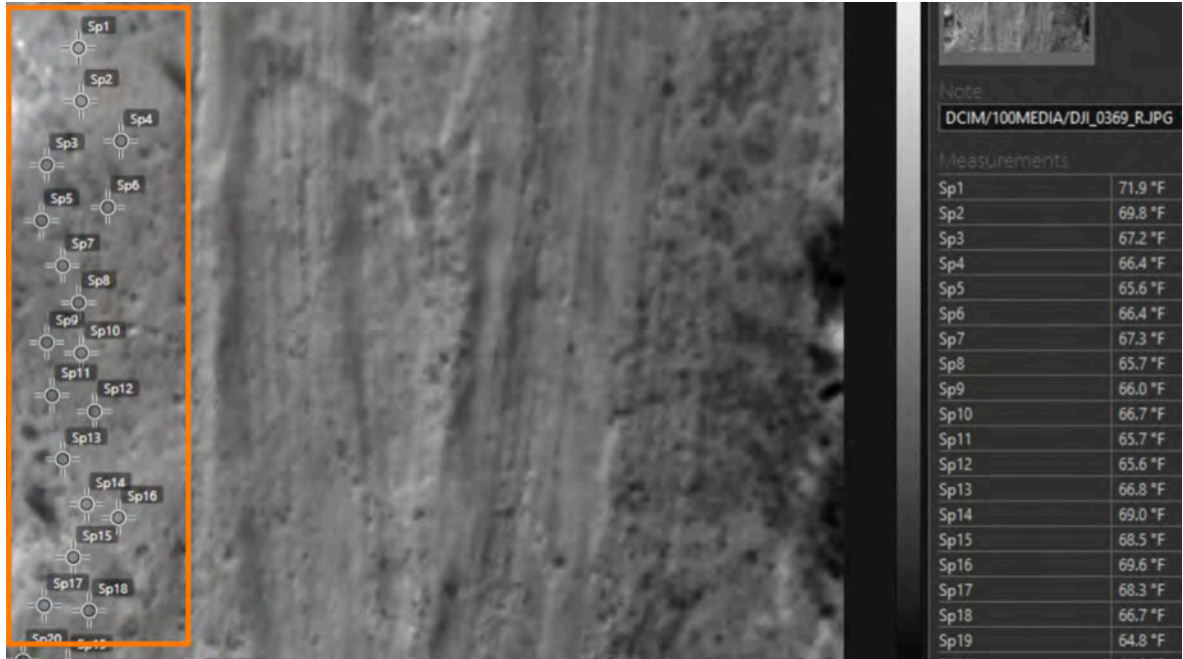
Figure 18B. Thermal aerial image showing the location (orange box) of the temperature anomaly observed early morning on May 27, 2019. The water pipeline runs along the left side of dirt road. The thermal images for LVVWA2 were generated using DJI Matrice 200 with Zenmuse XT2 sensor and DJI Pilot software. Flir Tools software was used to analyze the image and temperature values. As the flight proceeded along the pipeline, approaching the ‘N’ mark on the ground (Figure 17A. green letter on the ground, bottom center), the Pilot in Command observed temperatures that were consistently 10F higher than the previous leg of the flight. The contrast in temperature appeared as an anomaly due to the flight’s early hour and lack of extended exposure to solar radiation.

The MW pilot in command contacted LVVWA staff, but the thermal anomaly in this area was no longer apparent later. The potential causes of the temporary anomaly and lack of clear visibility of the exiting leak(s) are discussed in the Summary and Findings sections below.

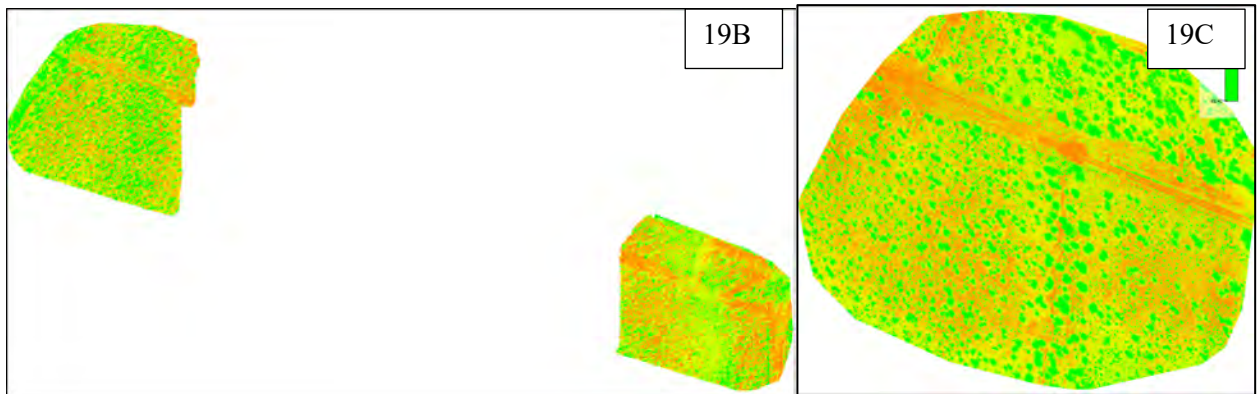
Figures 19B, 19C. Reflectance index map from LVVWA2 flight on October 31, 2019, using sUAS DJI M200 with the XT2 sensor and DJI Pilot software. The reflectance index map from this flight illustrates the cooler ground surfaces (orange) and vegetation that indicated warmer temperature (green) compared to the adjacent ground. The reflectance index map on the left (19B) shows both sections 2.1A-B and 2.2A-B. The reflectance map on the right (19C) is from a later flight on October 31<sup>st</sup> of segment 2.1A-B. No thermal anomalies attributable to water leakage were observed during the flights or in the reflectance index maps. (Source: MW, 2019.)
