City of Fullerton Meter Health Analytics Pilot Project

Deliverable #2: Final Report

City of Fullerton

July 11, 2024

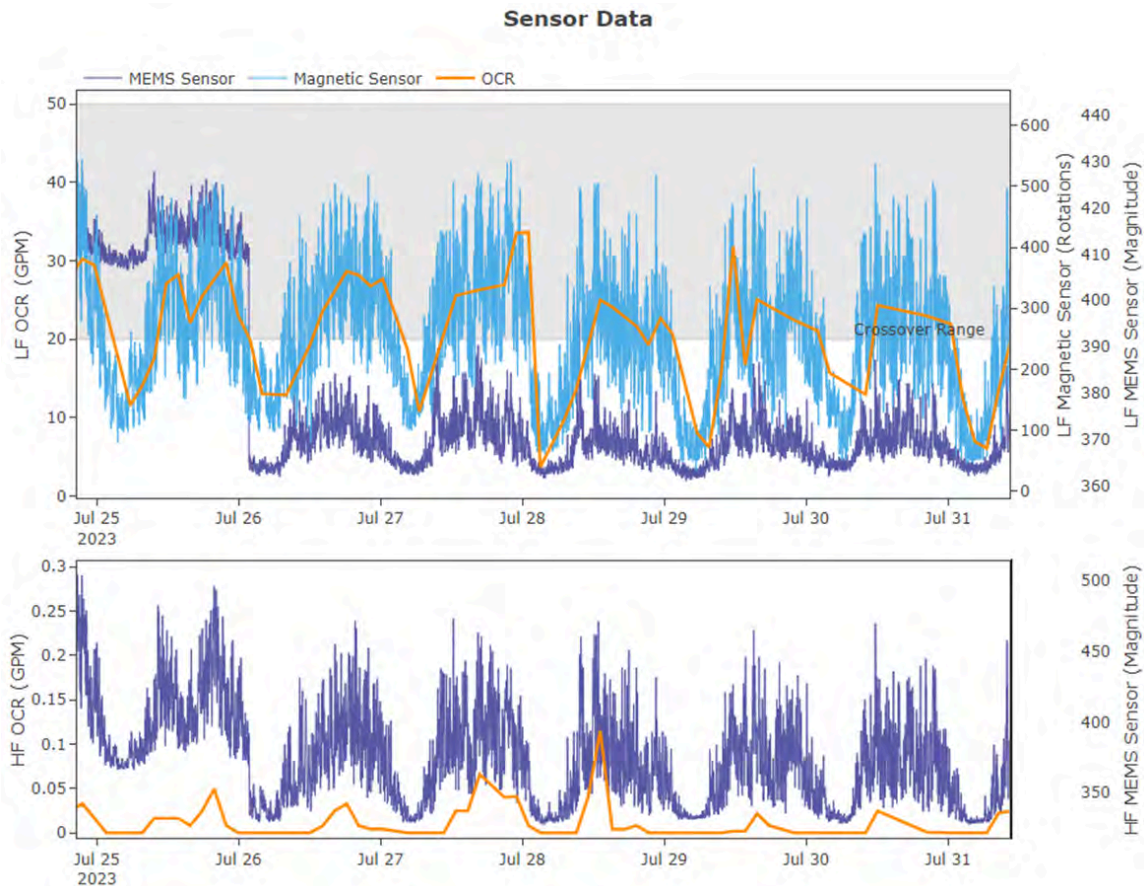
Meter Health Status: Error, Incorrect position of inlet valve and outlet valve, Potential high flow measuring element failure.

Figure 11 - Meter experiencing incorrect valve positions and a measuring element malfunction

- This meter is experiencing a high flow side measuring element malfunction, as well as incorrect valve positioning at the supply side and customer side valves.

- Observation (Figure 11): Flow is being recorded within the crossover range on the low flow side of the compound meter, but the high flow register data shows very low flows (<0.15 GPM), while Olea's acoustic sensor indicates that higher flows are present. This is indicative of a measuring element failure/malfunction on the high flow side of the compound meter.

- Both City and Customer side valves are not fully open, it is recommended that these be opened to the full position.
- The high flow side of the compound meter is not accurately representing flow because of a suspected malfunctioning measuring element. It is recommended that the measuring chamber be inspected for blockage or debris, or replaced.

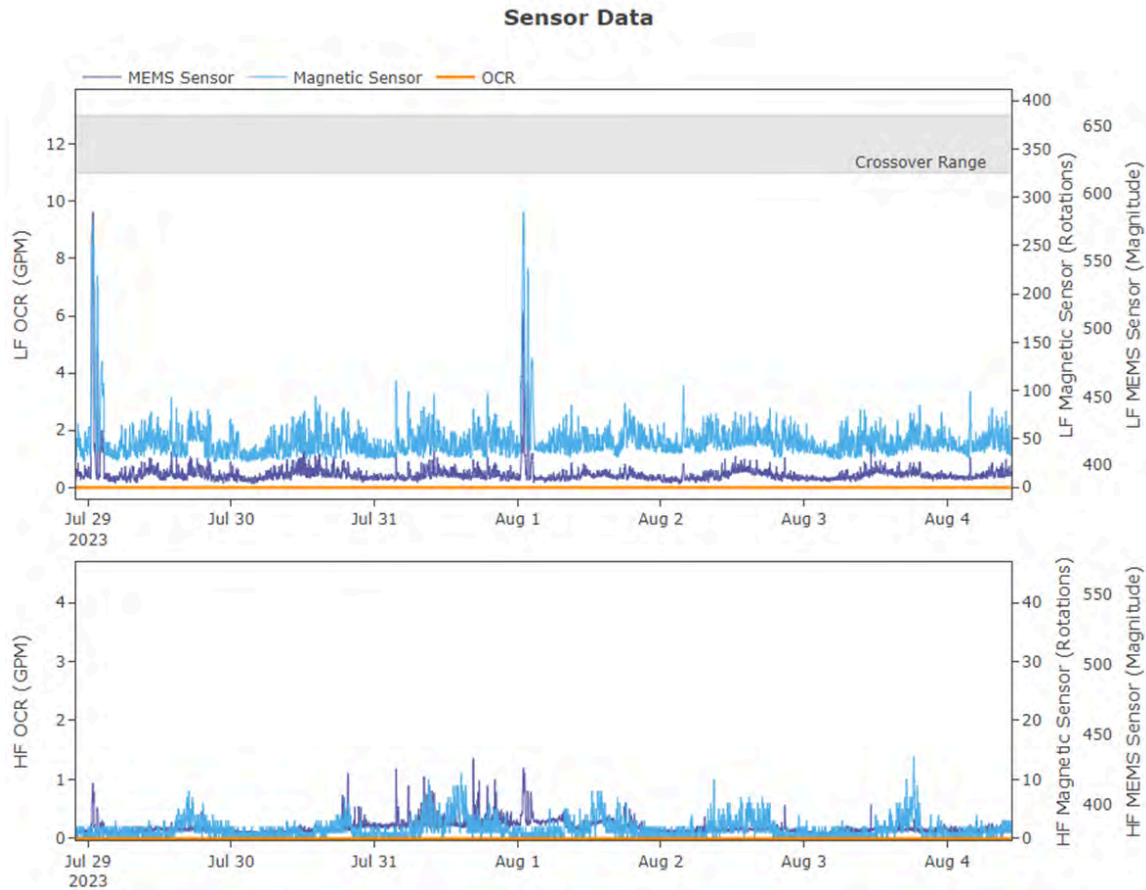
Meter Health Status: Error, High flow register failure & low flow register failure.

Figure 12 - Meter experiencing low flow register failure & high flow register failure

- This meter is experiencing failures on the low flow register and high flow register of the compound meter.
- Observation: The low flow side of the compound meter is not registering any flow. Olea's magnetic and acoustic sensors are picking up consistent flow through this meter. This is indicative of register failure.
- Observation: The high flow side of the compound meter is not registering any flow. Olea's magnetic and acoustic sensors are picking up consistent flow through this meter. This is indicative of register failure.
- There is also potential for there to be a crossover valve failure but Olea cannot confirm this until the low and high flow registers are fixed/replaced.

- The low flow and high flow registers on this compound meter are not recording flow, despite Olea's sensors indicating that flow is present on both the low and high flow sides.
- It is recommended that both registers be replaced.
- Is it also recommended that the crossover valve mechanism be inspected for malfunction, damage or blockage.

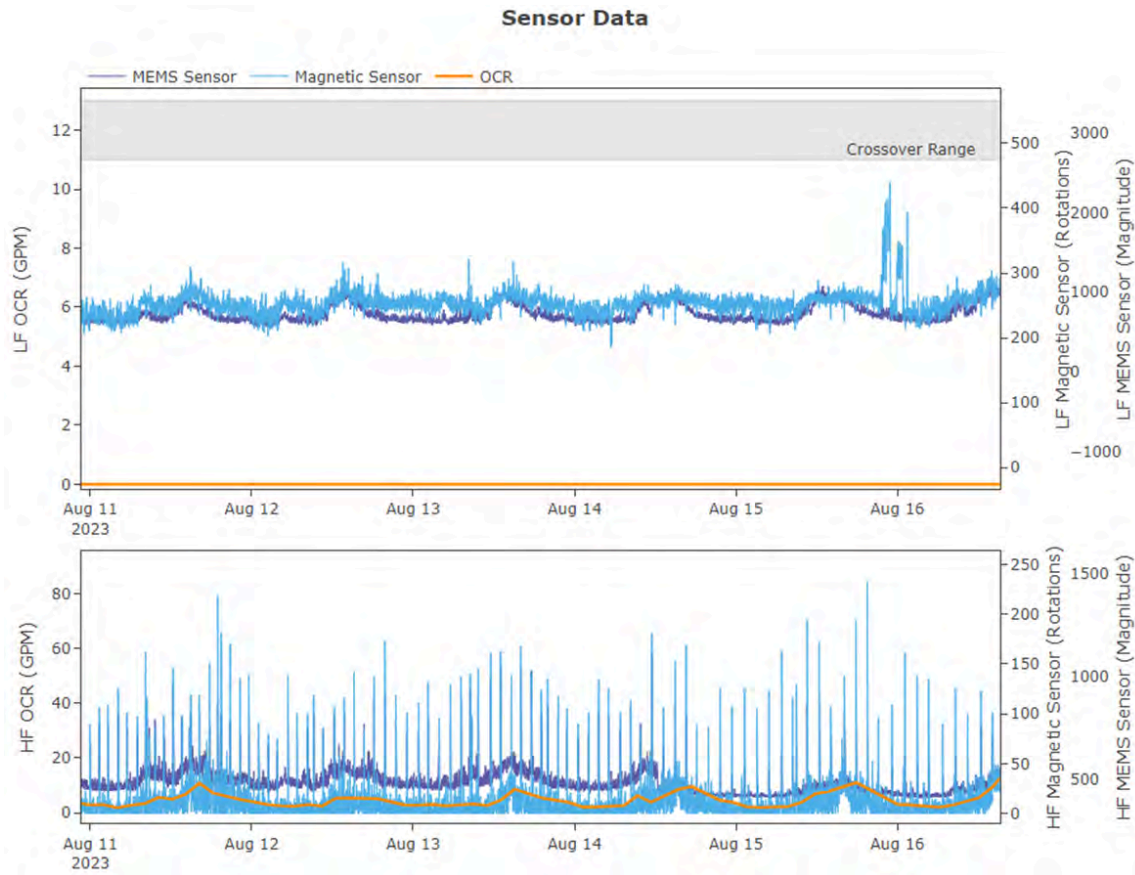
Meter Health Status: Error, Low flow register failure

Figure 13 - Meter experiencing a low flow register failure

- This meter is experiencing a failure on the low flow register.
- Observation: The low flow side of the compound meter is not registering any flow. Olea's magnetic and acoustic sensors are picking up consistent flow through this meter. This is indicative of register failure.
- There is potential for there to be a crossover valve failure but Olea cannot confirm this until the low and high flow registers are fixed/replaced.

- The low flow register on this compound meter is not recording flow, despite Olea's sensors indicating that flow is present. It is recommended that this register be replaced.
- It is also recommended that the crossover valve mechanism be inspected for malfunction, damage or blockage.

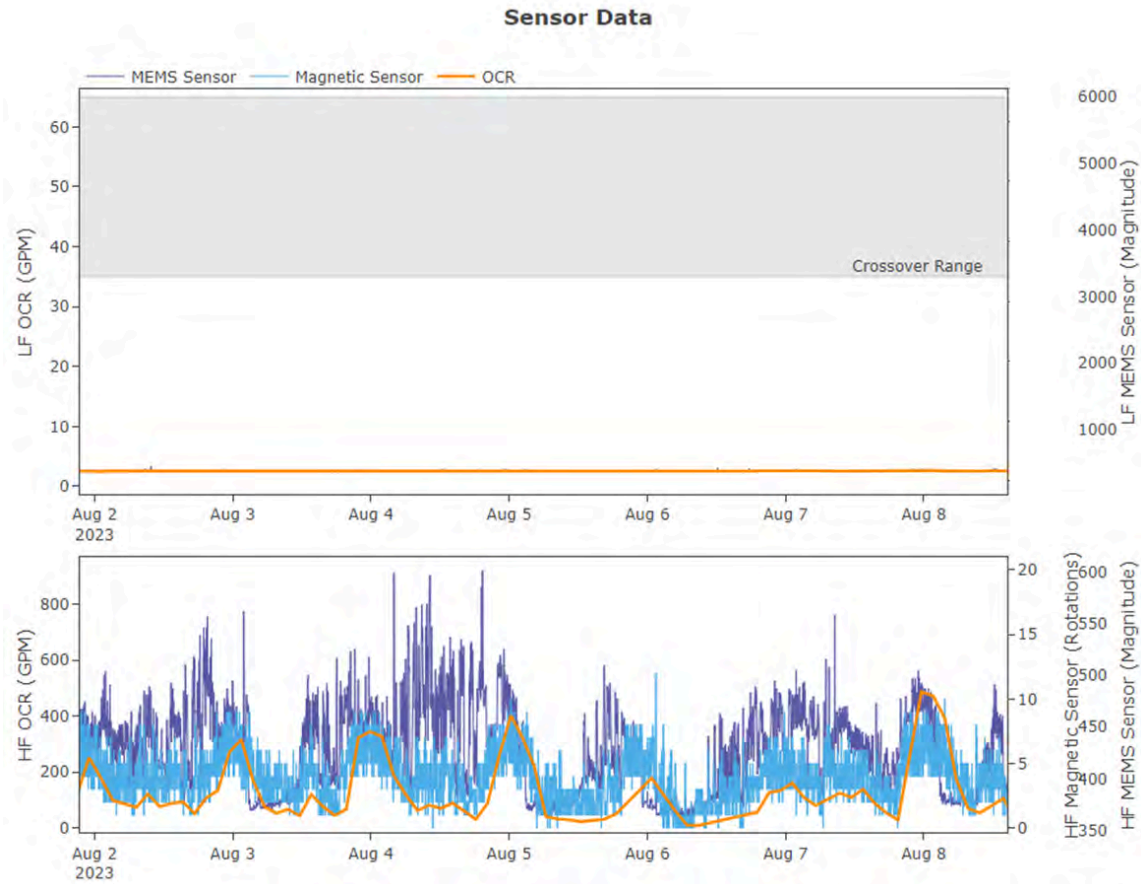
Meter Health Status: Error, Early crossover valve malfunction.

Figure 14 - Meter experiencing an early crossover valve error

- This meter is experiencing an early crossover valve error condition.
- Observation: 2.5 GPM is being consistently registered on the low flow side of the compound meter, this is nowhere near the crossover range of 35 GPM. Despite this, significant flow is being recorded on the high flow register. This is indicative of crossover valve malfunction.

- It is recommended that the crossover valve mechanism be inspected for damage or blockage.

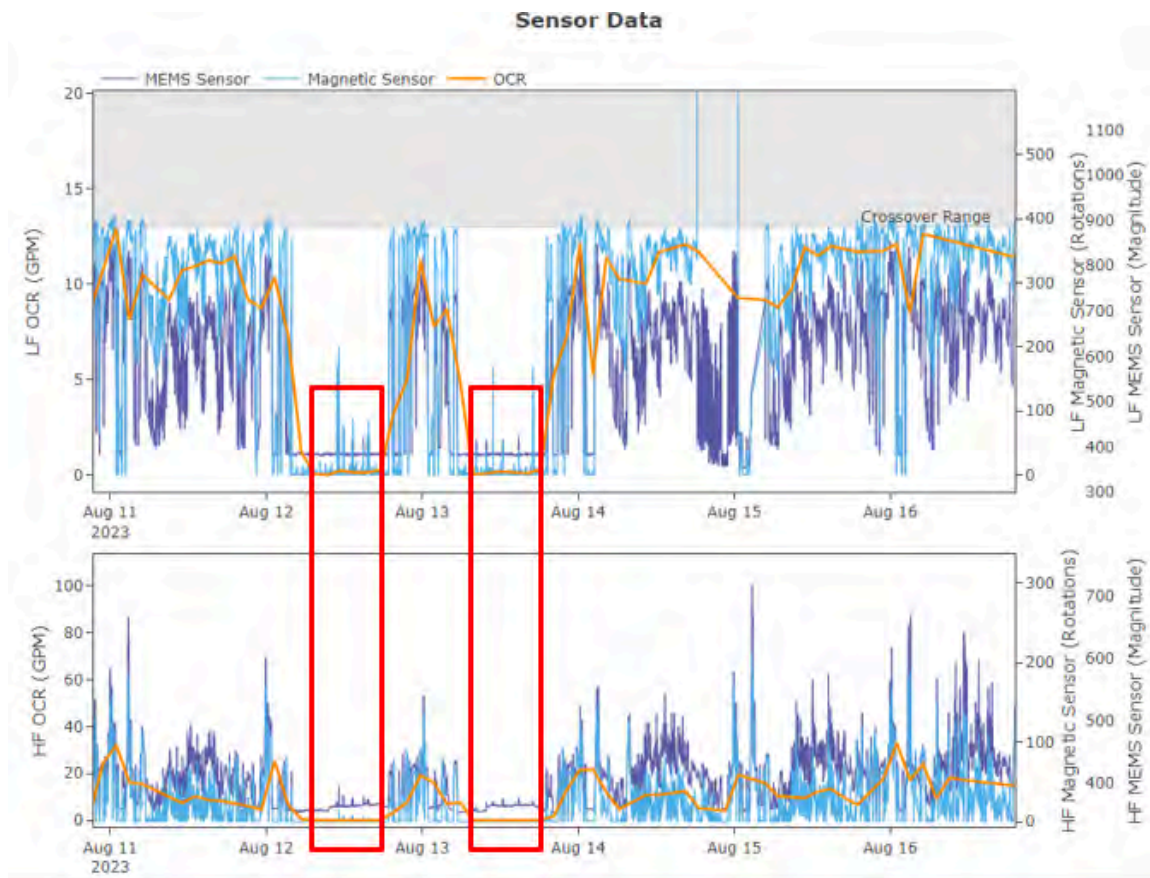
Meter Health Status: Error, Early crossover valve malfunction

Figure 15 - Meter experiencing an early crossover valve error

- This meter is experiencing an early crossover valve error condition.
- Observation: A small amount of flow (0.13 GPM) is being recorded on the high flow register when the low flow is not in the crossover range (13 GPM). This is indicative of crossover valve failure.
- During higher flow periods the crossover valve appears to be operating correctly.

- Although the early crossover error is allowing a very small amount of flow to enter the high flow side of the compound meter, this may be an early indication of a much larger crossover valve issue. It is recommended that the crossover valve mechanism be investigated for damage or blockage.

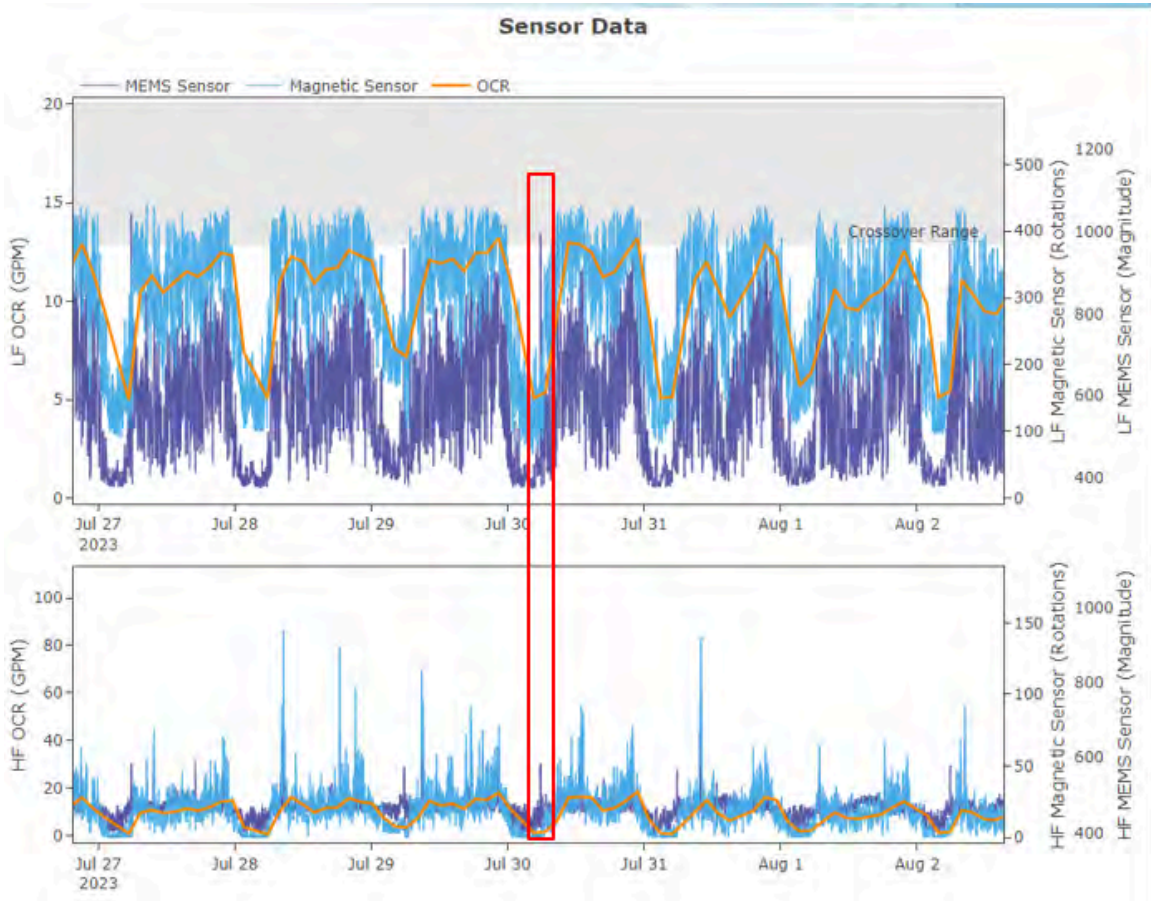
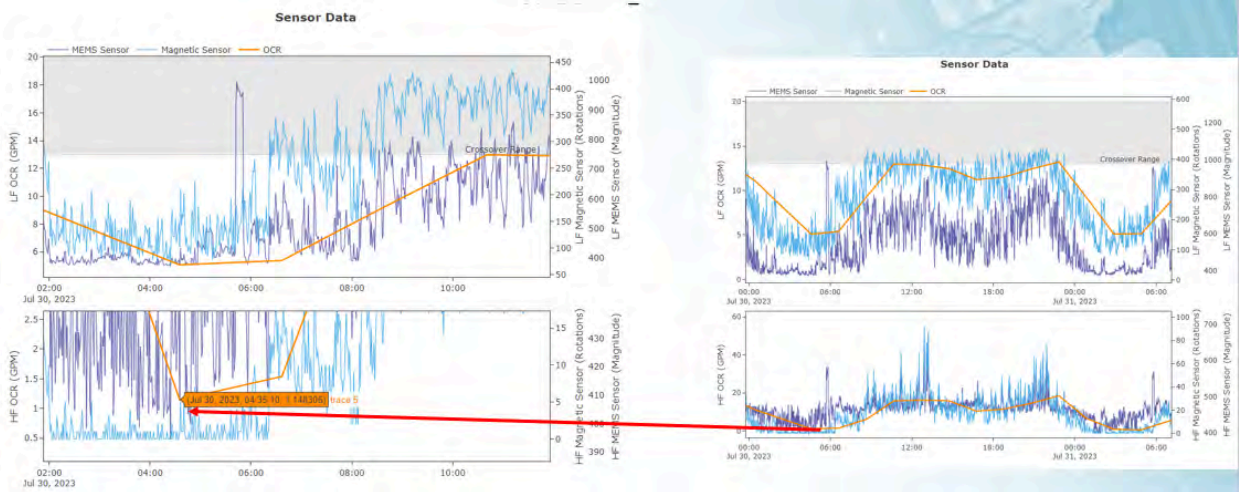
Meter Health Status: Error, Early crossover valve malfunction

Figure 16 - Meter experiencing an early crossover valve error

Figure 17 - 1.148 GPM being recorded on the high flow register despite the low flow side register recording 5 GPM, which is well under the crossover range of 13 GPM.

- This meter is experiencing an early crossover error condition.
- Observation: Flow is being recorded on the high flow register when the low flow register flow is not in the crossover range (13 GPM). This is indicative of crossover valve malfunction.
- During higher flow periods the crossover valve appears to be operating correctly.

- The early crossover valve error is allowing a small amount of flow (~1 GPM) to enter the high flow side of the compound meter; this may be an early indication of a much larger crossover issue. It is recommended that the crossover valve mechanism be investigated for damage or blockage.

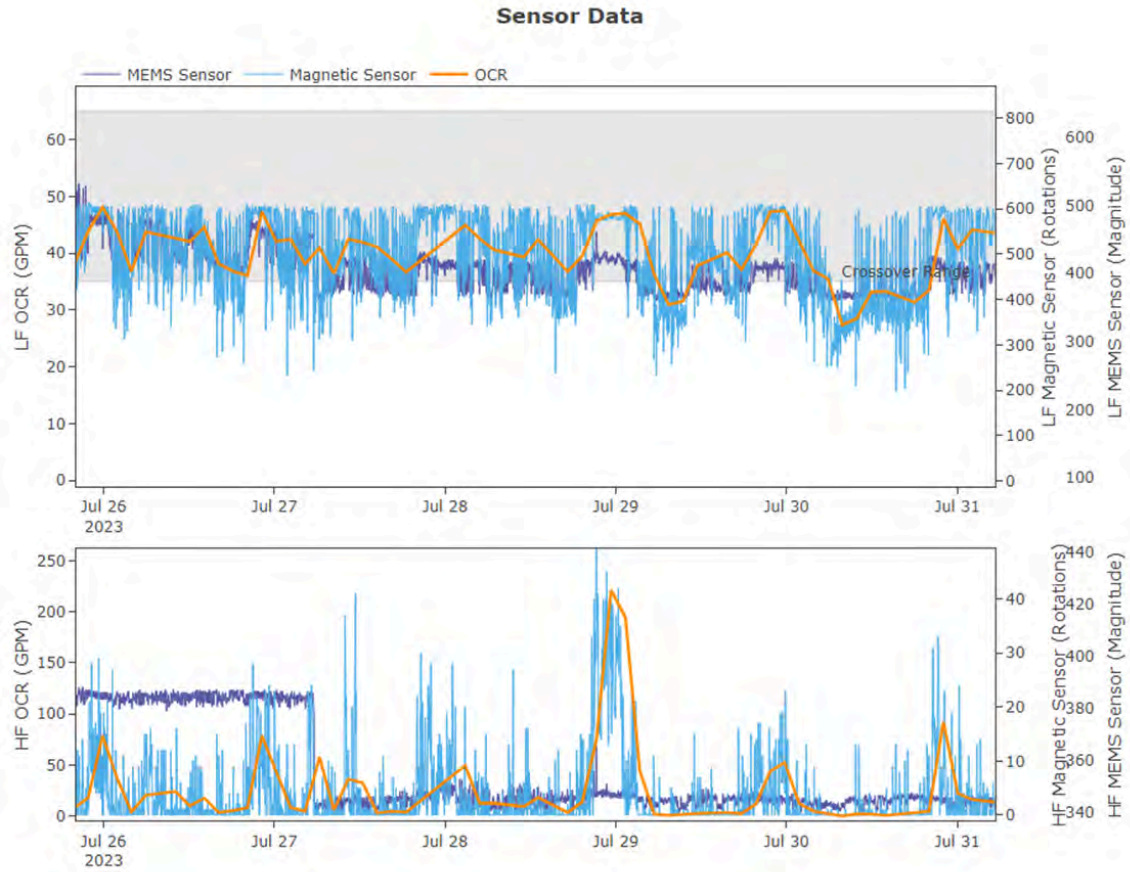
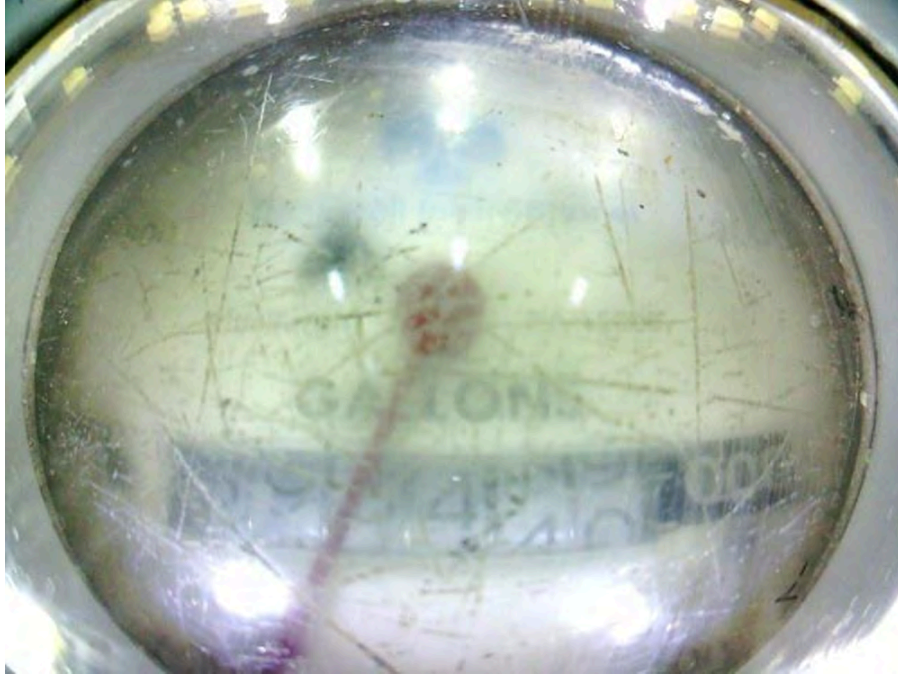
Meter Health Status: Error, Damaged Register

Figure 18 - Meter experiencing a damaged register

Figure 19 - Damaged register which makes meter reading difficult and prone to misreads.

- The high flow side of this compound meter has a damaged register.
- Observation: The high flow register is severely worn/scratched and has water residue inside of it.
- Olea's high flow side camera captured images of the register during the monitoring week. Our automated 'Optical Character Recognition' technology to convert images to digital numbers was unable to accurately capture consumption information due to the damaged register. Olea utilized manual procedures to capture the flow.
- While this is mostly a cosmetic issue, mistakes may occur with manual reading of the register. Water inside of the register may eventually lead to malfunction.

- It is recommended that the high flow register be replaced so that accurate consumption readings can be completed, and to avoid potential future issues associated with water in the register.

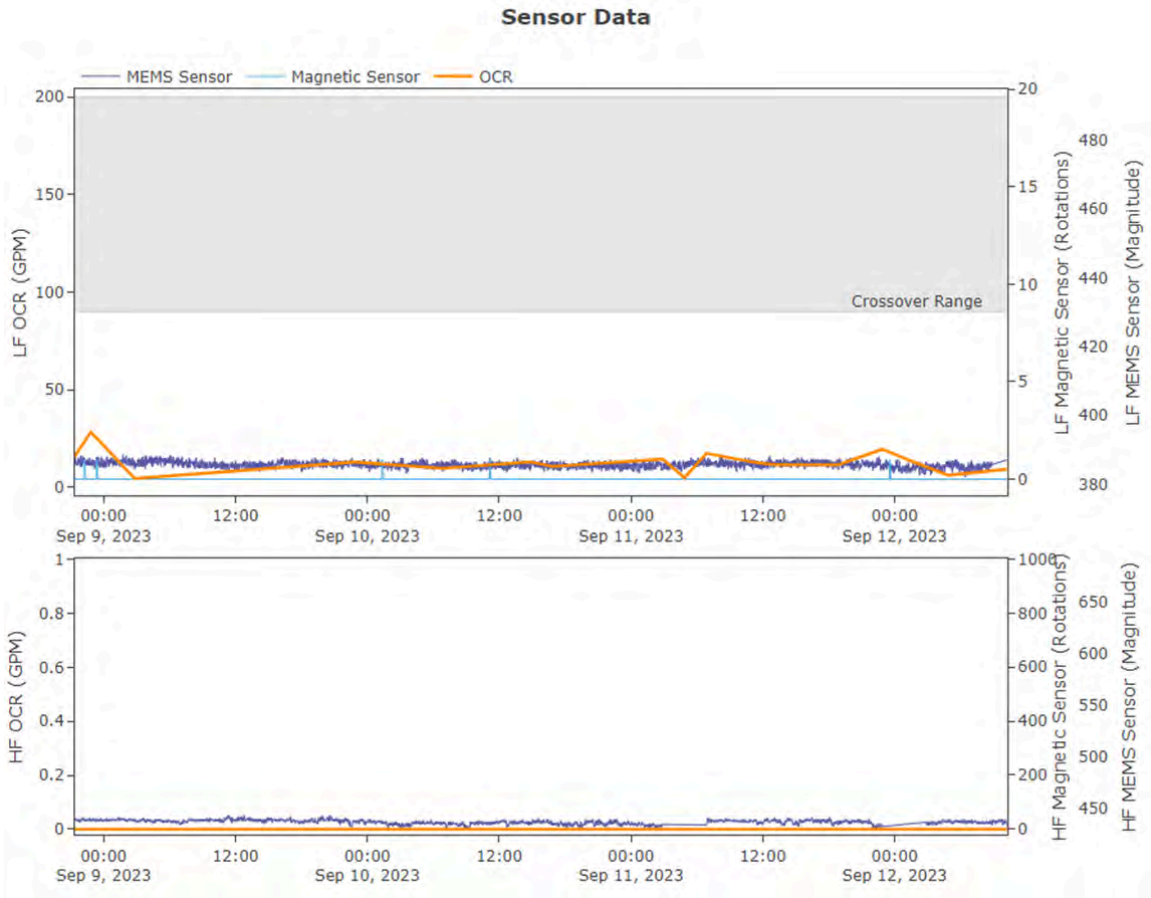
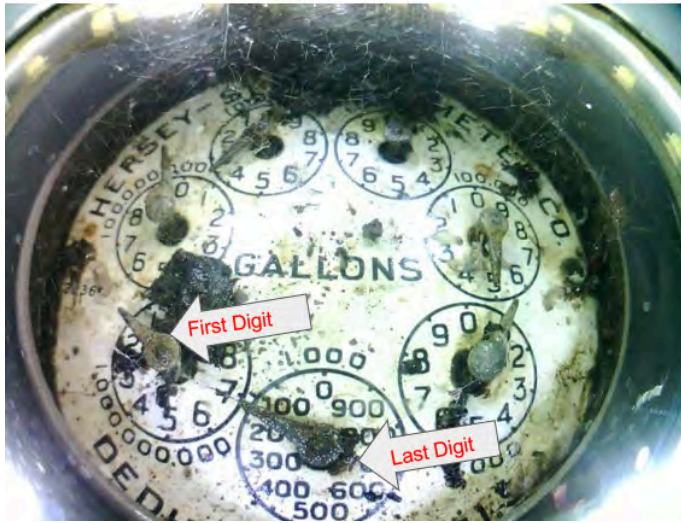
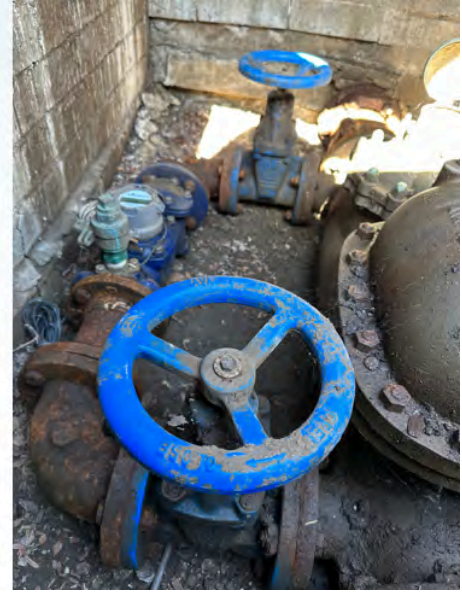
Meter Health Status: Error, Damaged register & incorrect meter configuration

Figure 20 - Meter experiencing a damaged register and incorrect meter configuration

Figure 21 - Damaged register & incorrect meter configuration

- The high flow side of this compound meter has a damaged register, and there is an incorrect meter type installed on the low flow side of the compound meter.
- Observation: The high flow register has signs of corrosion and dirt inside of it, this may be due to water in the register. It should be noted that no flow is being recorded on this register due to the low flows on the low flow side meter. Olea cannot conclude if the register has failed or not.
- Observation: This is a Hershey brand compound meter. A Sensus Omni C2 meter has been installed on the low flow side, Olea flags this as an install error due to the setup conflicting with the meter manufacturers specifications.

- It is recommended that the high flow side register be replaced.
- This Hershey compound meter has been configured with a Sensus meter on the low flow side. While this setup may operate without issue, it has been flagged as an error by Olea due to it conflicting with the meter manufacturers specifications.

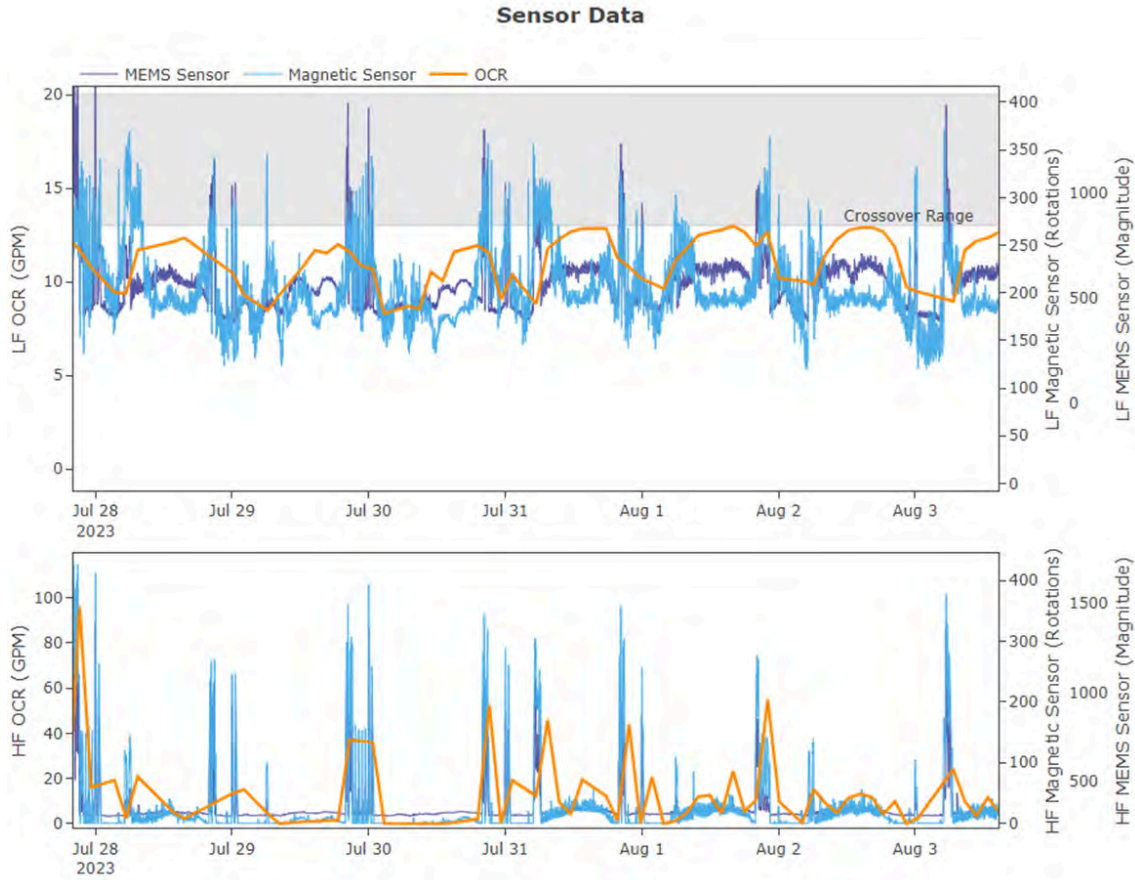
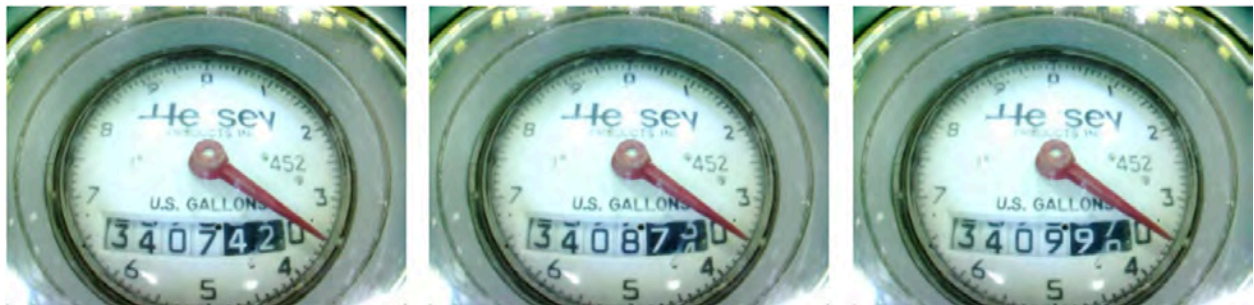
Meter Health Status: Error, Damaged register

Figure 22 - Meter experiencing a damaged register

Figure 23 - Consumption numbers changing on the register but the dial is not moving

- The low flow side of this compound meter has a damaged register.
- Observation: The low flow meter register dial is not moving, despite the consumption numbers turning correctly. This is not a major error/failure, but could indicate deterioration of the register.

- It is recommended that the low flow side register be replaced, although this is not a severe error it could be considered as preventative maintenance.

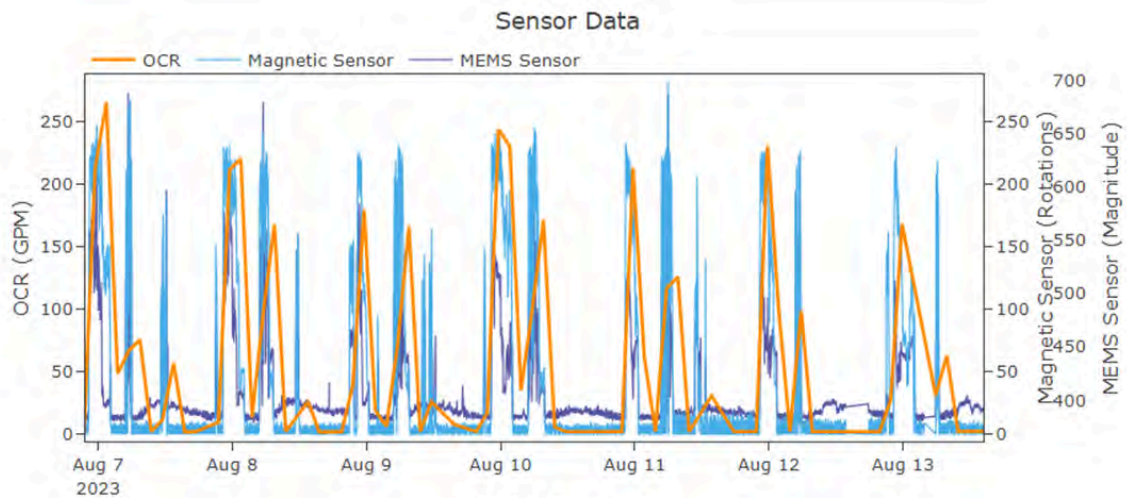
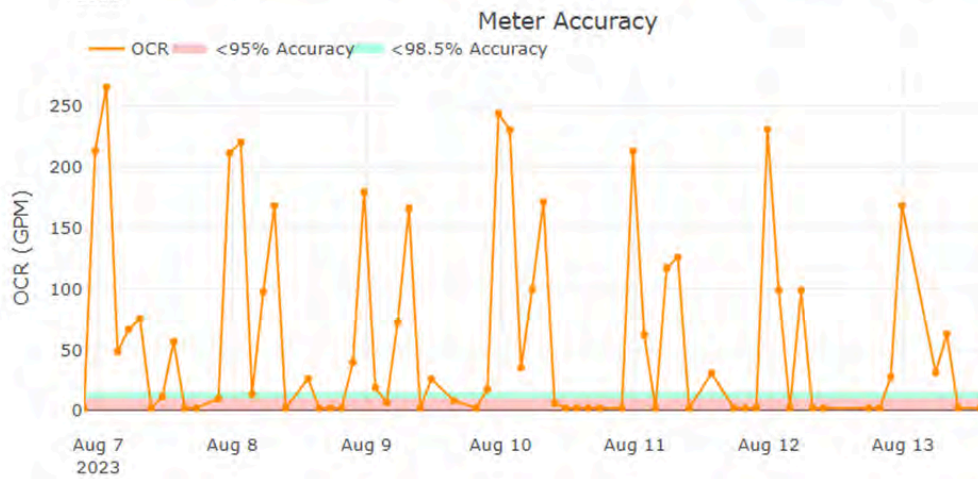
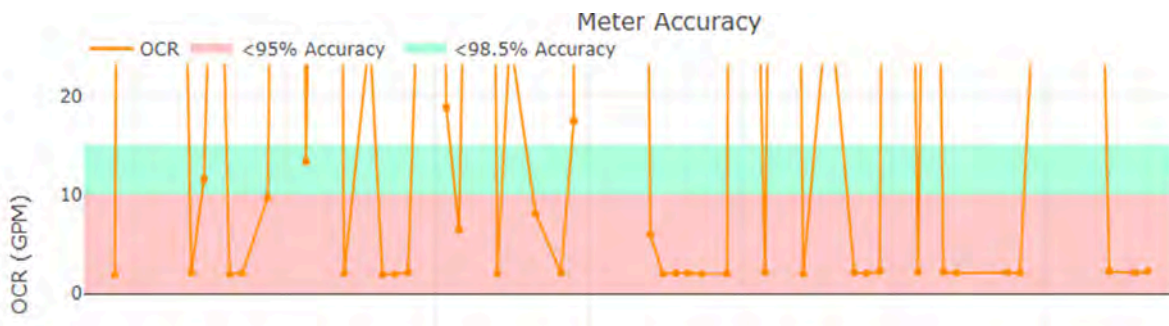
Meter Health Status: Error, Oversized & Potential customer side leak

Figure 24 - Meter oversized and experiencing a potential customer side leak

Figure 25 - Evidence of a Potential customer side leak, with low flow consistently at 2 GPM.

- Analysis reveals that this meter is oversized, and that there is a potential customer side leak.
- Observation: Manufacturer suggested minimum flow is 15 GPM. During the analysis period, 50% of registered readings occur below AWWA standards of 95% accuracy and 53% under the normal operating range of 98.5% accuracy as cited by manufacturers specifications.
- This meter is intermittently operating between 2 and 265 GPM.
- Olea has reason to believe that there is a potential customer side leak at this location; the low flow never gets to 0 GPM, but consistently reaches 2 GPM.
- Mechanically there were no problems found with this meter.

- It is recommended that Olea meter health analysis be continued for a few more months to see if water usage behavior changes.
- If intermittent low and high water usage continues, it may be worth considering exchanging this meter for one that can handle lower flows.
- It is recommended that the City communicate with this customer to determine whether they use water 24/7. If water is not being used 24/7 then it may be necessary to investigate a potential leak on their property.
- If the leak is identified and resolved, then this meter may not be oversized.

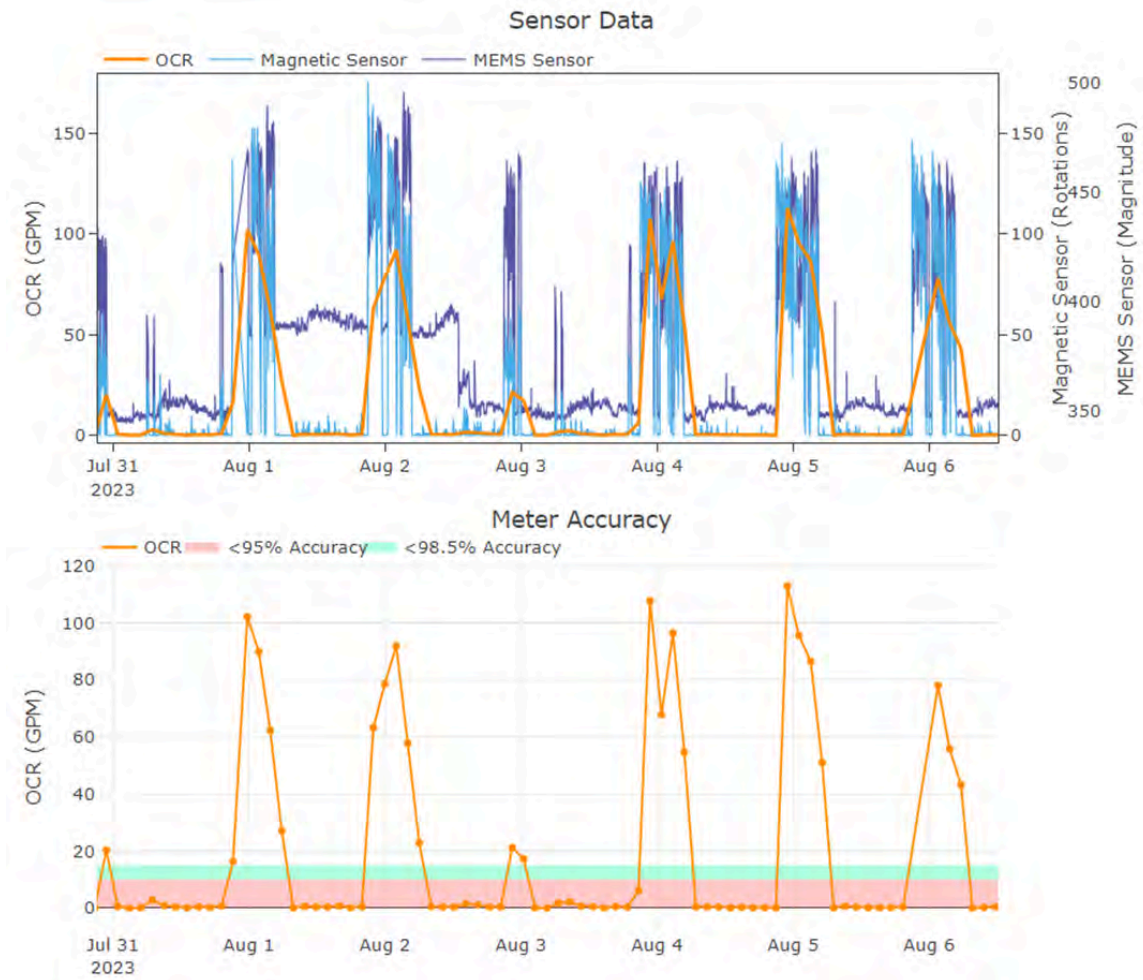
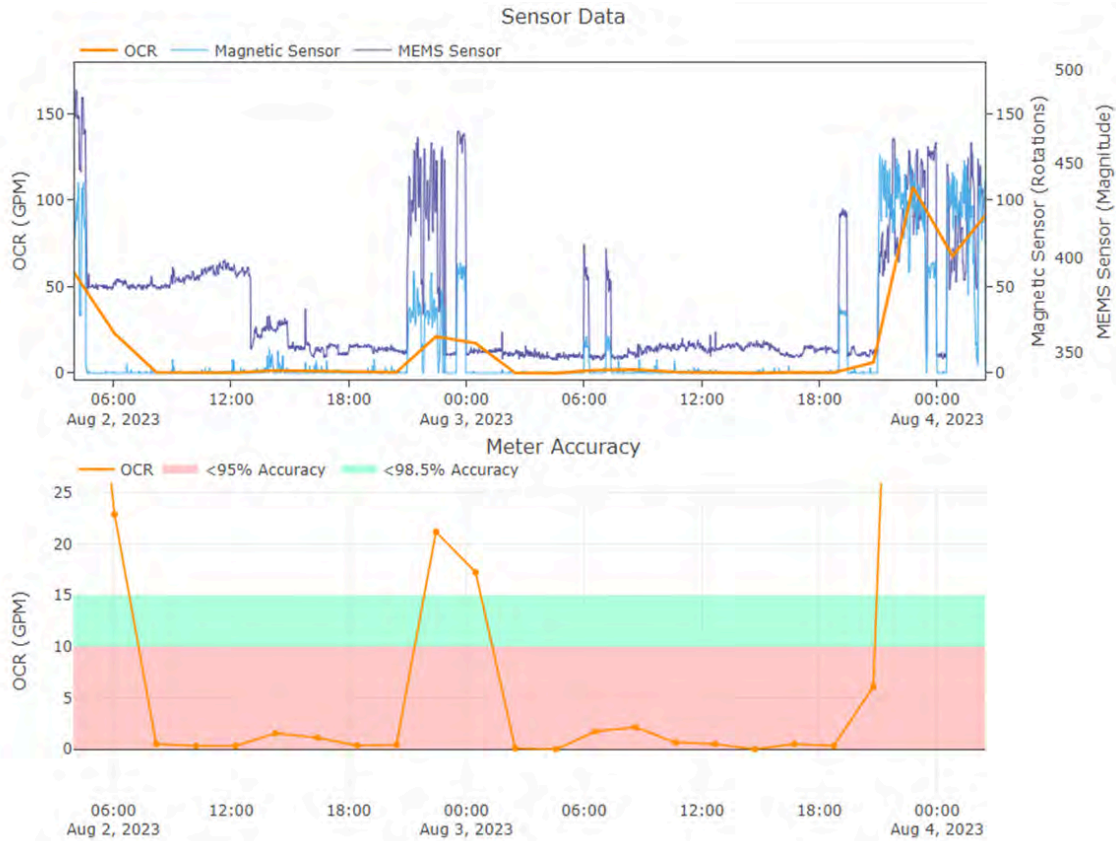
Meter Health Status: Error, Oversized meter

Figure 27 - Meter experiencing an oversized meter error condition

Figure 28 - Zoom showing flow outside of meter operating range

- Analysis reveals that this meter is oversized.
- Observation: Manufacturer suggested minimum flow is 15 GPM. During the analysis period, 64% of registered readings occur below AWWA standards of 95% accuracy and 64% under the normal operating range of 98.5% accuracy as cited by manufacturers specifications.
- This meter is intermittently operating between 0 and 112 GPM.
- Mechanically there were no problems found with this meter.

- It is recommended that Olea meter health analysis be continued for a few more months to see if water usage behavior changes.
- If intermittent low and high water usage continues, it may be worth considering exchanging this meter for one that can handle lower flows.

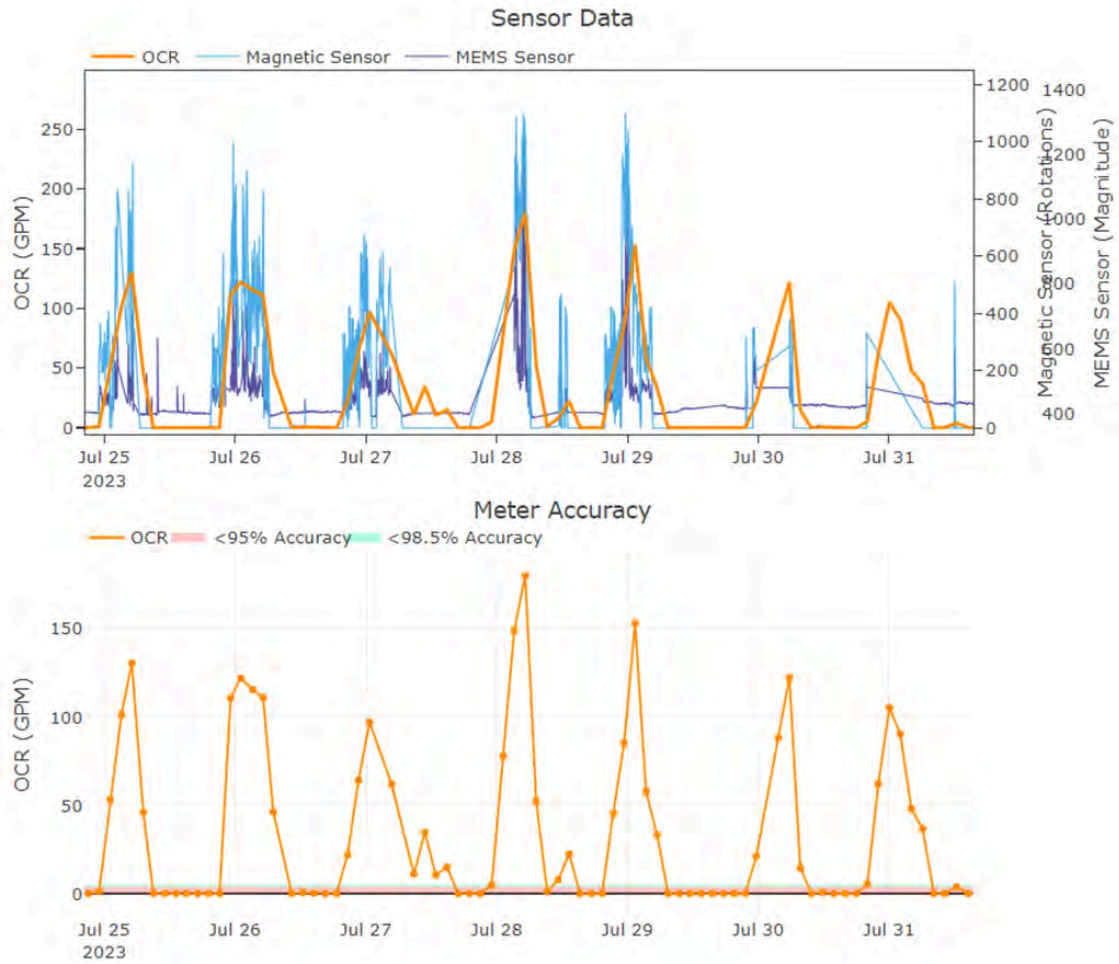
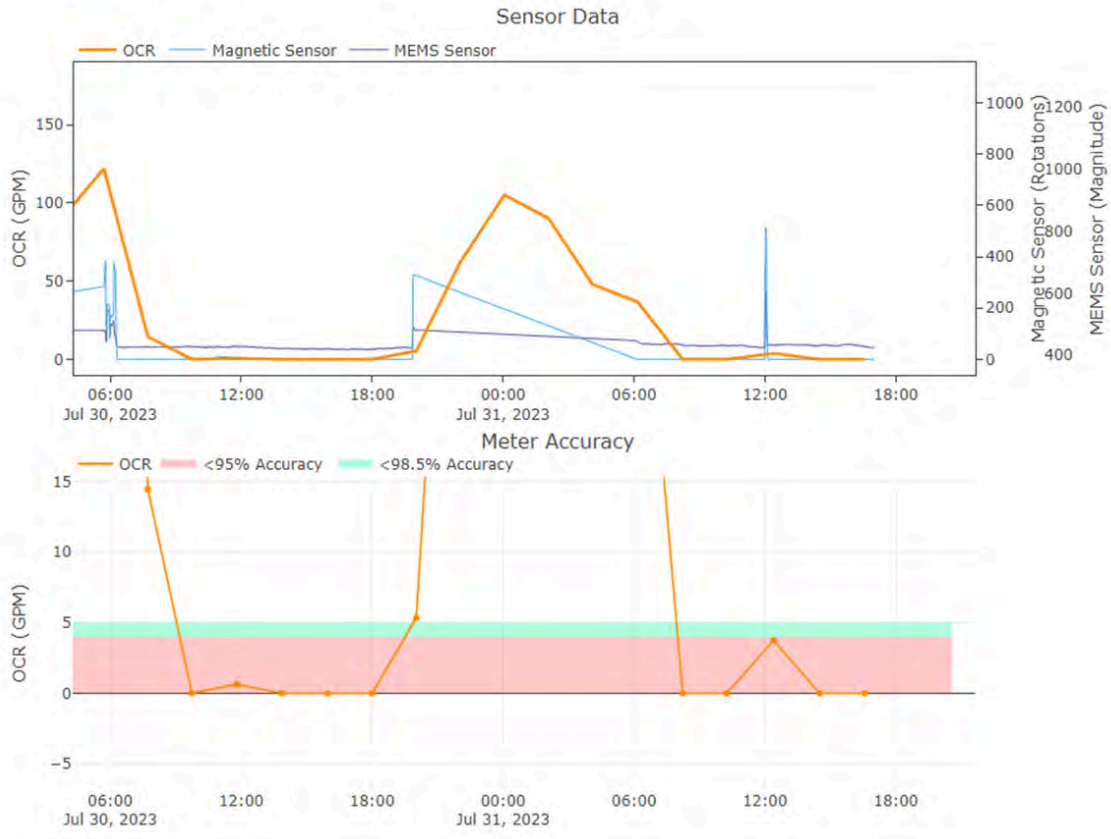
Meter Health Status: Error, Oversized meter

Figure 30 - Meter experiencing an oversized meter error condition

Figure 32 - Zoom showing flow outside of meter operating range

- Analysis reveals that this meter is oversized.
- Observation: Manufacturer suggested minimum flow is 5 GPM. During the analysis period, 20% of registered readings occur below AWWA standards of 95% accuracy and 22% under the normal operating range of 98.5% accuracy as cited by manufacturers specifications.
- This meter is intermittently operating between 0 and 180 GPM.
- Mechanically there were no problems found with this meter.

- It is recommended that Olea meter health analysis be continued for a few more months to see if water usage behavior changes.
- If intermittent low and high water usage continues, it may be worth considering exchanging this meter for one that can handle lower flows.

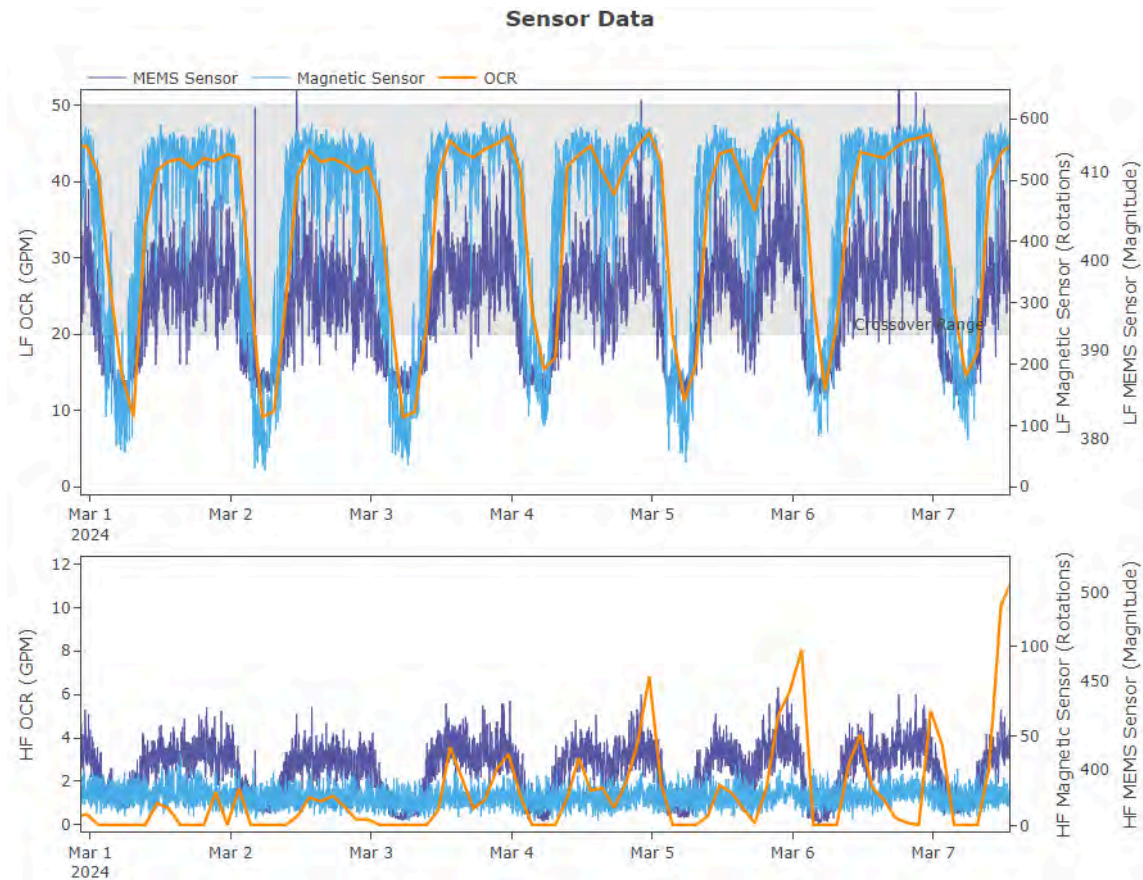
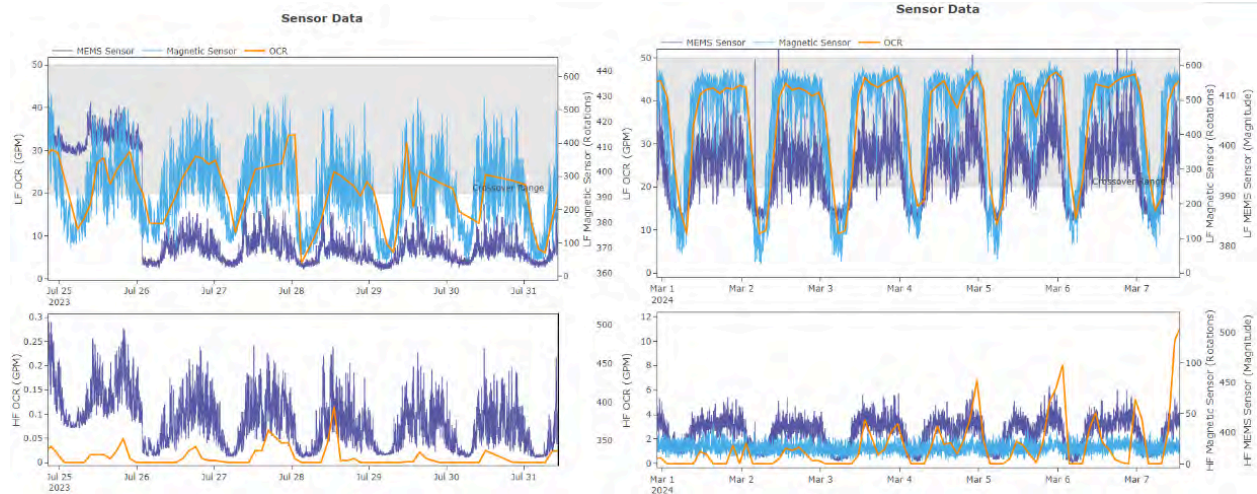
Figure 33 - No Problem Found meter

Figure 34 - Pre and post meter repair comparison

- This Sensus compound meter (Figure 33), previously had partially closed city and customer side valves. Now that Fullerton staff have completely opened both valves, the low flow and high flow side meters are operating within meter manufacturers specifications, and this meter is now identified as 'No Problem Found'.
- The high flow side meters flow is now reaching 8 GPM, compared to its previous maximum level of 0.1 GPM (Figure 34).
