City of Fullerton Meter Health Analytics Pilot Project

Deliverable #2: Final Report

City of Fullerton

July 11, 2024

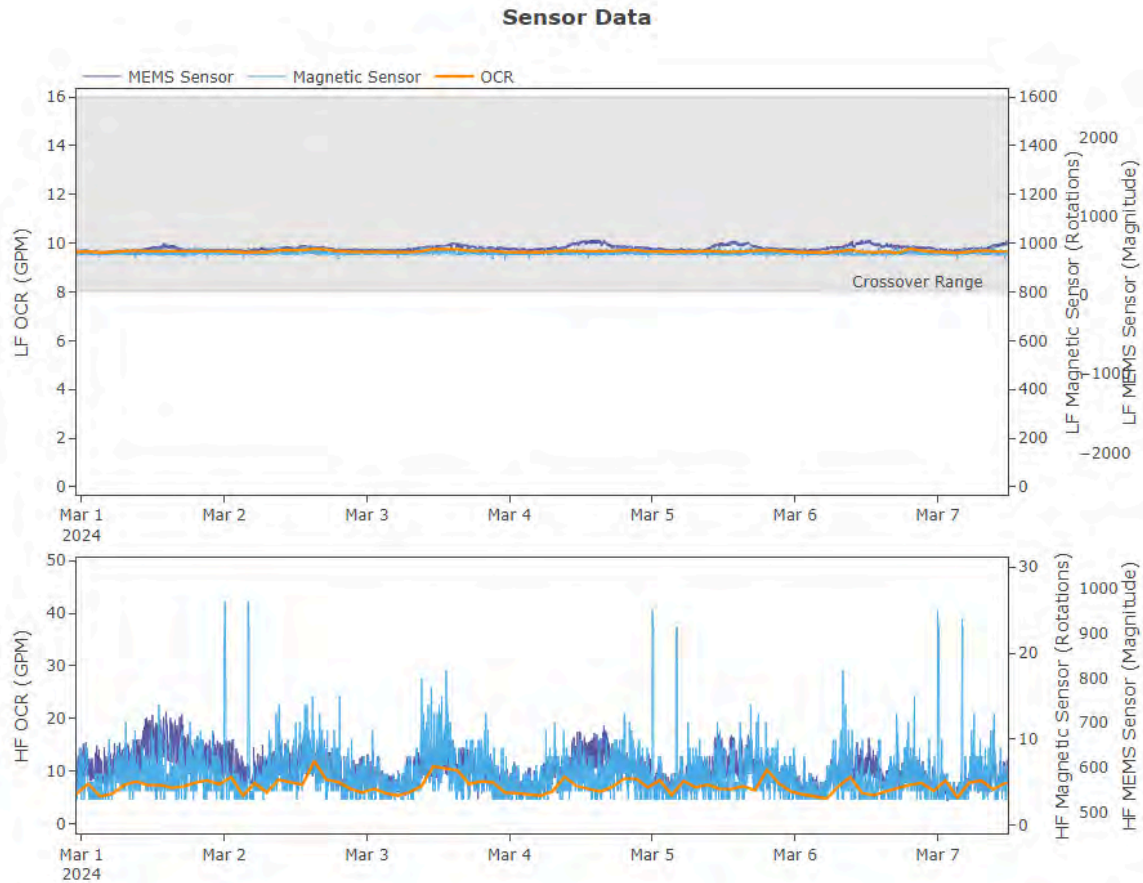
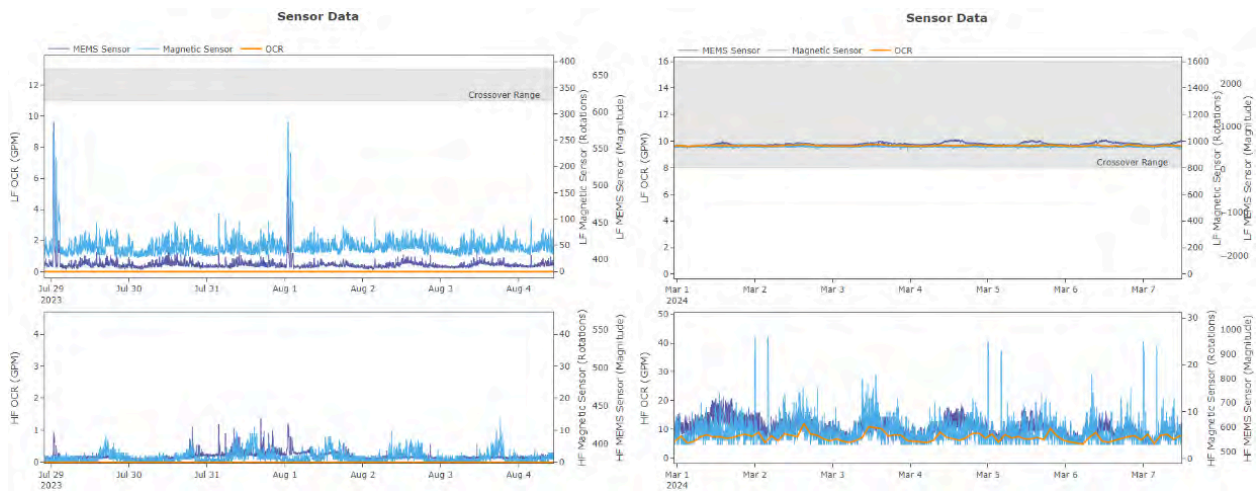
Figure 35 - Post repair No Problem Found meter

Figure 36 - Pre and post meter repair comparison

- This Badger compound meter (Figure 35), previously had failed low flow and high flow registers. Fullerton City staff have completely replaced the Hershey meter with a Badger meter, and Olea's MHA technology has identified this meter as 'No Problem Found'.
- The low flow side meter is now recording approximately 10 GPM of continuous flow, and the high flow side meter is recording approximately 10 GPM of continuous flow. Previous to the meter replacement, both low and high flow side meters were recording 0 GPM of flow (Figure 36).

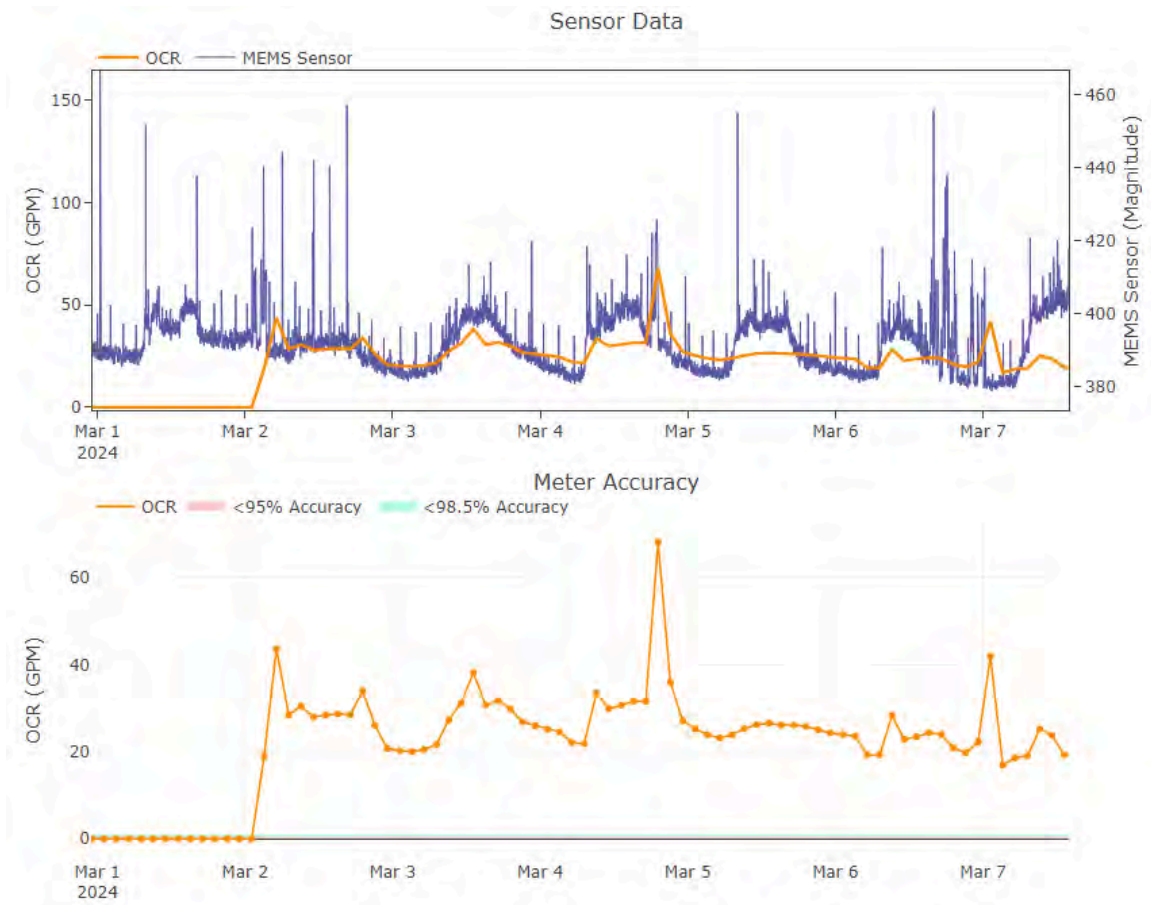
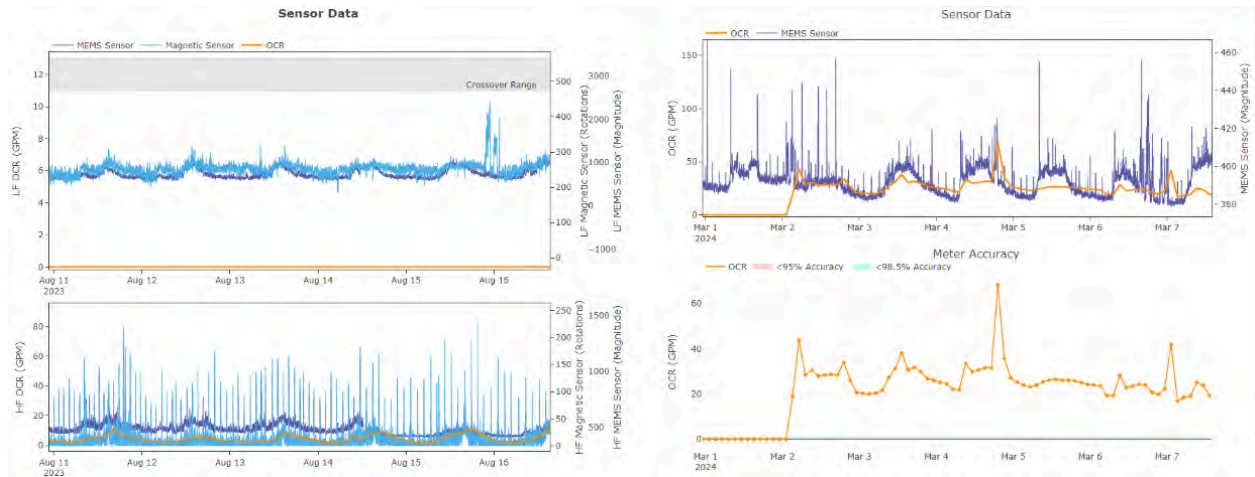
Figure 37 - Post repair 'No Problem Found' meter

Figure 38 - Pre and post meter repair comparison

- This Sensus compound meter (Figure 37), previously had a failed low flow register. Fullerton staff have completely replaced the Hershey meter with a Sensus meter, and Olea’s MHA technology has identified this meter as ‘No Problem Found’.
- This new meter register is now recording up to 75 GPM of flow, compared to the previously recorded combined flow of 15 GPM (Figure 38).

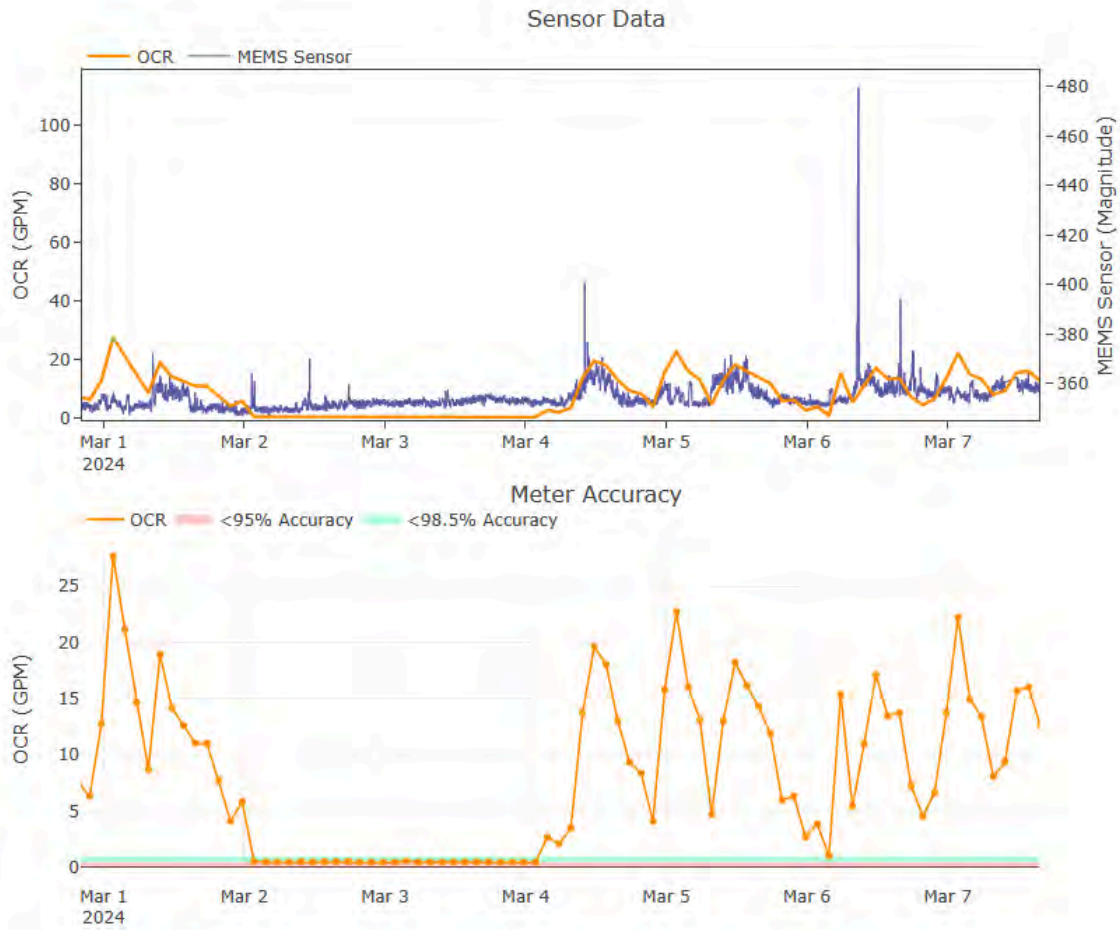
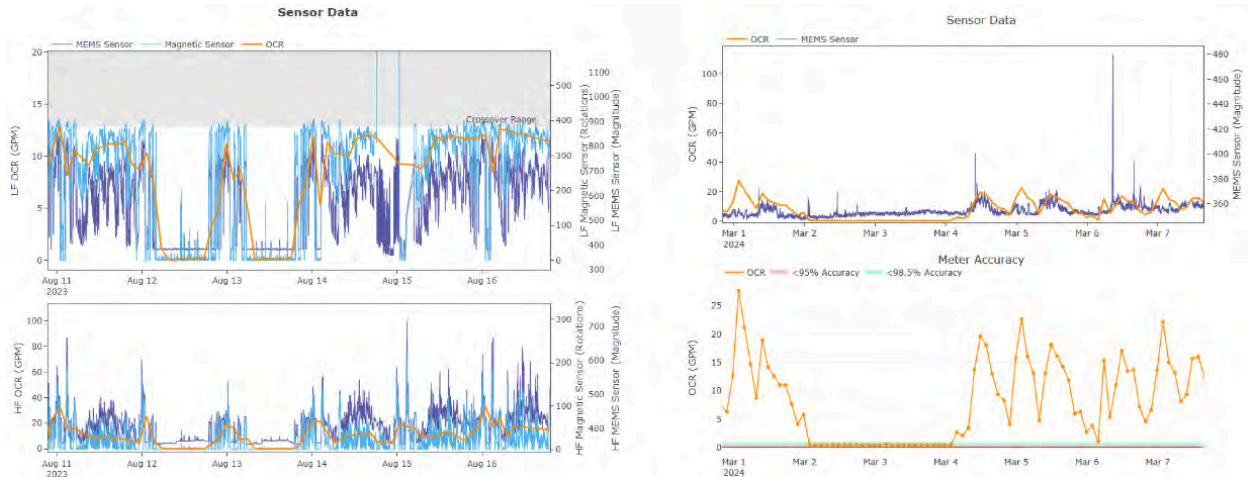
Figure 39 - Post repair 'No Problem Found' meter

Figure 40 - Pre and post meter repair comparison

- This compound meter (Figure 39), previously had an early crossover valve malfunction error. Fullerton staff have completely replaced the Hershey meter with a Sensus meter, and Olea's MHA technology has identified this meter as 'No Problem Found'.
- This new meter is correctly sized for the flow received during the validation phase. The new meter is now recording up to 30 GPM of flow, compared to the previously recorded combined flow of 40 GPM (Figure 40).

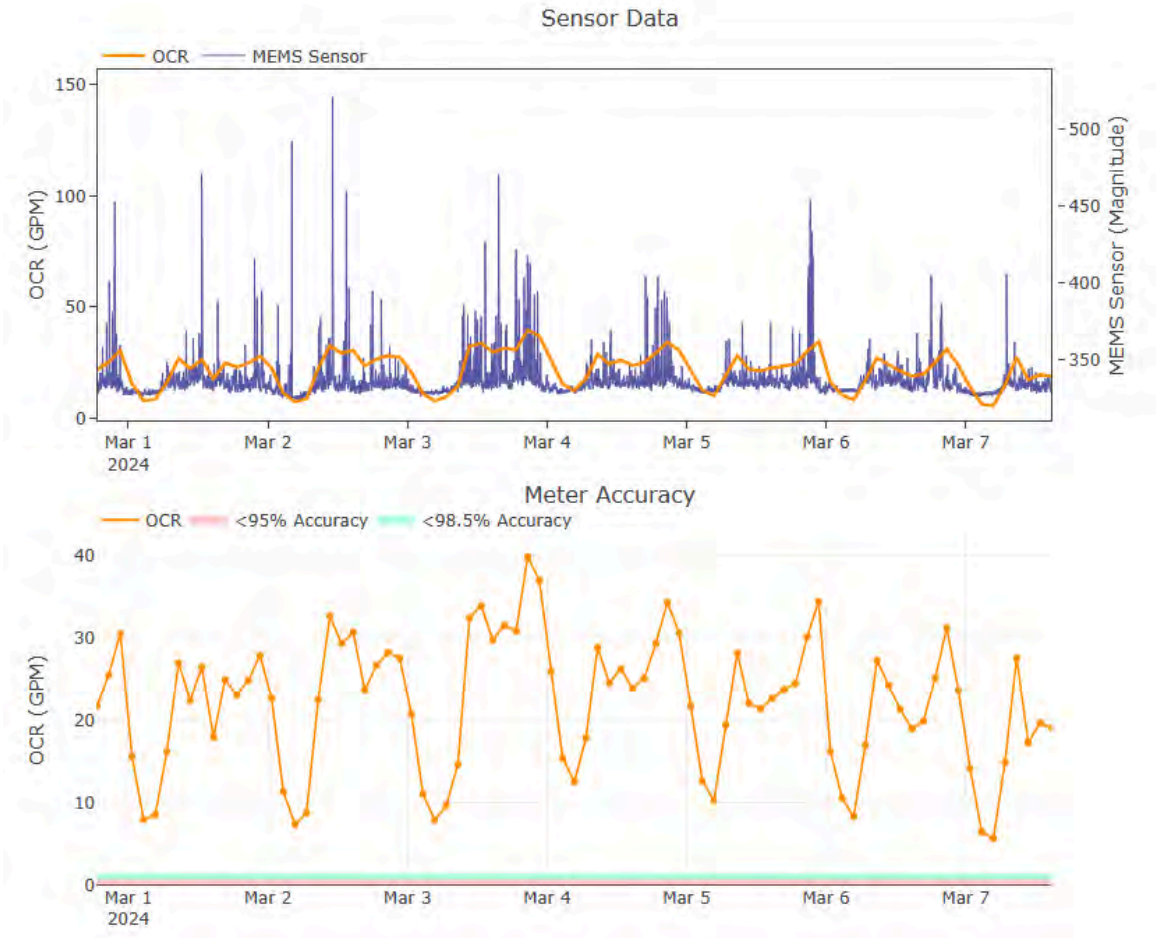
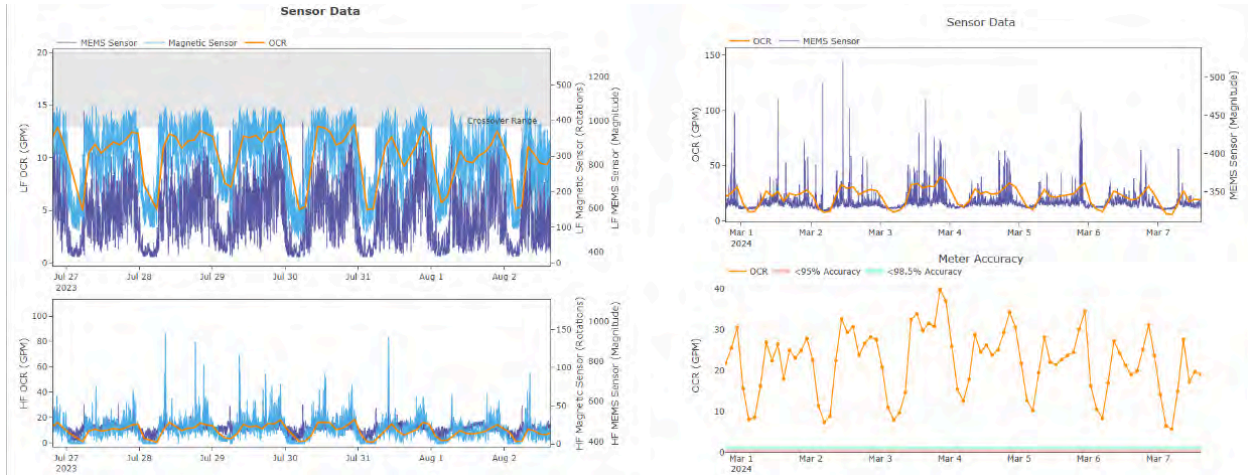
Figure 41 - Post repair 'No Problem Found' meter

Figure 42 - Pre and post meter repair comparison

- This compound meter (Figure 41), previously had an early crossover valve malfunction error. Fullerton staff have completely replaced the Hershey meter with a Sensus meter, and Olea's MHA technology has identified this meter as 'No Problem Found'.
- This new meter is correctly sized for the flow received during the validation phase. The new meter is now recording up to 40 GPM of flow, compared to the previously recorded combined flow of 35 GPM (Figure 42).

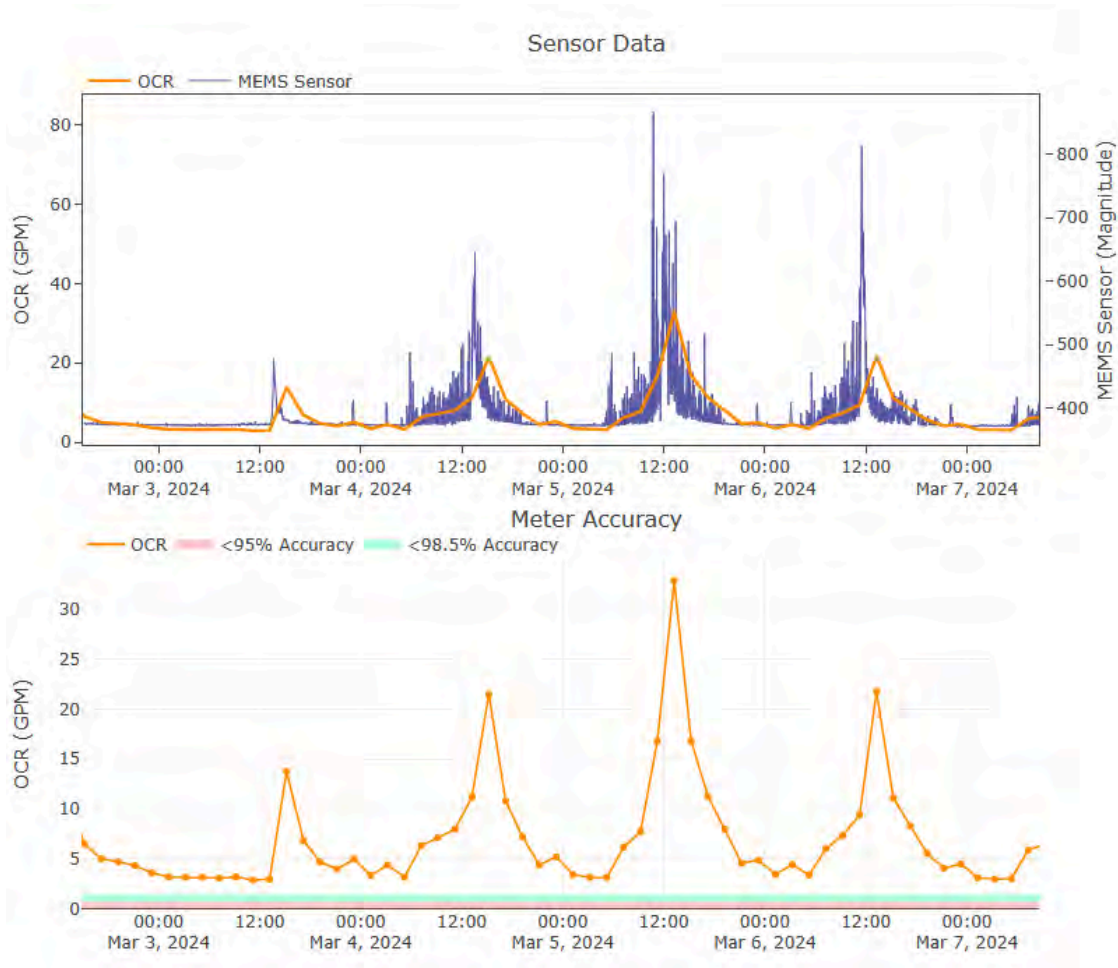
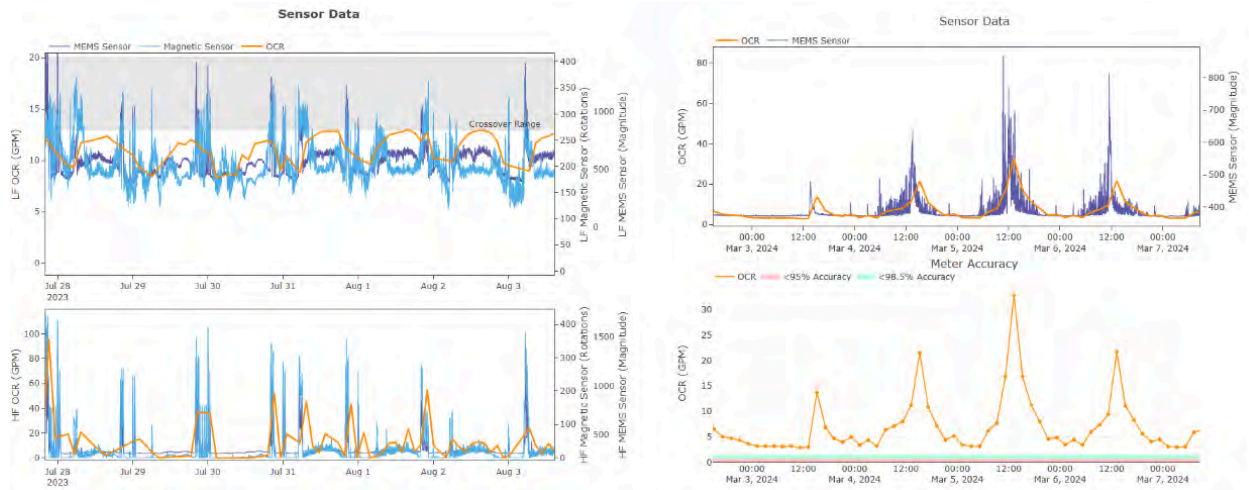
Figure 42 - Post repair 'No Problem Found' meter

Figure 43 - Pre and post meter repair comparison

- This compound meter (Figure 42), previously had a damaged low flow register error. Fullerton staff have completely replaced the Hershey meter with a Sensus meter, and Olea's MHA technology has identified this meter as 'No Problem Found'.
- This new meter is correctly sized for the flow received during the validation phase. The new meter is now recording up to 35 GPM of flow, compared to the previously recorded combined flow of 70 GPM (Figure 42).

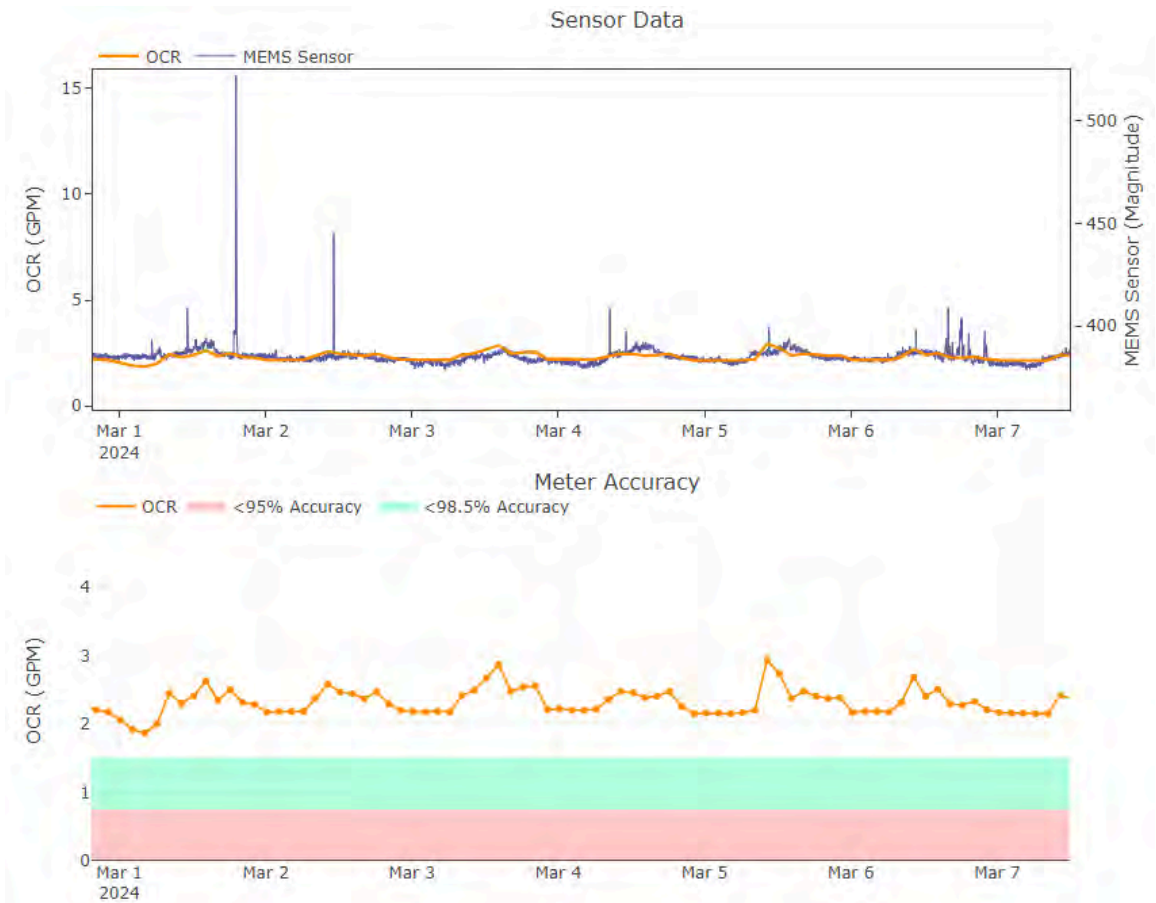
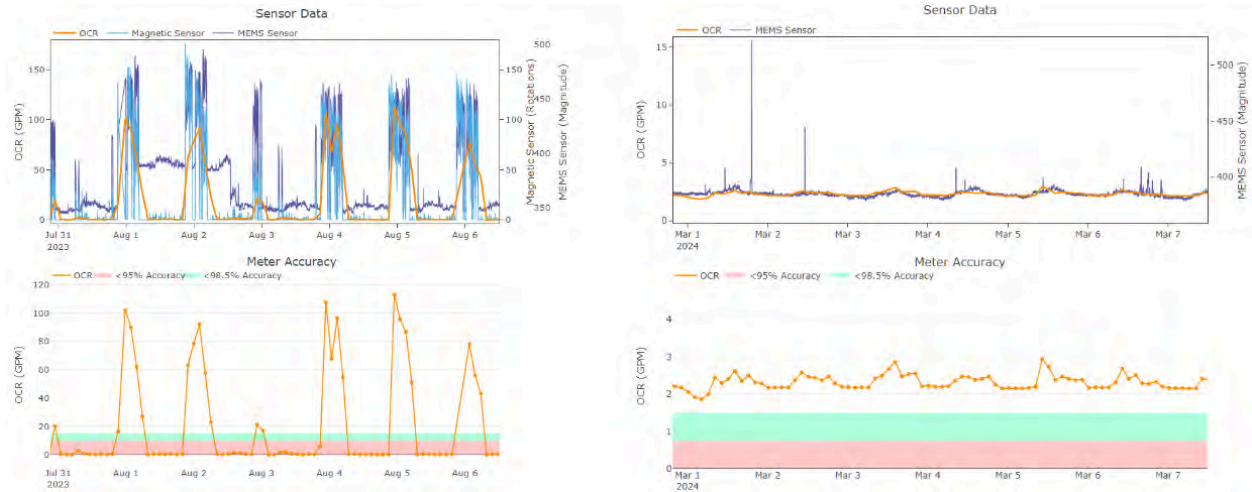
Figure 44 - Post repair 'No Problem Found' meter

Figure - 45 - Pre and post meter repair comparison

- This compound meter (Figure 44), was previously identified as having an oversized meter error. Fullerton staff have completely replaced the Sensus meter with a new Sensus meter, and Olea’s MHA technology has identified this meter as ‘No Problem Found’.
- This new meter is correctly sized for the flow received during the validation phase. The new meter is now recording up to 3 GPM of flow, compared to the previously recorded combined flow of 100 GPM (Figure 45).

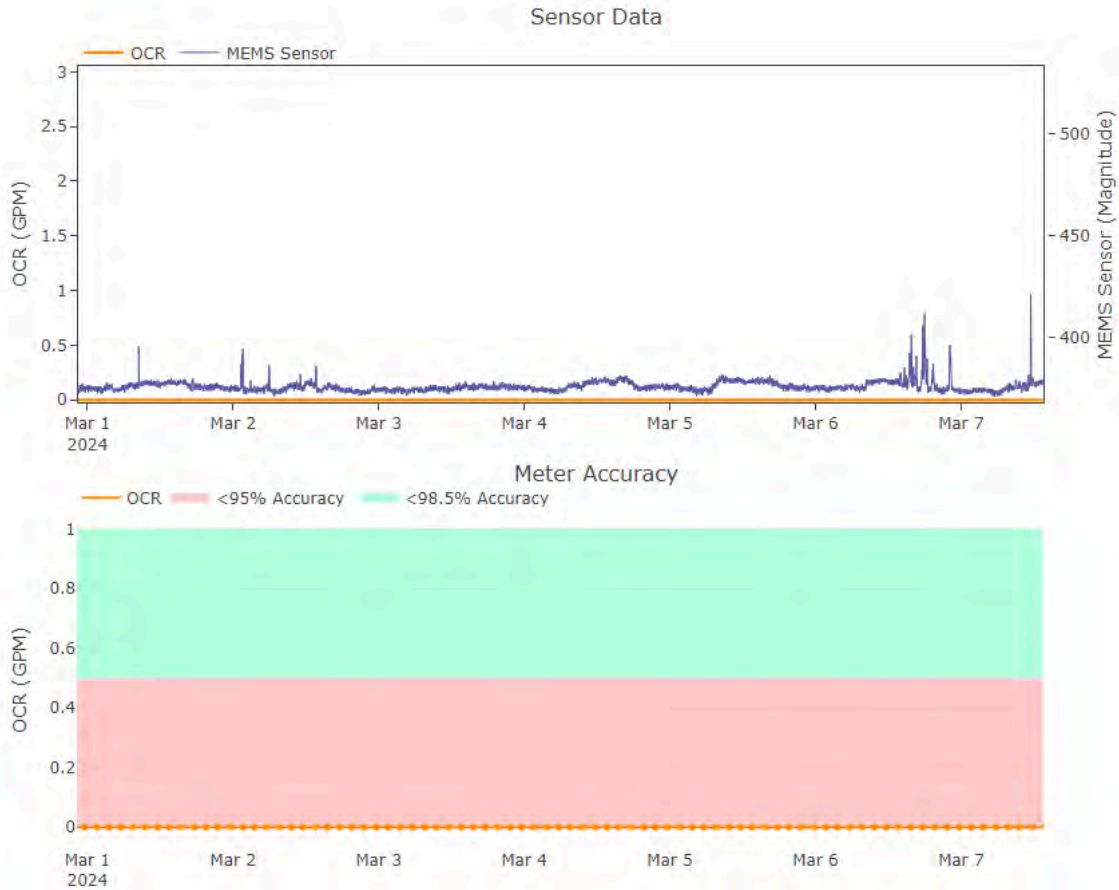
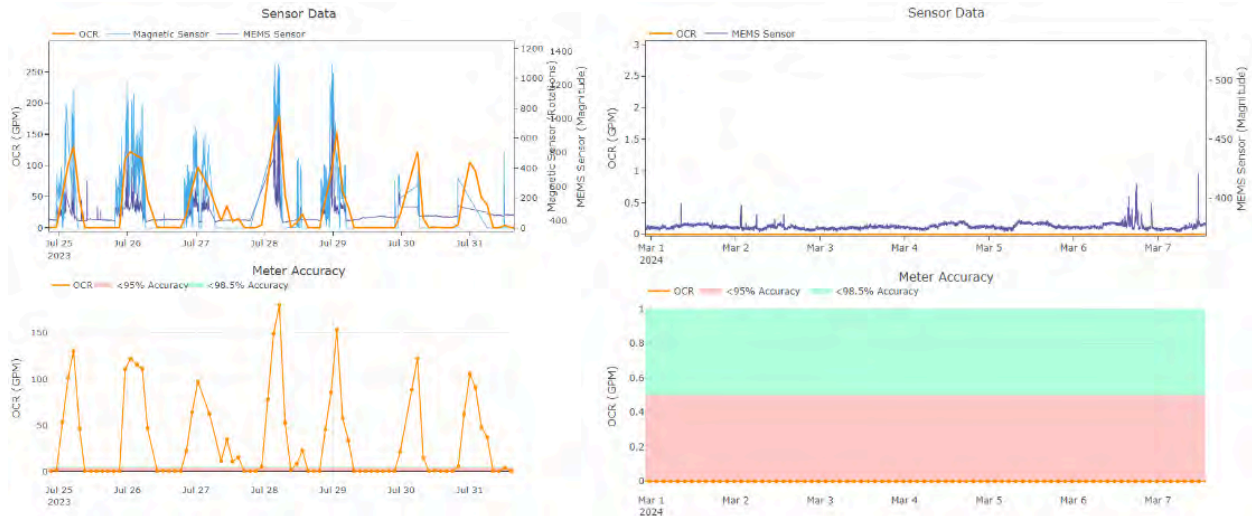
Figure 46 - Post repair 'No Flow - No Problem Found' meter

Figure - 47 - Pre and post meter repair comparison

- This compound meter (Figure 46), was previously identified as having an oversized meter error. Fullerton staff have completely replaced the Sensus meter with a new Sensus meter, and Olea’s MHA technology has identified this meter as ‘No Problem Found due to No Flow’.
- This new meter did not see any consumption during the March 1 to 7 Validation period. Olea captured another week of sensor data from April 2 to 8 and again no flow was recorded during this period.

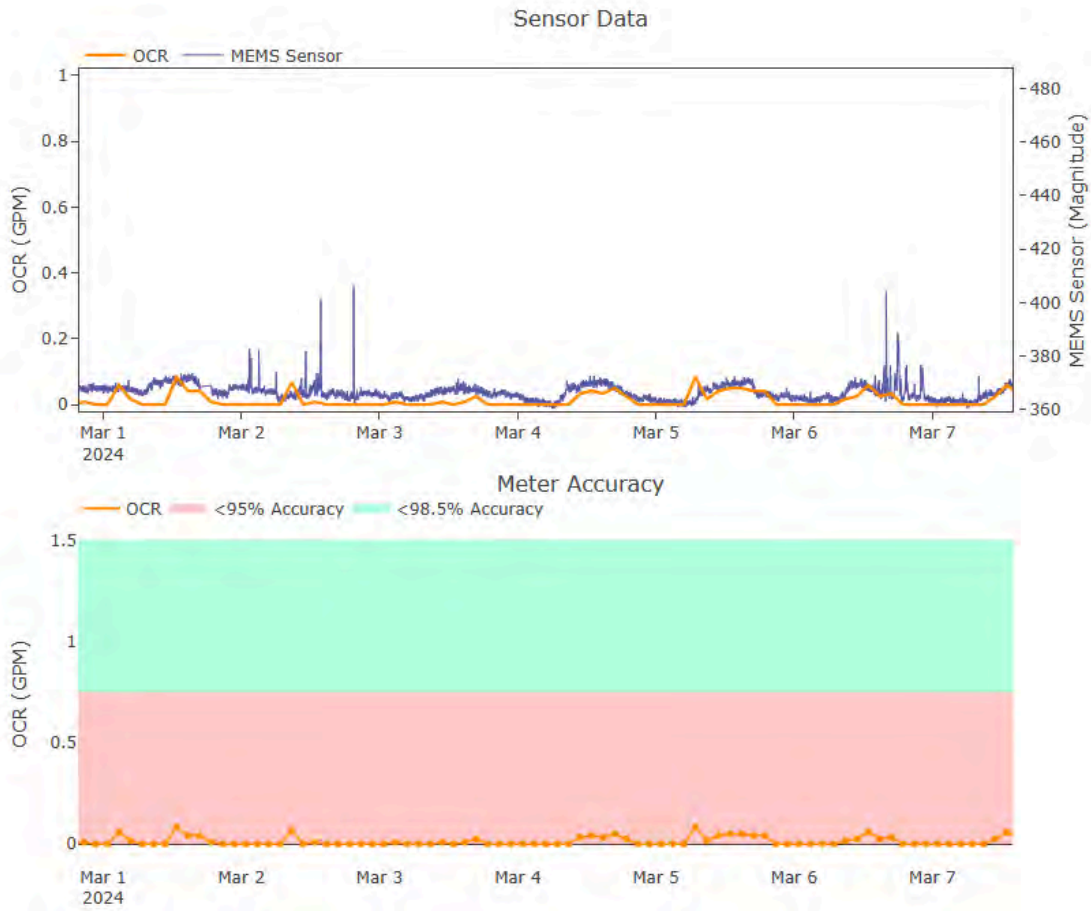
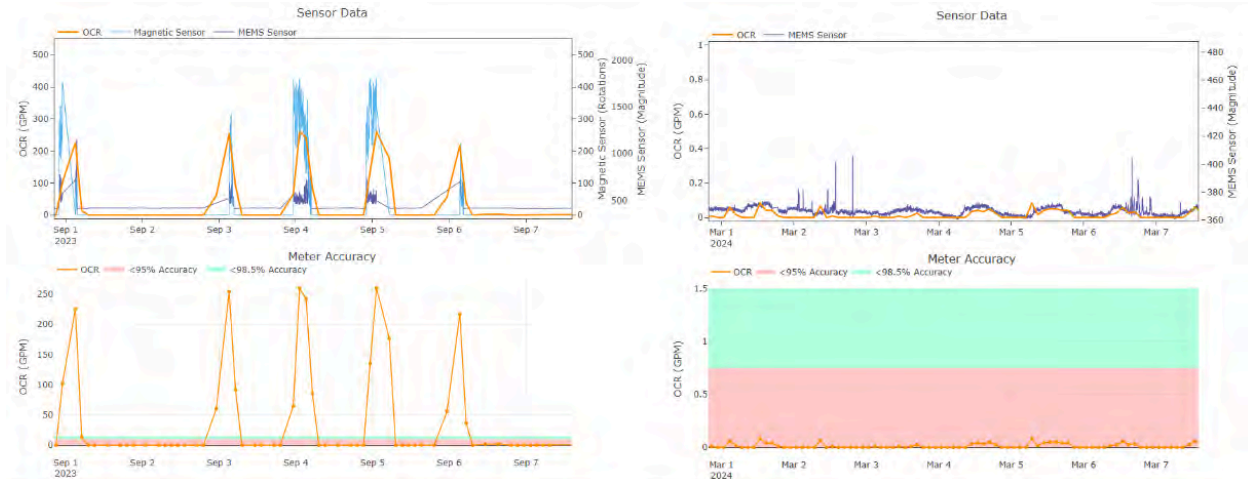
Meter Health Status: Error, Oversized meter.

Figure 48 - Post repair 'Oversized meter' error

Figure - 49 - Pre and post meter repair comparison

- This compound meter (Figure 48), was previously identified as having an oversized meter error. Fullerton staff have completely replaced the Sensus W Turbo 4" meter with a new Sensus Omni C2 4" meter, and Olea's MHA technology has identified this new meter is still identified as an 'Oversized' error condition.
- This new meter was analyzed in March of 2024, and the largest flow recorded was 0.1 GPM, compared with the Initial Phase which saw over 250 GPM of flow (Figure 49).

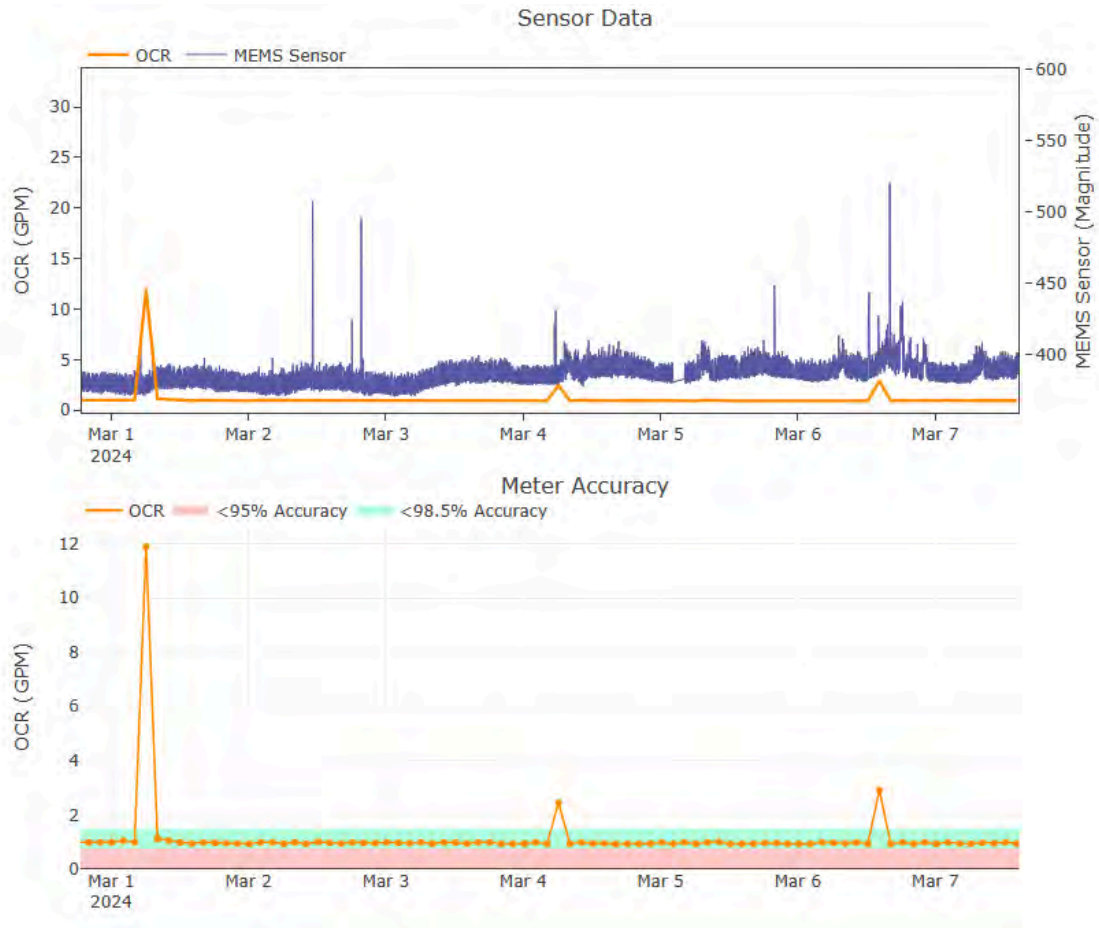
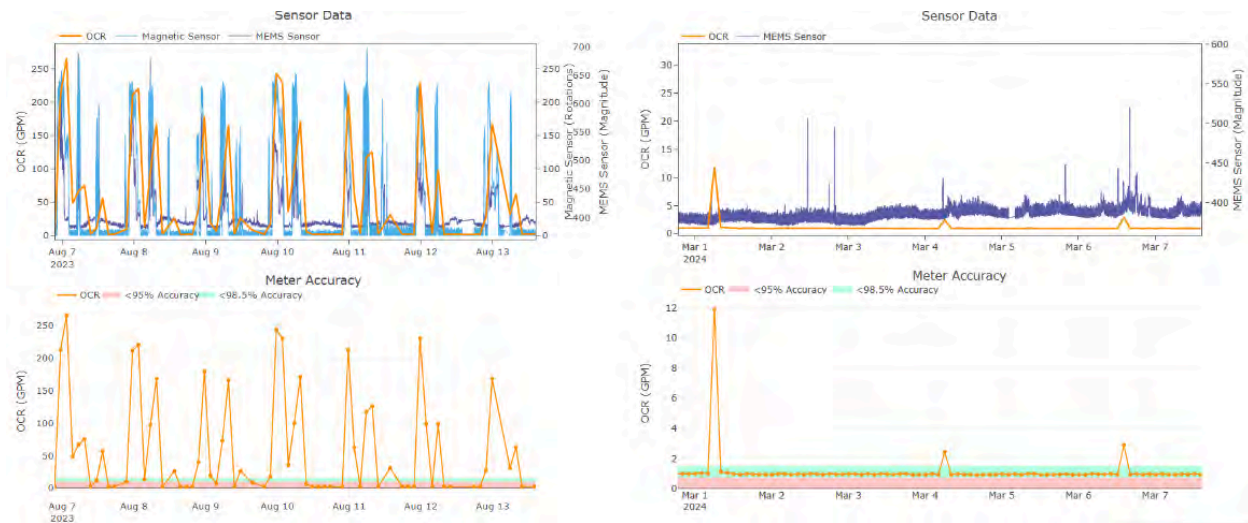
Meter Health Status: Error, Potential Customer Side Leak

Figure 50 - Post repair 'Potential customer side leak' error condition

Figure - 51 - Pre and post meter repair comparison

- This compound meter (Figure 50), was previously identified as having an ‘oversized’ meter error as well as a ‘potential customer side leak’. Fullerton staff have completely replaced the Sensus W Turbo 4” meter with a new Sensus Omni C2 4” meter, and Olea’s MHA technology has identified this new meter is no longer oversized, but the potential customer side leak remains (Figure 51).
