Conveyor Dishwasher Performance Field Evaluation Report

FSTC Report Number: P20004-R0
MWD Agreement Number: 143540

Prepared by:
Amin Delagah
Fisher-Nickel, Inc.

Test Sites:
The Claremont Hotel, Facebook, Google, Stanford

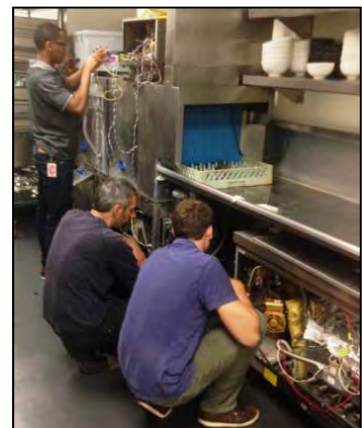
Figure 3: Installing instrumentation on a rack conveyor with booster heater

Electrical energy metering equipment was to measure electricity use of the dishwasher, tank heater(s) and booster heater. The setup included

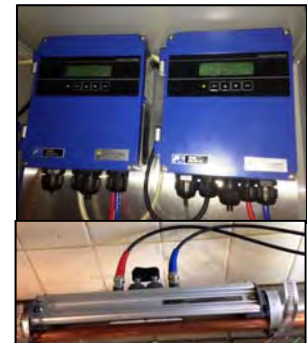
Figure 7: Ultrasonic meter

Fuji FSV IP66 ultrasonic meter, can measure pressurized sections of water piping from 0.5" to 4" pipe diameter, FLD-2 compact-type detector, accuracy ±1% of rate (Figure 7). www.fujielectric.com

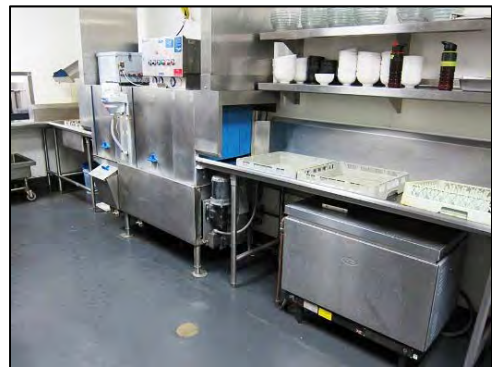
Figure 13: Baadal dishwasher with gas booster

The dishwasher was monitored from August 25th to October 9th, 2014 for a total of 33 operating days. The monitoring data compiled for each work day are shown in Appendix A.

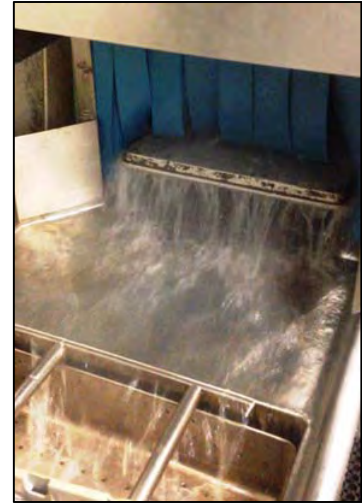
Figure 15: Scrapper tank overspray

Even with the lower rinse flow rate, the overall water use was still significantly higher than anticipated, which was later discovered to be due to the water consumed for filling the scrapper tank. Being that the scrapper fill water was not being directly measured, initially, it was thought that by counting the number of fills in the wash tank through data analysis, the scrapper wash tank fill could be readily estimated using manufacturer's scrapper tank volume specifications. On the second visit to the site, trial runs using racks with sheet pans revealed much greater scrapper water use than first assumed. After closer observation, it was recognized that a significant loss of hot water was occurring through overspray on the loading side of the machine, especially when sheet pans were washed (Figure 15). The high water velocity of the overspray

The biggest surprise was the intensity of overspray exiting the scrapper section of the dishwasher when washing large wares like sheet pans. Either the use of sheet pan racks designed to hold the pans vertically or replacement of this dishwasher with another with a taller cavity and/or a longer length could significantly reduce the water waste associated with the overspray. The other lesson learned was that the operator or maintenance professional cannot always depend on the pressure gauge to

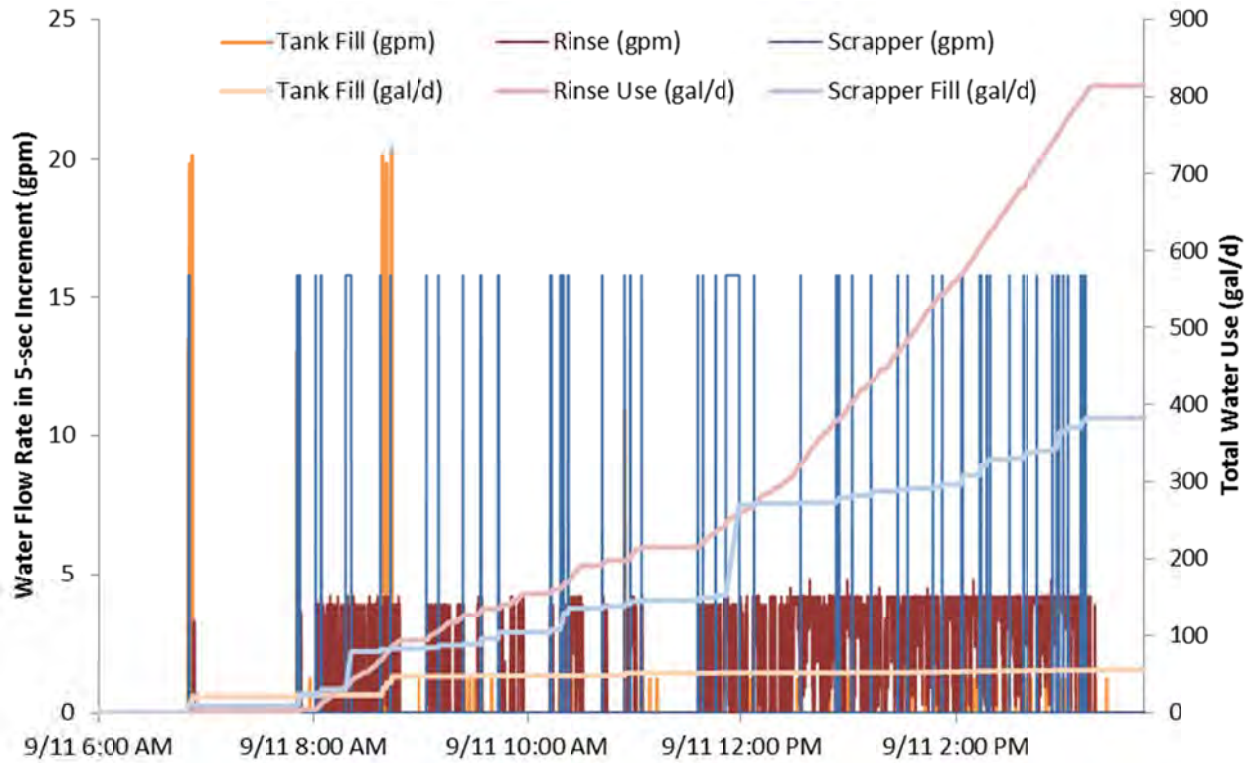
Figure 16. Café Baadal plot of daily water flow rates and total use

The overall average water use of the dishwasher during the monitoring period was 1319 gallons per day (gal/d). Representative of this average, the total hot water use on September 11th, 2014 was 1272 gallons. This daily water use profile is shown in Figure 16. Looking closely at the plot, there was a scrapper and wash tank fill at roughly 6:50 AM, and wash tank top-offs at 8:40 AM. The wash tank fill and top-off volume totaled 55 gallons and occurred at a flow rate of approximately 20 gpm. The scrapper tank top-off occurred more frequently throughout the day and totaled 365 gallons with a flow rate of 16 gpm. Rinse water flowed at 3.7 gpm and totaled 815 gallons.

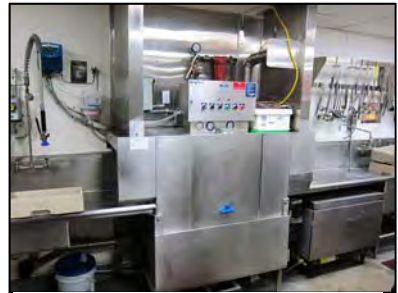
Figure 20: Backyard Dishwasher

This BBQ-inspired café serves breakfast and lunch during the work week (Figure 19). It uses a 2005 Stero SCT-44 high-temperature dishwasher with a natural-gas-fired tank and external booster heaters and has a rated rinse water use of 290 gph or 4.8 gpm (Figure 20).

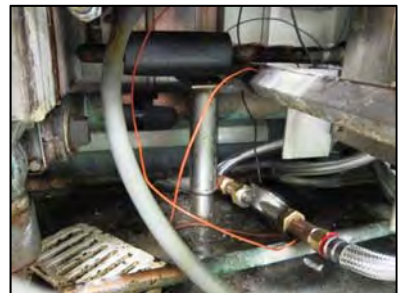
Figure 21: Mechanical meter installation on inlet to booster

The water use was measured at a single hot water supply to the dishwasher (Figure 21) and accounted for water use through the booster heater for rinse water, and for the tank fill water through a connection branching to the dishwasher. Temperature was measured at the inlet and outlet of the booster heater and at the drain. The gas solenoid on/off state was monitored to estimate gas use by assuming the nameplate gas input rates specifications for the tank and booster heaters and integrating that rate over recorded on time. The electricity use of the water pump motors, conveyor belt and controls was also measured.

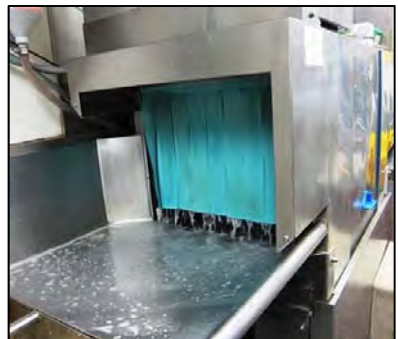
Figure 22: Overspray on inlet side slopping to pre-rinse sink

correlating gas use to water consumption and operating time. Similar to the Baadal dishwasher, although to a much lesser degree, there was a tendency for water to overspray out of the dishwasher and onto the feed table and then down the pre-rinse sink drain (Figure 22).

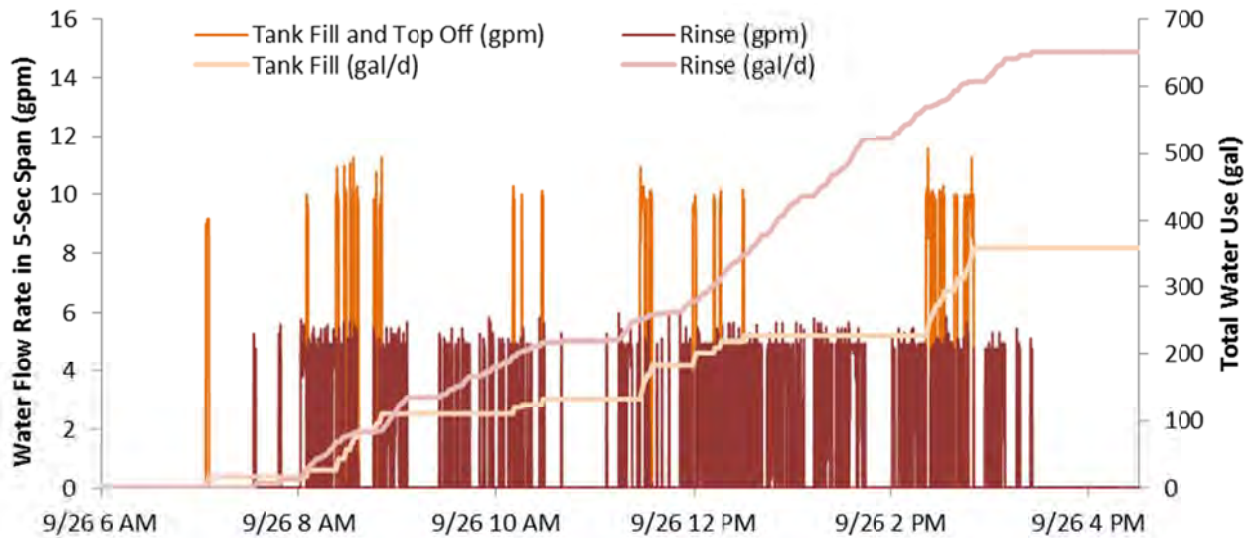
Figure 23. Backyard Café daily water flow rates and total use

The total hot water use was 1010 gallons on September 26th, 2014; the water use profile for this date is shown in Figure 23. This day’s water use total is representative of the overall average of 1053 gal/d. The wash tank fill (17 gal) and tank top offs (342 gal) totaled 359 gal at an average flow rate of 9.7 gpm. Rinse water flowed at a rate of 4.8 gpm and totaled 651 gallons for the day. Looking closely at the plot, there was one wash tank fill at 7:00 AM and subsequent wash tank top-offs throughout the rest of the day.

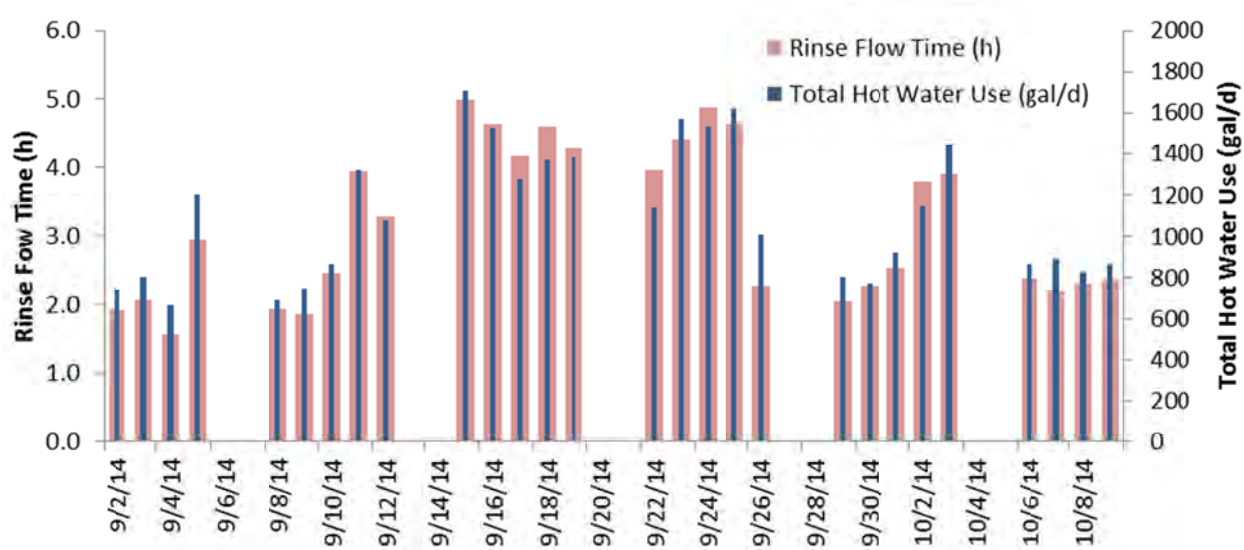
Figure 24. Backyard Café plot of daily rinse flow time and total hot water use

The average sanitizing rinse time was 2.9 hours. The conveyor run time was 4.1 hours, or roughly half of the dishwasher operating span from the initial fill at approximately 7 AM to shutdown at 3:30 PM. The plot in Figure 24 shows six weeks of dishwasher operation. The rinse time and total water use track each other well and there are moderate fluctuations in total hot water use and rinse time from a day to day or sometimes weekly basis.

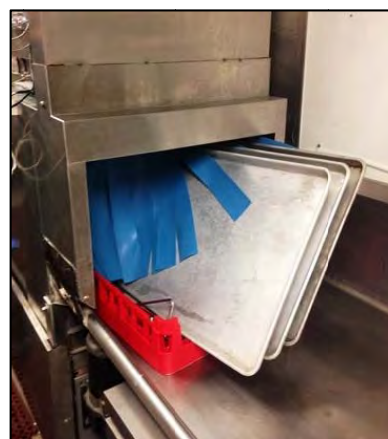
Upon witnessing the overspray and resultant water waste at two sites, some sheet pan racks (designed to hold pans vertically) were brought in to test their performance (Figure 25). Testing at the Backyard Café confirmed that the dedicated use of sheet pan racks instead of running the pans flat on conventional racks could significantly cut down the water waste associated with overspray

Figure 25: Sheet pan rack demo

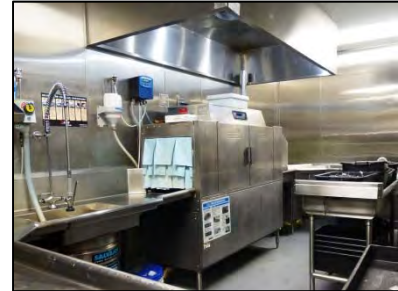
Figure 26: Heritage dishwasher and pre-rinse sink

This small cafeteria serves American style fare until 8 PM. Their niche is serving brunch all day during the work week. The café uses a Hobart CL-64E high-temperature dishwasher equipped with natural gas fired wash tank and powered-rinse tank heaters and an external natural gas fired booster heater (Figure 26). The machine has a rated rinse water use of 132 gph or 2.2 gpm.

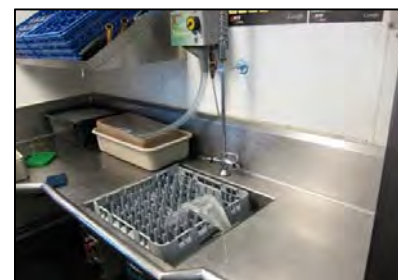
Figure 27: Pre-rinse station

This site was one of three sites where the pre-rinse station was sub-metered. This site was selected as it utilized a scrapper, which had not previously been studied by FSTC. Water was used for the 2.5 gpm pre-rinse spray valve, the scrapper and by the degreaser solution dispenser in Figure 27. The scrapper works by passing large volumes of water in a waterfall effect over the rack or individual wares and reuses the water continuously while typically adding 2 gpm of fresh water into the mix.

We had initially assumed that the hot water used for the degreaser solution to pre-soak utensils in the rectangular tub in Figure 27 would be minor. But on occasions, the degreaser solution hose line was redirected to the scrapper basin (Figure 28) and was a contributor to the overall water waste. When it was redirected, it was on continuously during the dishwashing period for the purpose of adding heat to the scrapper water. The pre-rinse sprayer was used on demand using tempered water, whereas the scrapper was on continuously using cold water during the meal period and sometimes operating unattended.

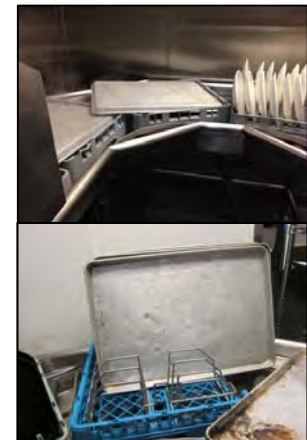
Figure 29: Conventional washing of sheet pans (top) vs. efficient washing of sheet pans (bottom)

This particular site utilized sheet pan racks for washing flat objects like cutting boards, lids and sheet pans (Figure 29). This measure greatly reduces the water and energy use of the dishwasher as multiple objects can be washed on the same rack, and the angle in which the spray heads hit the wares minimizes overspray leaving the machine out table. This practice was great to observe, but operating consistency is still needed as on another occasion sheet pans were washed the conventional way horizontally placed on a rack.

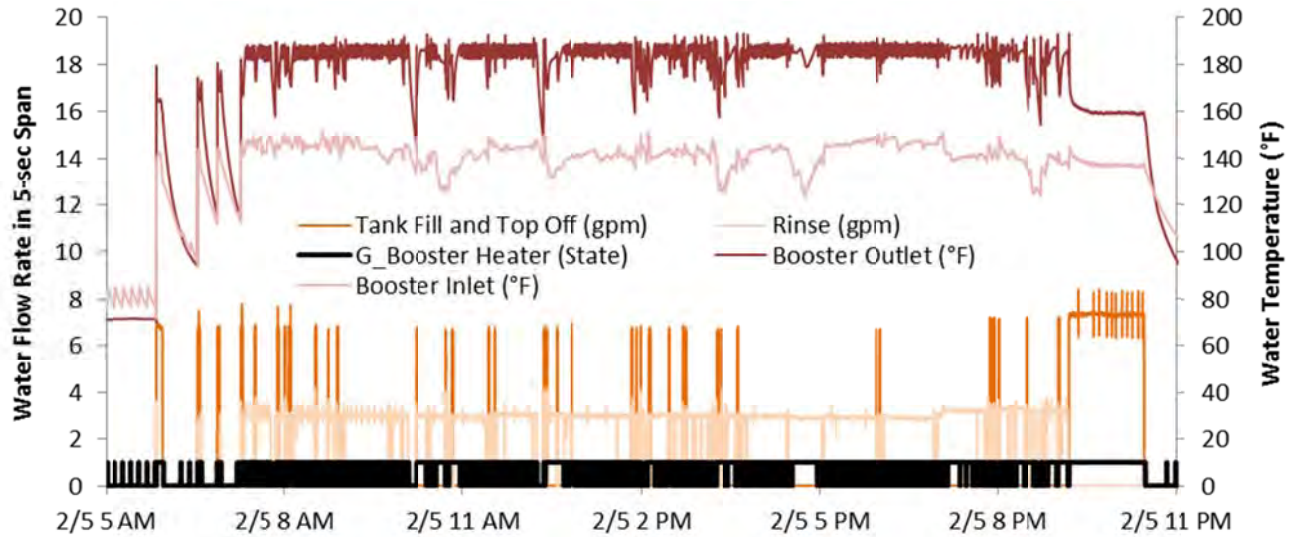
Figure 30: Dishwasher rinse and fill problems

There was a three day period starting in the afternoon of February 3rd until closing of operation on February 5th where the dishwasher was malfunctioning (Figure 30). For the first 2.5 days, it appears that the rinse activation lever was stuck in the on position, which is caused the fresh water rinse to operate anytime the conveyor was running. From 9:30 PM to 10:40 PM, it appears that the drain was left open as the tank fill was continuously activated until the machine is shut down for the night. On average, on the three affected days, the water use doubled from an average of 1262 gallons on an average day to 2503 gallons. The energy use increased as well, with an 83% increase in gas use and a 55% increase in dishwasher electricity use. The booster inlet and outlet temperature graphically show the nearly continuous rinse flow operation until the prolonged tank fill operation beginning at 9:30 PM.

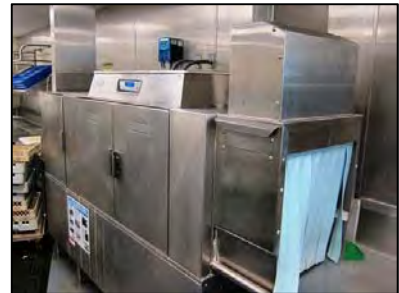
Figure 34: Masa Café dishwasher

This large cafeteria serves Mexican fare from 8 AM to 5:30 PM (Figure 33) covering the breakfast and lunch meal periods during the work week and lunch and dinner periods on the weekend. The café uses a Hobart CLPS-86ER high-temperature dishwasher with an integrated EAHR device (Figure 34). The unit has an integrated electric booster heater and electric tank heaters. The rated rinse water use is 133 gph or 2.2 gpm. This unit has a scrapper tank, a wash tank and a rinse tank. Our understanding of how the unit works prior to testing was that the unit uses a hot water supply for tank fills and top offs and cold water supply that is pre-heated (after passing through the heat exchanger and booster heater) for rinse operation. This dishwasher was the most complex and also the most efficient dishwasher amongst the four Google sites monitored.

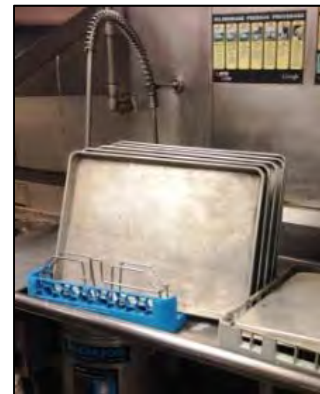
Figure 35: Pre-rinse station

This pre-rinse station was selected for monitoring as it had installed the same components of a pre-rinse spray valve and scrapper (Figure 35) as the Heritage site. At this site, staff training and commitment to minimize water use was taken seriously by dishroom staff and the Executive Chef who had begun his career in commercial kitchens in the dishroom. Water was only used by the 1.15 gpm spray valve and the scrapper was not used. Using the industrial hose that was intended for cleaning the floors was outlawed by management for rinsing wares.

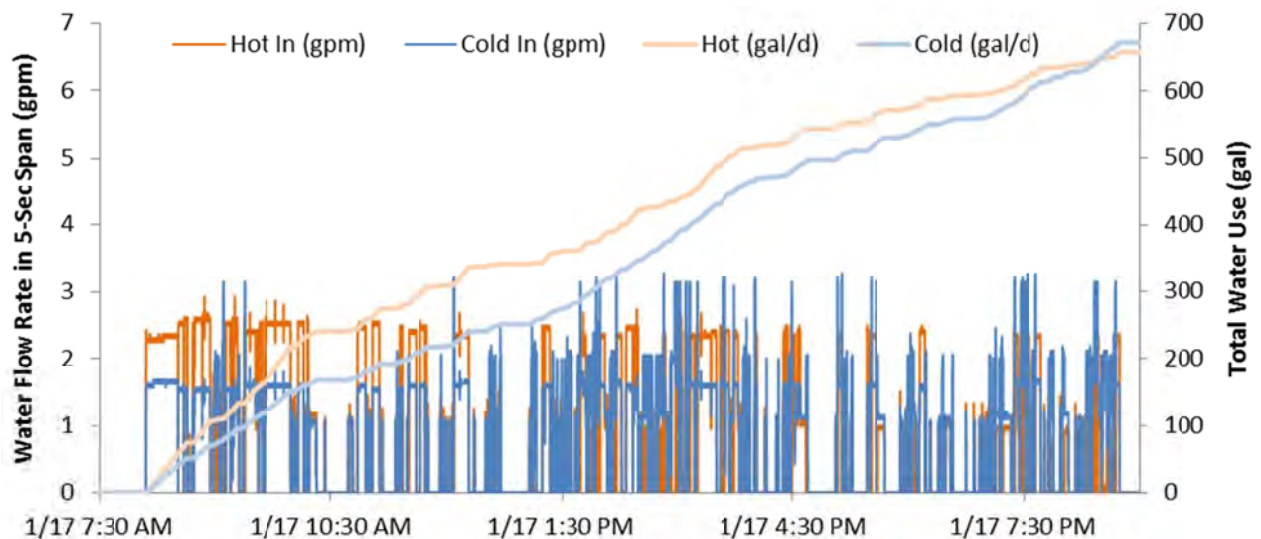
Figure 36. Masa Café daily water flow rates and total use

The representative average day water use profile is shown in Figure 36, totaling 1,330 gallons. The hot and cold water use measured was roughly equal. There was one rinse and wash tank fill at 8 AM totaling 177 gallons which is more than the manufacturer’s specification of 68 gallons. Overall, the dishwasher is used almost continuously from the morning breakfast to the evening cleanup with a few lulls during the day.

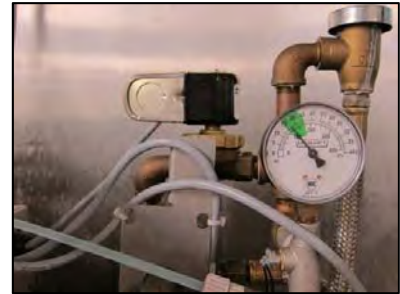
Figure 37: Rinse pressure gauge reading at 17.5 psi

The unit utilizes hot water and cold water simultaneously at average flow rates of 1.7 gpm and 1.5 gpm, respectively. The simultaneous and relatively even flow rate of hot and cold water for filling and rinsing operations for this dishwasher with integrated heat recovery was surprising. The working assumption was prior to monitoring this dishwasher that hot water would be used mainly for tank fills while cold water would be predominately used for the rinse operation when the heat exchanger has warmed up. The rinse flow rate measured at 2.4 gpm is not far off the manufacturer's specifications at 2.2 gpm.

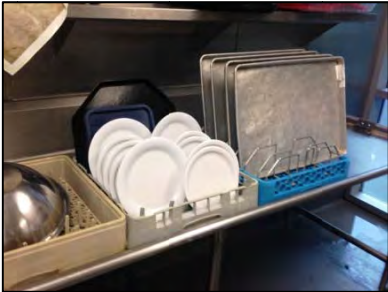
This site also had the most efficient pre-rinse operations of the four Google sites visited. They consistently used sheet pan racks and had long tables on the entrance and exit ends of the machine in which they utilized well by running continuous racks back to back. The dishroom had installed conveyor shut off switches shown in Figure 39 that reduces wear and tear on the machine and racks as well as improving the efficiency of the conveyor dishwashing operation to some extent.

Figure 39: Long unloading table with auto conveyor shut off on right edge

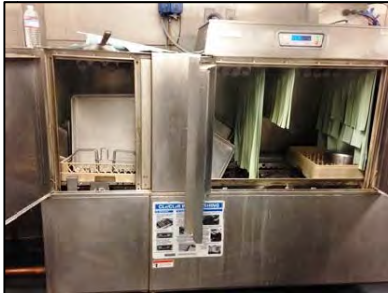
Figure 40: Conveyor jam caused by sheet pan rack loading

Although sheet pan racks were used, we quickly realized that during high-speed dishwashing operations, it is easy to dislodge a sheet pan or two from its rack and have it obstruct the dishwasher conveyor

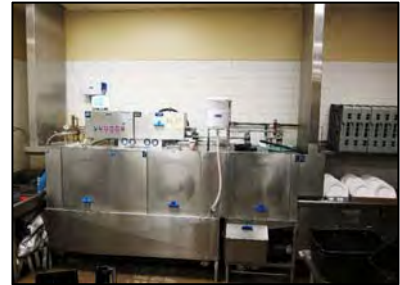
Figure 42: Wilbur Café original dishwasher

The original dishwasher used in this café was a 2001 Stero SCT-108S high-temperature dishwasher (Figure 42) with a rated throughput of 309 racks per hour. Its rated rinse water use is 272 gph or 4.5 gpm. This was a steam heated model utilizing a centralized steam boiler to provide direct steam to the tank heaters and to indirectly heat water through a heat exchanger for the final rinse operation. This was the largest rack conveyor tested during this study, and included a scrapper tank, a wash tank and a rinse tank. The initial observations during the first site audit was that the dishroom was very hot and steamy—even with 3 fans in operation (Figure 43). After a visual check of the elevated rinse and tank temperatures, the usage of a steam distribution system and the layout of the dishwashing tables. It was immediately apparent that this would be a great site to monitor an

In Figure 42 on the left there is a hard 90 degree corner on the dish table that requires a staff member to manually dislodge the rack after it has been rinsed (the original motor and drive roller system designed to move the racks had long since failed). Otherwise the rack could not travel further, thereby causing a backup of racks through the machine. The excessive wear and tear from this had caused many of the racks in the dishwasher to wear out prematurely (Figure 45) causing them to not advance through the dishwasher until a following rack in good working order pushes the worn rack through the machine.

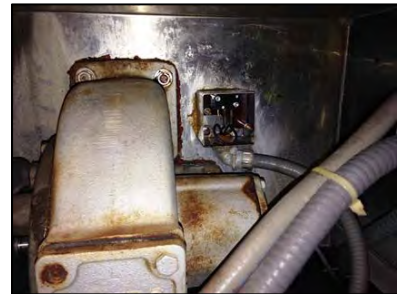
Figure 44: Tank fill relay switch

The installation of monitoring equipment on this steam based system was very challenging in several respects. First, the steam entering the kitchen goes through a steam to hot water heat exchanger whereby domestic hot water is blended to condense the steam, providing hot water at 180°F or higher for the sanitizing rinse. Due to either the setting or age of the heat exchanger, the outlet rinse water contained a mixture of hot water and steam which occasionally caused the temperature sensors to read excessively elevated rinse temperatures. In response, any temperature readings above 208°F were readjusted down to 208°F while any temperature below this threshold was left unchanged. As part of our instrumentation calibration process, we uncovered that the dishwasher auto fill function was not working consistently due to worn out relay switches (Figure 44). The switches only sometimes triggered the wash tank fill solenoid valve to open in order to fill it while simultaneously filling the scrapper and rinse tanks. Consequently, a manual fill of all three tanks was required to ensure that the tanks were full.

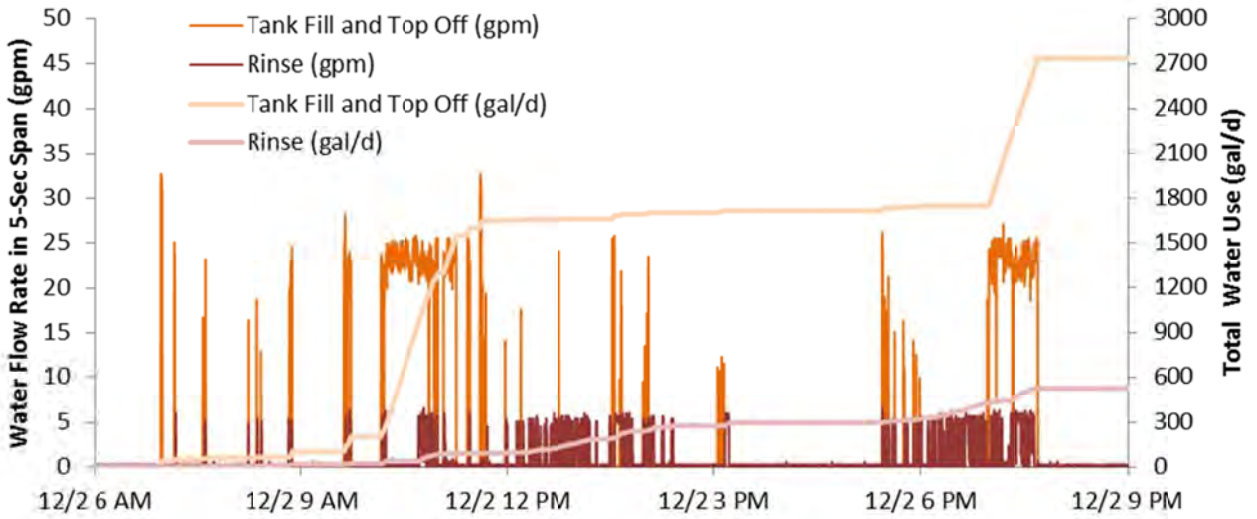
Figure 47. Wilbur Cafe December 2nd water flow rates and maximum daily water use graph

The maximum daily water use profile occurred on December 2nd and is shown in Figure 47. On this day 2,738 gallons were used for the tank fill and top off while only 595 gallons were used for the rinse. There were two tank fill sessions at 10 AM and 7 PM where water waste from the fill operation totaled roughly 2,500 gallons.

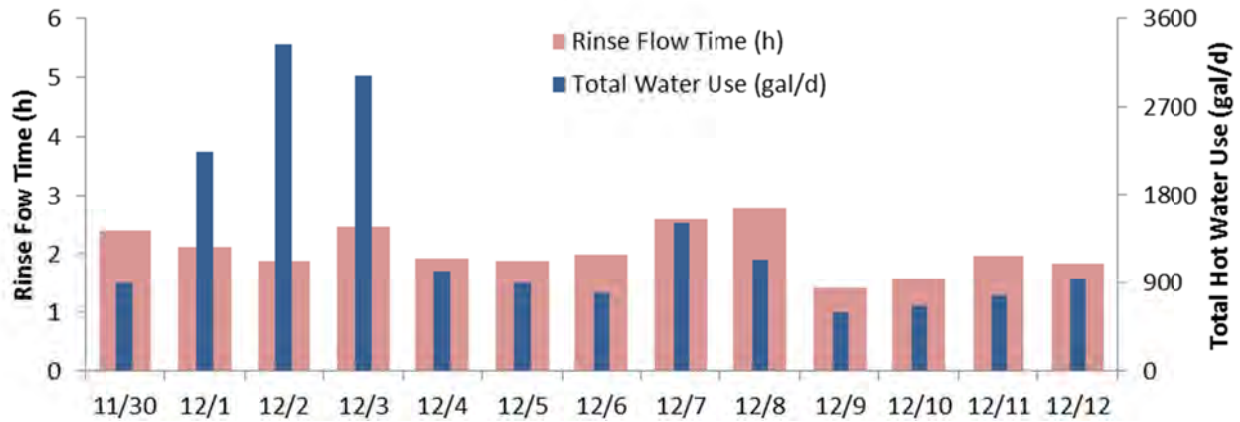
Figure 49. Wilbur Café plot of daily rinse flow time and total hot water use on original dishwasher

The plot in Figure 49 shows a period of two weeks where dishwasher rinse time and total water use were analyzed together. The dishwasher had some major malfunctions on December 1st through the 3rd in what appears to be occasions where the drain was left open during tank filling or rinse operation. The rest of the days were pretty moderate for rinse time and total water use. Both these parameters track each other well for the remaining ten days where the machine was operating normally.

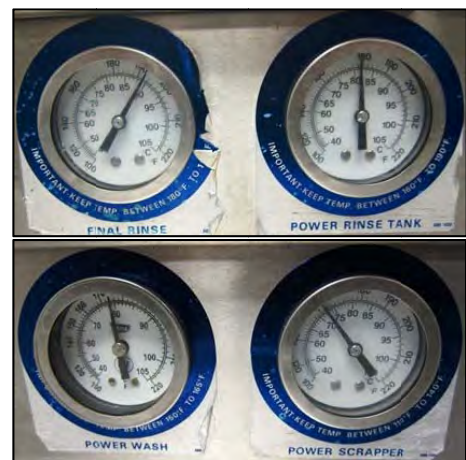
This dishwasher operated at the highest elevated temperatures seen thus far-- all temperature gauge readings exceeded manufacturer's minimum specifications by 15 to 20°F (Figure 50) during the initial site visit. The elevated water temperatures and the uninsulated steam heat exchanger that was radiating heat

Figure 50: Temperature gauge readings on dishwasher during rinse operation

into the room contributed to a hot and steamy dishroom. The average scrapper tank temperature at 151°F was elevated since the cold water supply to the scrapper tank was disconnected. Scrapper tank temperatures should normally be in the 110°F range. The purpose of the scrapper tank is to use warm water to knock down food debris, however if the water temperature is too high certain types of food debris can get baked onto the dishes.

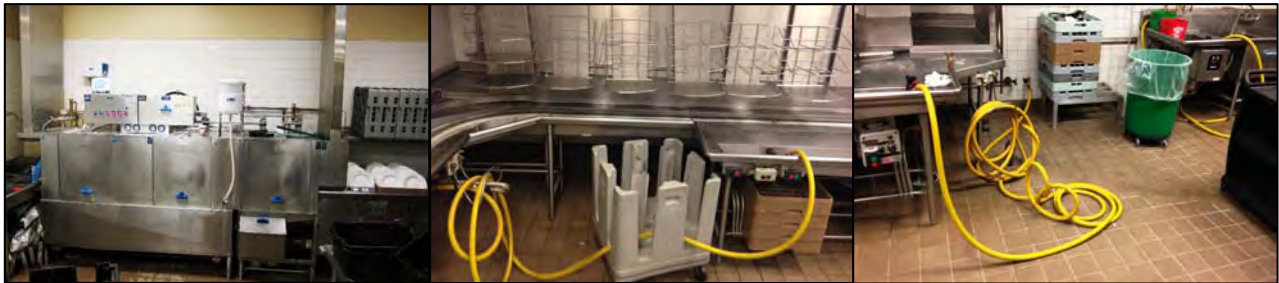
The biggest lesson learned about this dishwasher and more so the overall dishroom is that it fits the mold for absolute inefficiency on all accounts: equipment specification, operation and maintenance, and dishroom design. To start, the cafeteria dishroom design relies on automatic mechanical operations that inevitably break down, and in doing so makes the rest of the sanitation process more inefficient. Originally, the design relied on a cafeteria tray delivery system to a trough-based pre-rinse system, with rack advancing systems on both ends of the machine. The trough based system is now broken or no longer used, thus it is being supplemented by three industrial hoses with pre-rinse sprayers operating at 5-7 gpm (Figure 51). Moving along the warewashing assembly, the rack advance system works well on the entrance but is restricted on the other end due to a broken rack advance feature, causing a bottleneck for the racks moving through the hard 90° turn. The dishwasher is oversized and poorly maintained by engineering/maintenance staff, although it was one of the cleanest machines studied. Lastly, the heat loss from the uninsulated heat exchanger next to the dishwasher, coupled with the elevated water temperatures delivered to the machine by the steam distribution system made the room very uncomfortable to work in while being a major contributor to energy waste.

Figure 51: Dishroom pictures from left (dishwasher outlet) to right (pre-rinse station)

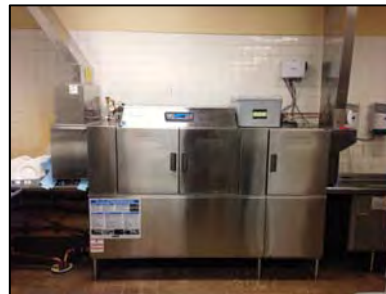
Figure 52: Replacement Hobart dishwasher

Over the winter holidays, Stanford replaced older Stero conveyor dishwashers in three cafeterias. At Wilbur Café, a Hobart CLPS-86ER was installed (Figure 52). It is a heat recovery unit that also has an electric internal booster heater and electric tank heaters. The electrical service was upgraded to accommodate this additional load. The rated rinse water use is 133 gph or 2.2 gpm. The internal water connections with these advanced dishwashers with heat recovery are very extensive (Figure 53). The benefits of the new unit include the steam removal system, insulated doors and door seal system, which combined and with the elimination of the steam heat exchanger system made for a comfortable work environment even without the room fans running. Additional features of the high-efficiency dishwasher include a door actuated drain closure system, vent fan control, energy saver mode, and integrated booster heater.

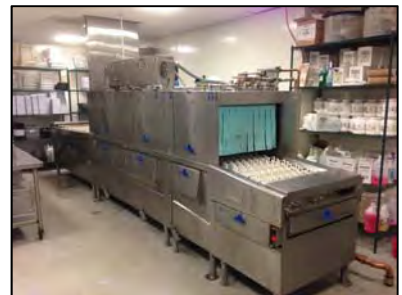
Figure 63: Epic Café original dishwasher

The preexisting dishwasher was a 2008 Stero STPCW-ER-20 high-temperature dishwasher with electric tank and booster heaters (Figure 63). The rinse water consumption was rated at an efficient 98 gallons per hour. The unit measured 20 ft. in length and included a 36-gallon scrapper tank and 47-gallon wash and rinse tanks.

The initial observations during the first site audit of this dishroom were that this was a very high-throughput dishwasher operated by multiple staff members while they carried out supplementary tasks. This facility utilized a drainwater tempering device to attempt to keep the exiting temperature below 110°F— a special circumstance since the facility drain level is below that of the main sanitary sewer system and requires that the wastewater be pumped vertically up to the main sewer level. High dishwasher drain temperatures in the past routinely had resulted in seized water pumps, therefore causing problems for this and other facilities on campus.

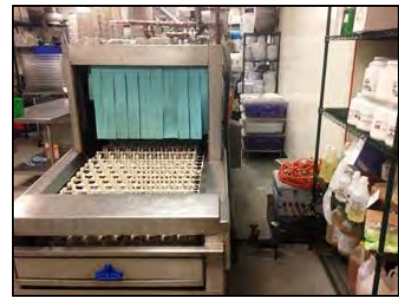
This was a high traffic dishroom, and it was quickly realized after losing data for over a month that all of the instrumentation would need to be fastened very securely and with the instrumentation enclosure situated so it would not be moved thus dislodging any connected wiring and causing further data gaps (Figure 64). However, between July 5th and 24th, one temperature sensor did get dislodged and an estimate was made for the missing data based on the average temperature rise observed on a daily basis with in the remaining dataset.

Figure 64: Instrumentation box (lower right)

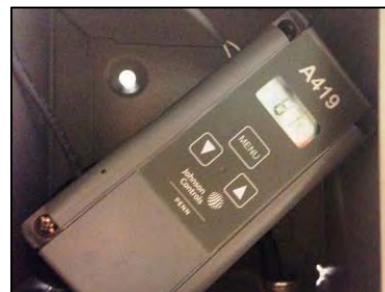
The cold water is used for tempering at a low flow rate and water continues to flow until the drain water temperature drop down to the 87°F setpoint on the tempering controls (Figure 68). Due to the capped 1 gpm flow rates for cold water tempering, the drain temperature spikes during tank dump operation or situations where

Figure 68: Tempering controls set at 87°F

the drain is left open accidentally during operation.

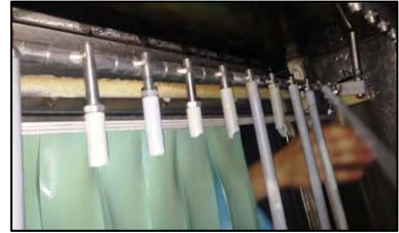
These large flight machines are commonly found not holding rinse specifications and their overall water use in this case is greatly increased by the lack of maintenance by a trained internal or external technician. From elevated rinse pressure, drains left open or clogged in the open position, broken rinse fingers (Figure 70) and to missing strip curtains (Figure 71), there is a considerable amount of maintenance issues that cause the dishwasher to perform poorly. A continuous maintenance program and employee training program needs to be in place to operate these large machines to close to specifications.

Figure 70: Broken rinse sensor fingers

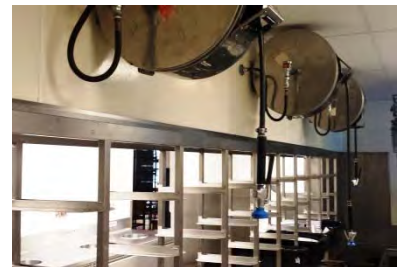
Figure 72: Dining tray drop off window

There were some positives to this monitoring project. This was the first large conveyor that was correctly sized for the operation. They also utilized plenty of operating staff working in coordination to run this large dishwasher productively. Their passive tray drop off window and manual hand scrapping of food waste combined with a row of three high efficiency pre-rinse sprayers were an efficient and reliable pre-rinse combination. It shows that minimizing hardware for the pre-rinse (Figure 72), even a high foot-traffic dishroom is efficient and reliable versus the automated pre-rinse system at the much lower throughput Wilbur dishroom. The Facebook dishroom did have a trough based scrapper system that we did not see being utilized.

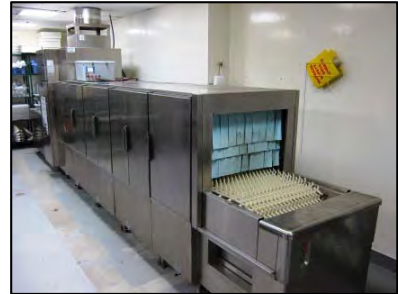
Figure 73: Replacement Hobart dishwasher

In Spring of 2015, Facebook went ahead and replaced the dishwasher with a high efficiency model with integrated heat recovery. The Hobart FT1000 ER was installed and monitoring commenced on May 4th 2015. The unit has an electric internal booster heater and tank heaters. The rated rinse water use is 58 gph or 1 gpm (Figure 73).

The water and electrical connections with these advanced dishwashers with heat recovery are extensive. The features and benefits of the new unit include the steam removal system, insulated doors and door seal system, an automatic soil removal system, auto clean and descaling functions, vent fan control, energy saver mode, pumped rinse system, and integrated booster heater.

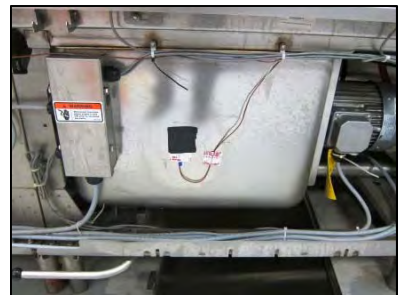
Figure 75: Temperature sensor affixed to tank

The same monitoring setup was used for both the original and replacement dishwasher. Electricity use to the unit was measured at three points using the power meter instrumentation shown in Figure 74. This included the two, 480V 3-phase connections to the machine that operate the dishwasher heaters, controls and motors and an additional meter for monitoring the booster heater separately. Two ultrasonic meters were used to measure the hot and cold water entering the dishwasher. Temperature was measured on the incoming cold and hot water line, to the inlet and outlet of the booster heater and at the drain. Tank temperatures were measured at the powered rinse, wash, and scrapper tanks (Figure 75).

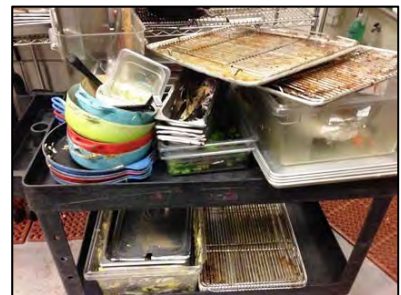
Figure 81: Kitchen prep wares

This was our first opportunity to see the performance of blower dryers installed on flight dishwashers. In this facility, the dishroom staff member commented that 70% of the wares are back of the house preparation wares (examples are shown in Figure 81) and only 30% are front of the house plates, cups and utensils. The blower dryer have a lot of trouble drying non metal or ceramic wares. The water can be

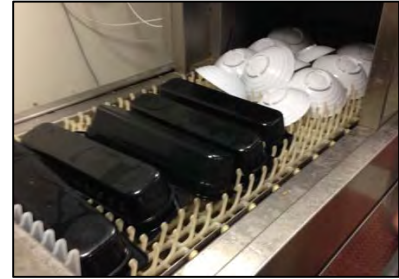
Figure 82: Wet wares exiting the blower dryer

visually seen on these salad bar trays in Figure 82. The bigger observation we made was that the blower dryer fan seldom turns off and it takes a minimum 30 seconds for the blower dryer heater to turn off when the conveyor is not running. Thus for an operation such as this, the blower dryer fan and heater are on practically continuously using a significant amount of energy in the process with marginal labor savings.

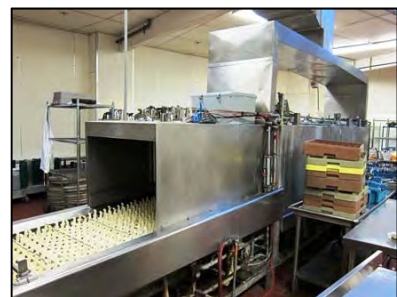
Figure 85: Steam Heated Flight Dishwasher

The nameplate was missing on this dishwasher, but it is estimated that the unit is 20 years old and is one of the older Stero STPCW series machines that is rated at 336 gallons of rinse water use per hour. The unit uses steam heat for all its water heating functions (Figure 85). Information such as the number of seats or square footage was not gathered for this facility because it was unclear which portion of the wares was being cleaned for the restaurant or another hotel function.

The initial observations during the dishroom site audit were that this dishwasher was underutilized (i.e. not heavily loaded with wares and not used for long durations), not in the best of shape and ready for replacement. This facility utilized a water temperature tempering to introduce cold water to maintain the scrapper tank and drain temperatures at 120°F and 110°F respectively. The steam boiler and distribution system was old and leaking and was mainly operating to produce steam to run the dishwasher. The hotel reached out to the FSTC with interest in making a business case for replacing the entire steam heating system for the kitchen including the end-use equipment such as the dishwasher, steam cooker, proofer and steam tables.

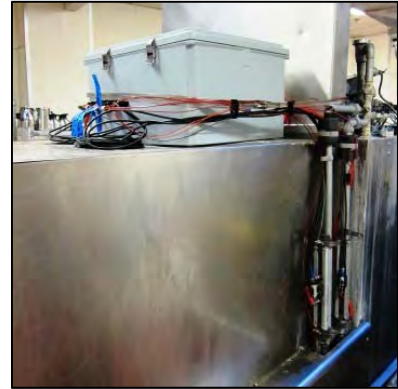
Figure 86: Instrumentation box and ultrasonic water meter transducers

motors, conveyor belt and controls was measured at the dishwasher. Two ultrasonic meters were used to measure the rinse and fill water entering the dishwasher (Figure 86). The cold water flow rate was spot metered prior to removing the instrumentation. The fixed cold fill flow rate and fill flow time was used to calculate the daily water use. The cold tempering flow time was estimated based on a change in temperature from ambient to cold water supply temperature at the cold water fill spout.

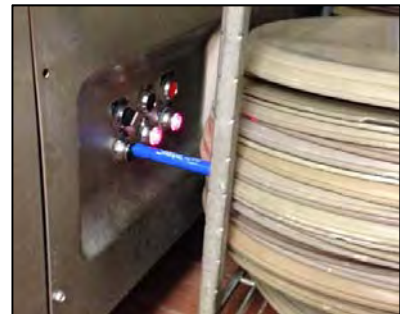
Figure 94: Sharpie manual overfill

Otherwise it can get costly and use a lot of resources. The best example of this is that the auto tank fill function on the dishwasher was only filling two of the three tanks. The operator would be required to hold the button down for approximately 4 minutes to manually override the system to allow for the third tank to get filled. In doing so, it would cause the other two tanks to overflow sending clean water down the drain. The staff learned to compensate by

developing their own version of an autofill so they would not have to be burdened by the manual procedure. They used a Sharpie dry erase marker in Figure 94 to depress the autofill button and parked a drying and storing rack next to it so they can move on to the next task, sometimes forgetting about it. Unfortunately, this “sharpie fill” was on average using 510 gallons of potable water.

The biggest lesson learned from monitoring this dishwasher was that as maintenance with the machine gets limited, malfunctions become a mainstay, and the operator has to adjust practices to operate the machine sufficiently, which results in wasteful practices. A continuous maintenance program and employee training program needs to be in place to operate these large machines to specifications.

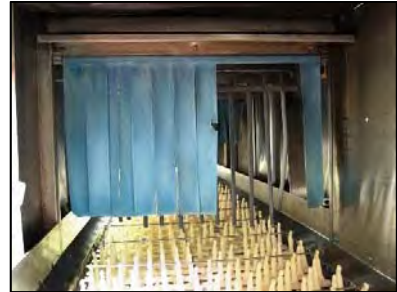
Figure 95: Missing and short strip curtains

Other notable problems with this dishwasher include water leaks, poor cleaning performance and the strip curtains requiring replacement (Figure 95). Missing or short strip curtains may cause the mixing of rinse and wash water or wash and scrapper water contaminating or diluting individual tanks or causing overfills in one tank and water loss in another. The blower dryer was not working, causing the two dishroom staff members to stop or slow operation to dry wares. Holes in the rackless conveyor were causing small wares to fall in (Figure 96). Time was lost in trying to fetch them before they can cause damage to the conveyor. Also, broken pegs were creating spaces where plates couldn't be racked creating rack loading inefficiency.
