# A Cost-Effective Approach for Leak Detection and Leak Localization in Multi-Family

Innovation Conservation Program - ICP 213934

Metropolitan Water District of Southern California

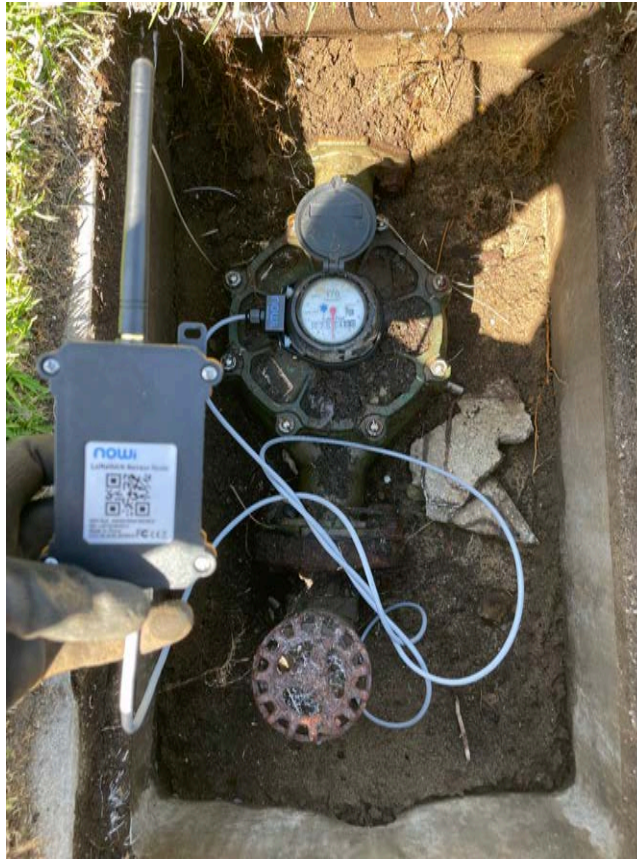
**Figure 6** - Is an example installation with the sensor strapped onto the register of a property's water meter.

44 Building Monitors were installed on March 26th, 2024 and April 8th, 2024. Each device takes about 5-10 minutes to install once you're at the site. Installation only takes a few steps. First, the sensor is strapped around the water meter's register. Secondly, the node is attached so that the antenna is pointing towards the sky. Below are a few example installations.

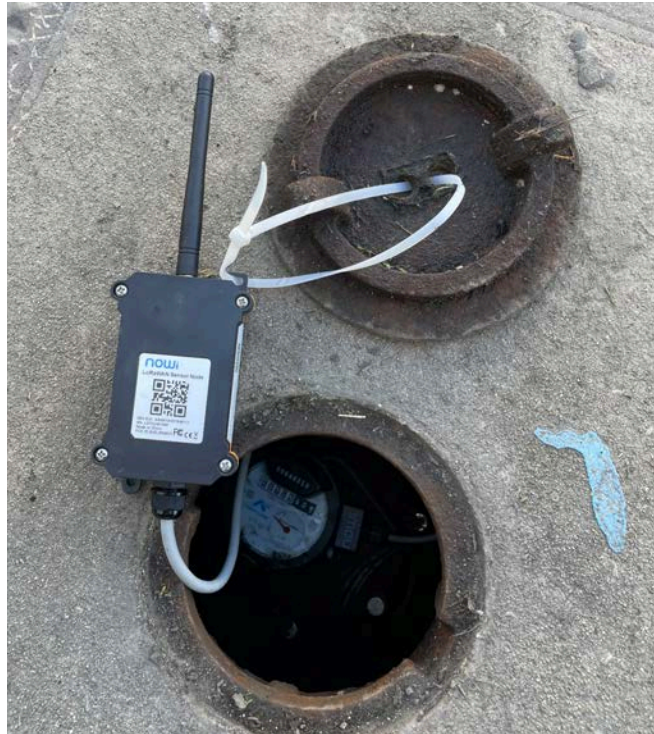
**Figure 7** - A building monitor zip-tied to the lid of a water meter pit.

At first, the devices were attached to the water meter pit lid with a zip tie. While this was a quick and effective way to install them, we later saw issues with the devices being damaged when the utility company opened the pits and read the meters. To fix this the devices were attached to a mount affixed to the side of the pit.

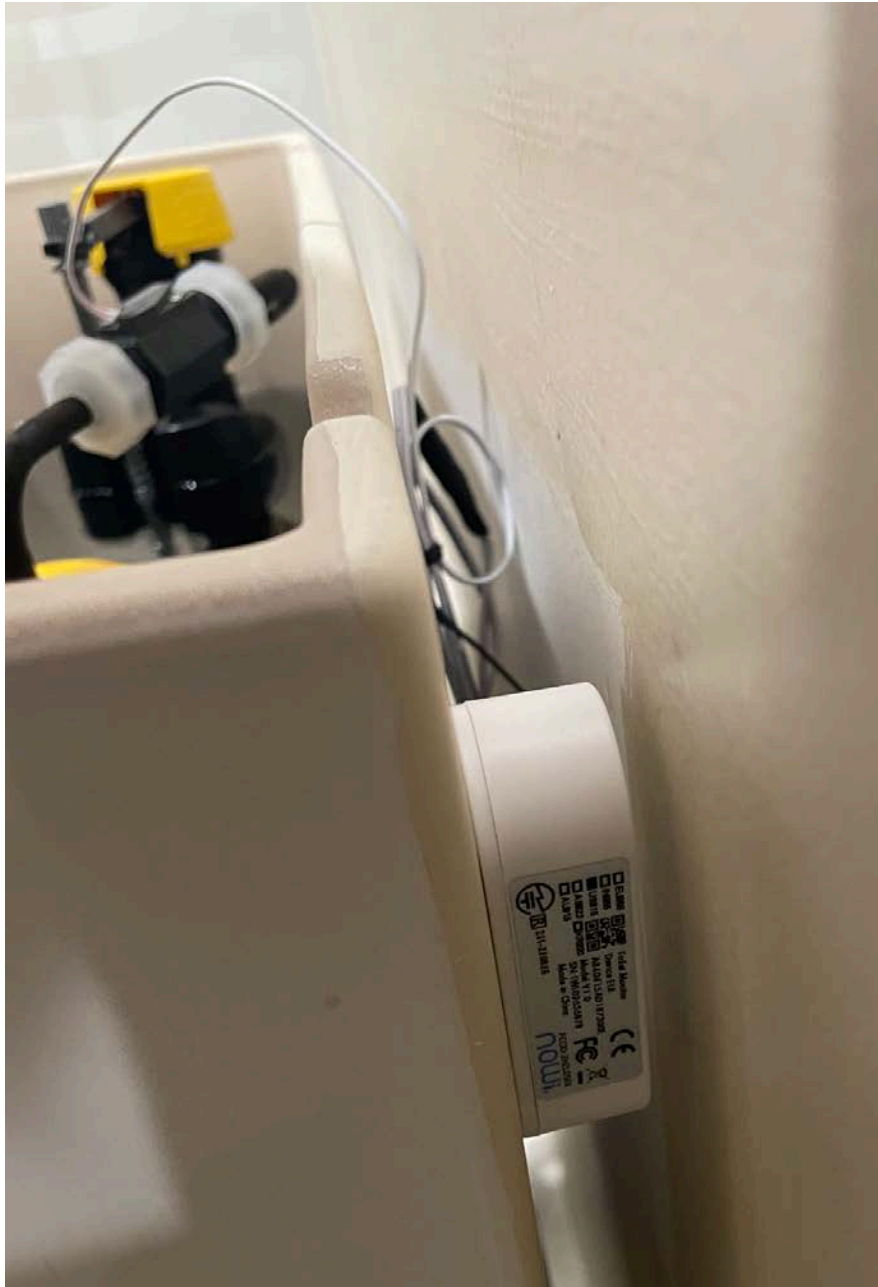
**Figure 13-** Shows the Toilet Monitor's communication node hidden behind the toilet between the wall.

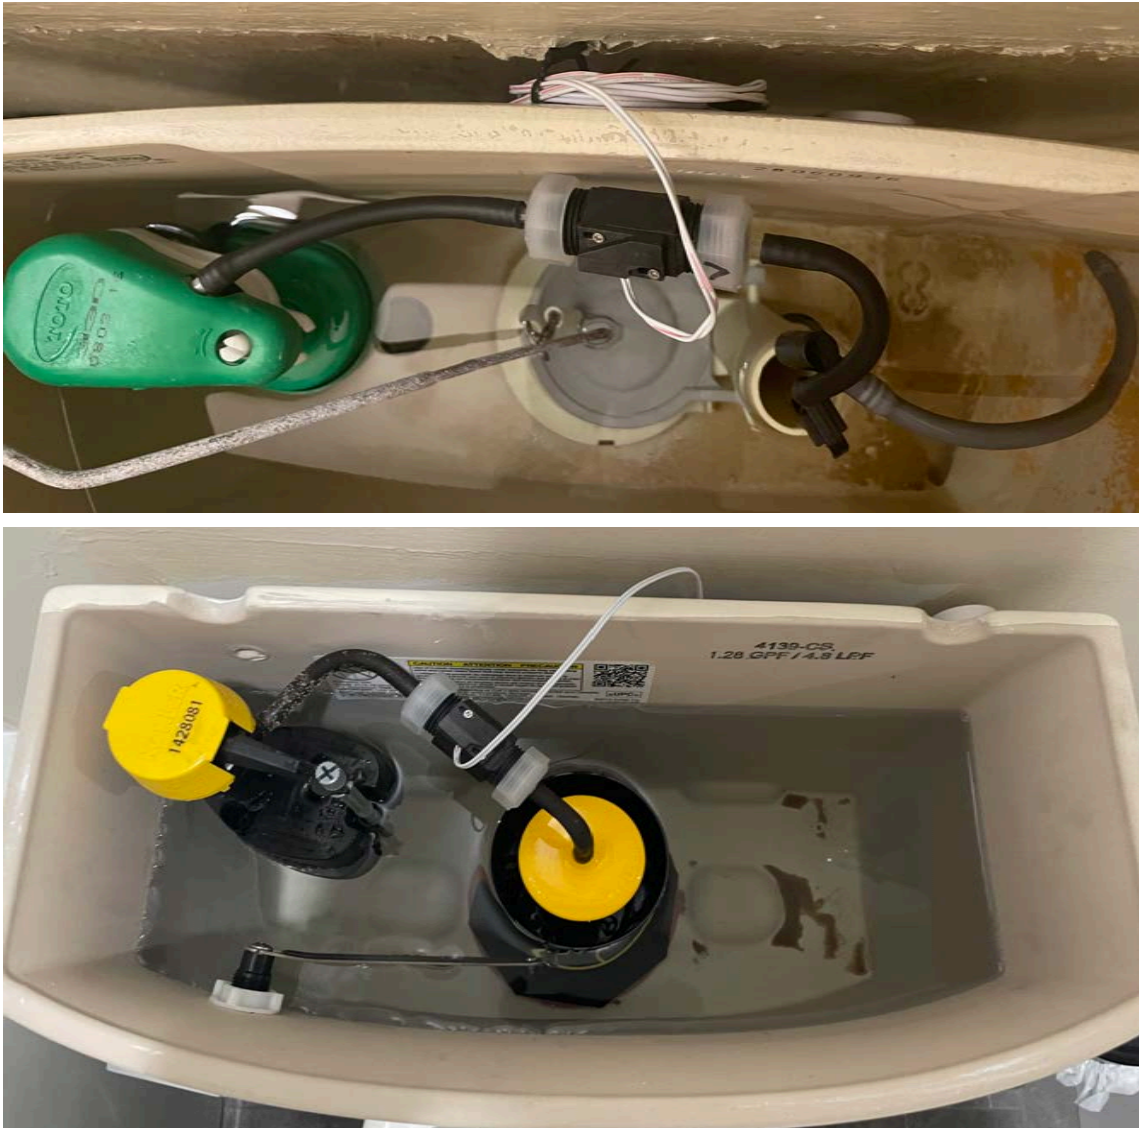
**Figure 14** - Shows two examples of how the Toilet Monitor sensor is installed within the toilet.

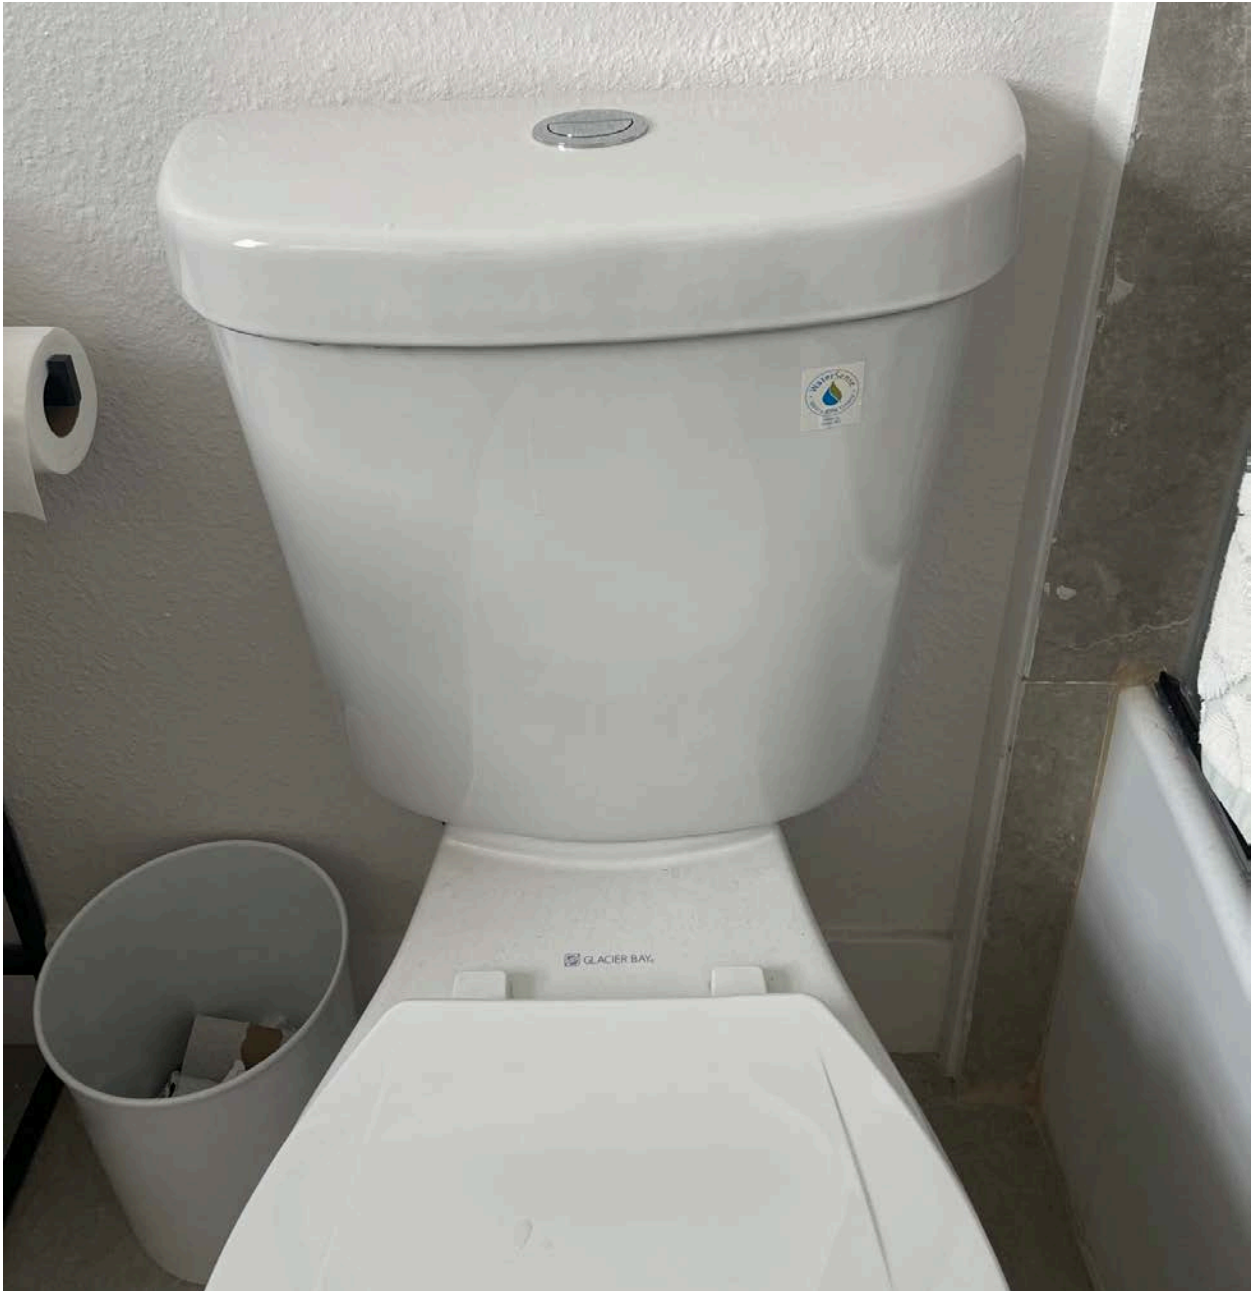
**Figure 15** - Shows how the toilet monitor is completely hidden from the tenants after installation.

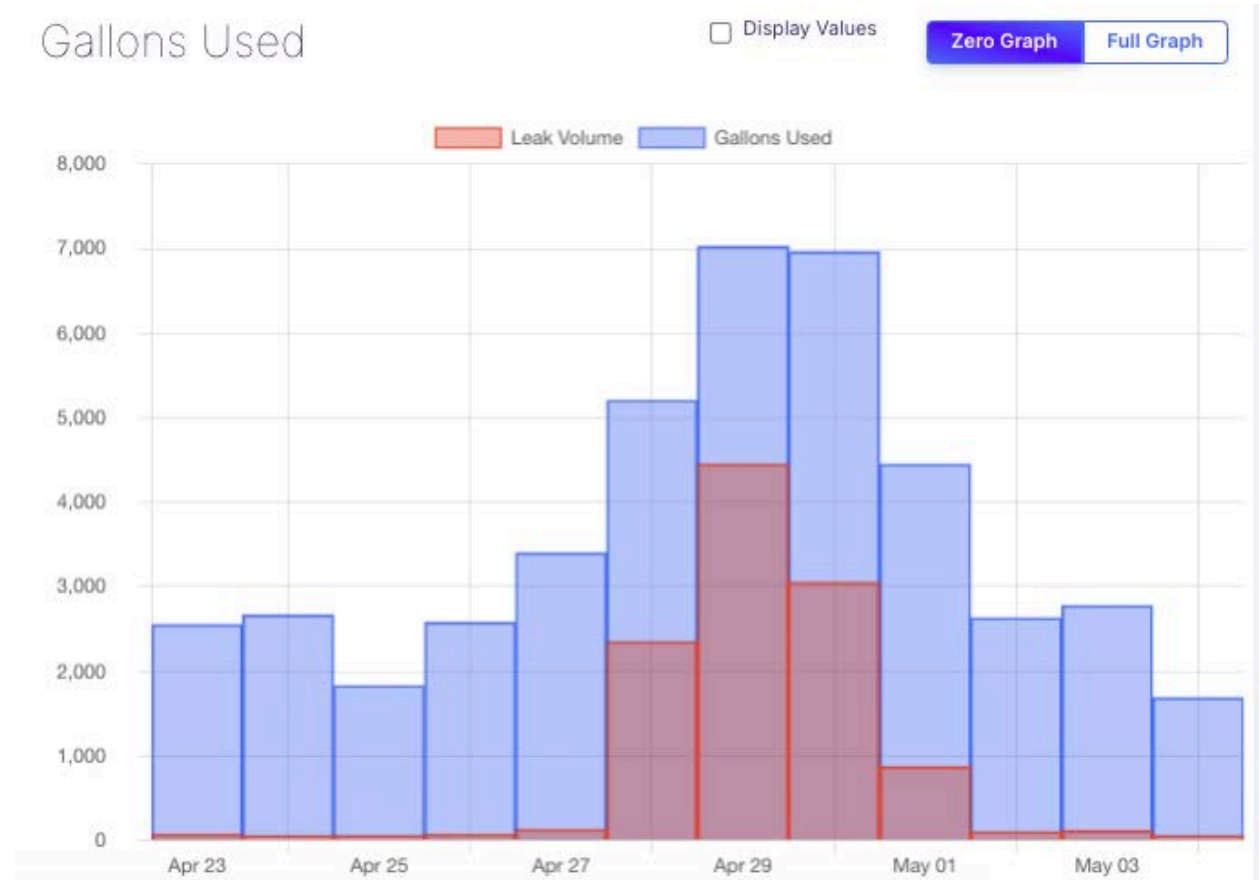
**Figure 17** - BLUE is the total gallons used daily, and RED is NOWi's leak detection algorithm's estimated leak size daily. The Y-axis is the number of gallons used and the X-axis is the date.

Below is an example irrigation leak that was detected by a Building Monitor. The leak was leaking around 173 Gallons Per Hour and had gone unnoticed by the on-site staff until our monitor detected the leak.

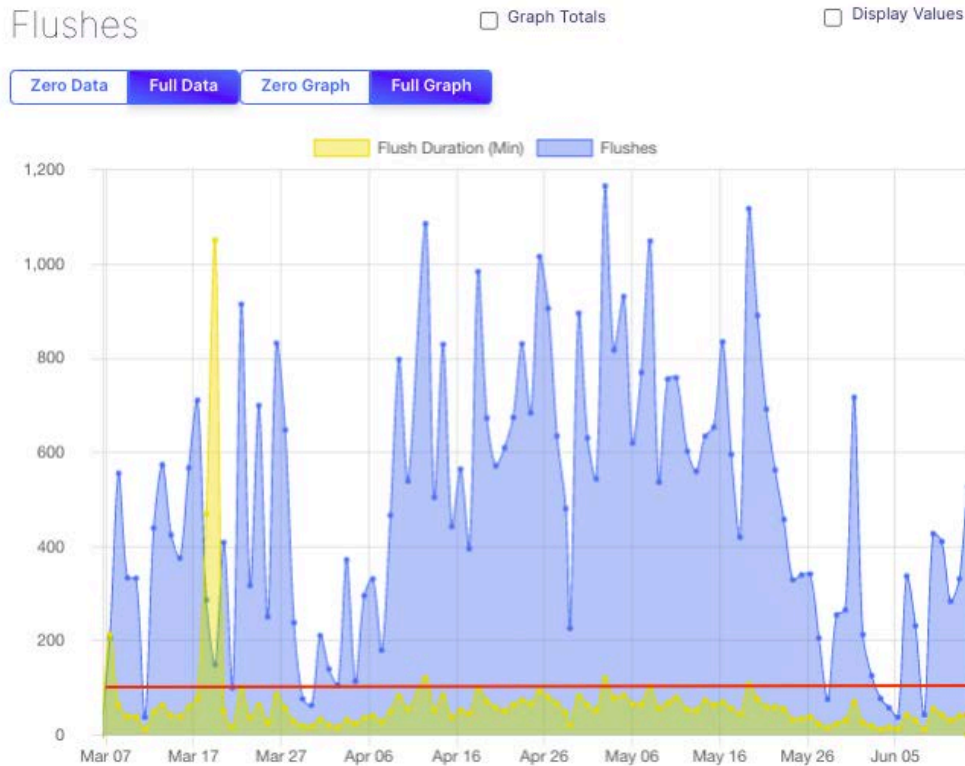
**Figure 20** - The BLUE line is the number of flushes seen over each day. The YELLOW line is the duration of flow in minutes over each day. The RED line is the threshold for either metric, above which the toilet is considered leaking.

Here is an example of a leaking flapper valve. When a flapper valve leaks the toilet fills up (turns on), then leaks the tank over time into the bowl (turns off), then starts filling up again. A toilet can do this once every 10 minutes down to once a minute or even constantly filling. Any toilet that flushes (turns on and off) more than 100 times in a day is typically a leak. The toilet below is flushing up to 1150 times in one day. If this toilet is even a 1.68 Gallon low flush toilet that means it wastes up to 1,900 gallons per day.
