Final Report for 2021 Study for Metropolitan Water District

Purpose of This Study

In 2021 a comparative study was conducted at the OC Fair & Event Center in Costa Mesa, CA by Responsive Drip Irrigation, funded by the State of California - Metropolitan Water District. The comparison was between Responsive Drip Irrigation’s GrowStream™ and Netafim’s standard drip tape - focusing on which product produced the healthiest plants, as well as which used less water and fertilizers.

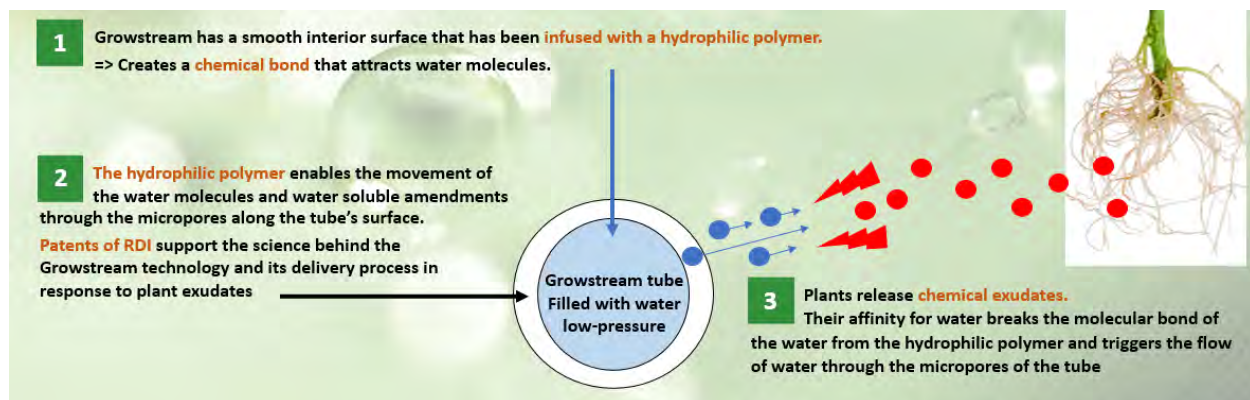
GrowStream™ ushers a new generation for water delivery as the world's first truly plant-responsive irrigation system. GrowStream™ interacts with plant roots through the release of exudates to deliver exactly what each plant calls for (water & nutrients), minute-by-minute, plant-by-plant. While standard "forced" irrigation is based upon timed intervals for delivery of set amounts of water, plant-responsive irrigation is based on organic chemistry interacting directly with the plants' roots to deliver water and amendments on demand. GrowStream™ operates at a constant low pressure, providing a reservoir that plants can access as needed. The diagram below demonstrates in detail how RDI's GrowStream™ interacts with plant exudates.

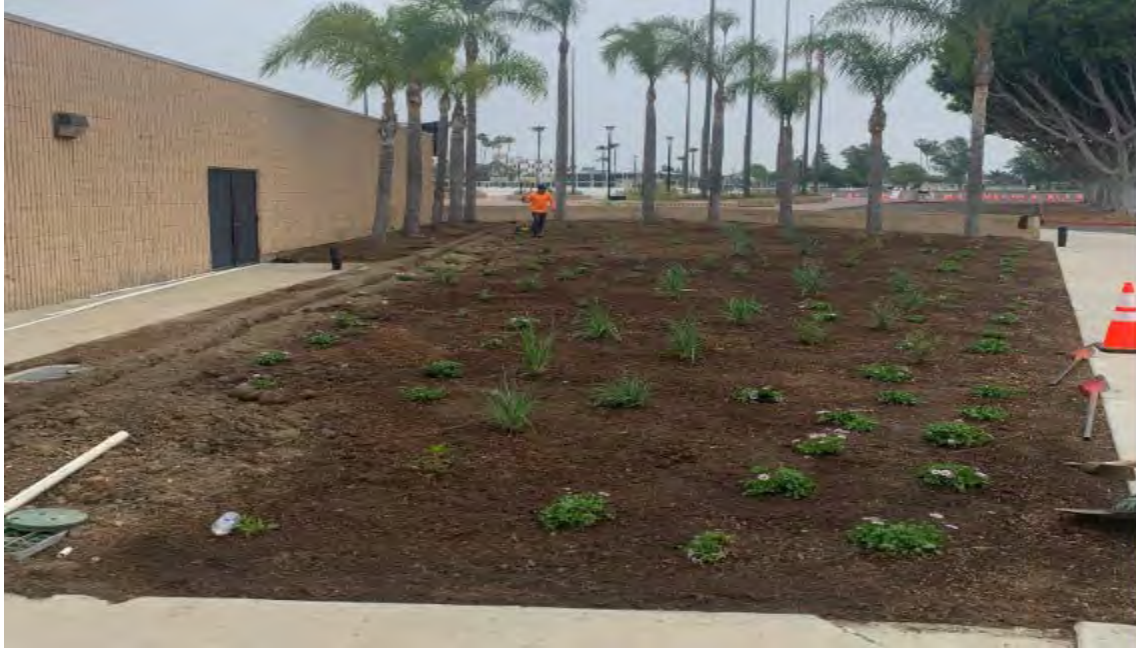
Pictured Below is the RDI plot immediately following installation:

After these plans were approved and plants were ordered, a professional landscaping team completed the installation of both irrigation systems as well as the planting. The major difference in installation between the two systems is that Netafim's standard drip system is laid above ground and the GrowStream™ system is sub-surface irrigation - aesthetically more appealing. The table below quantifies the number of each plant species that was planted at each plot:

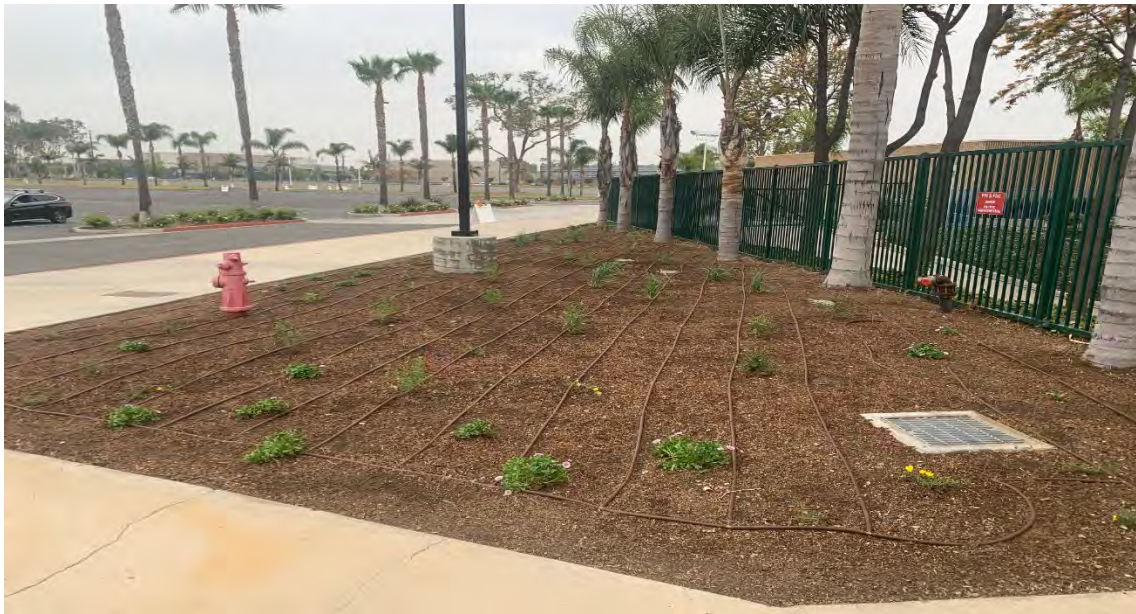
Pictured below is the Netafim plot immediately following installation:

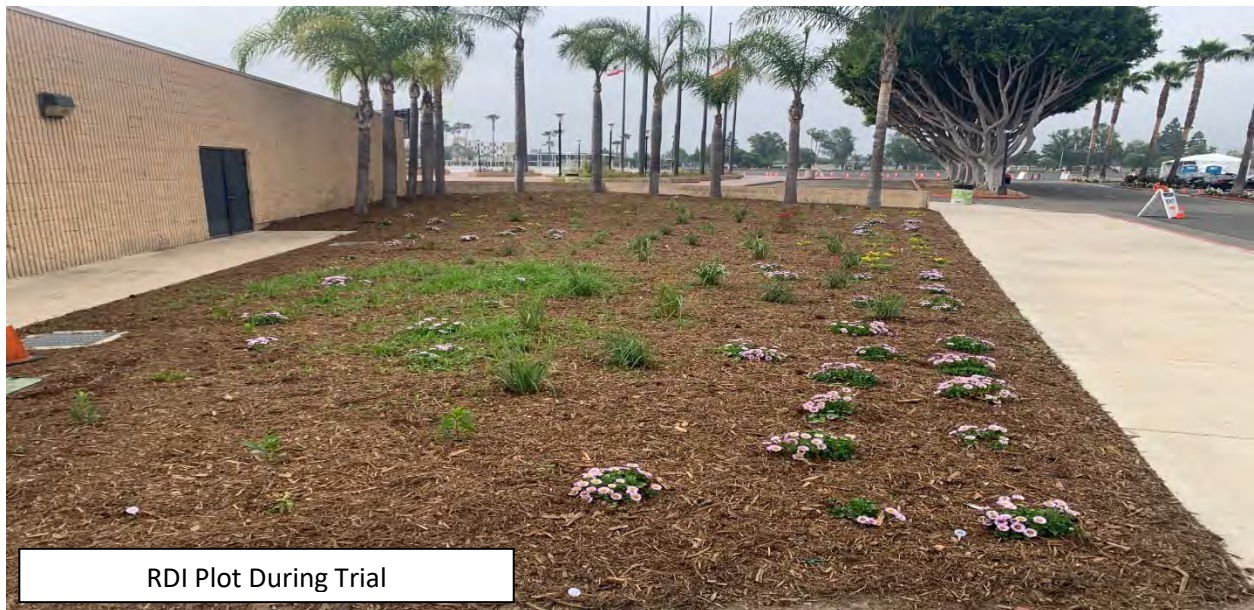
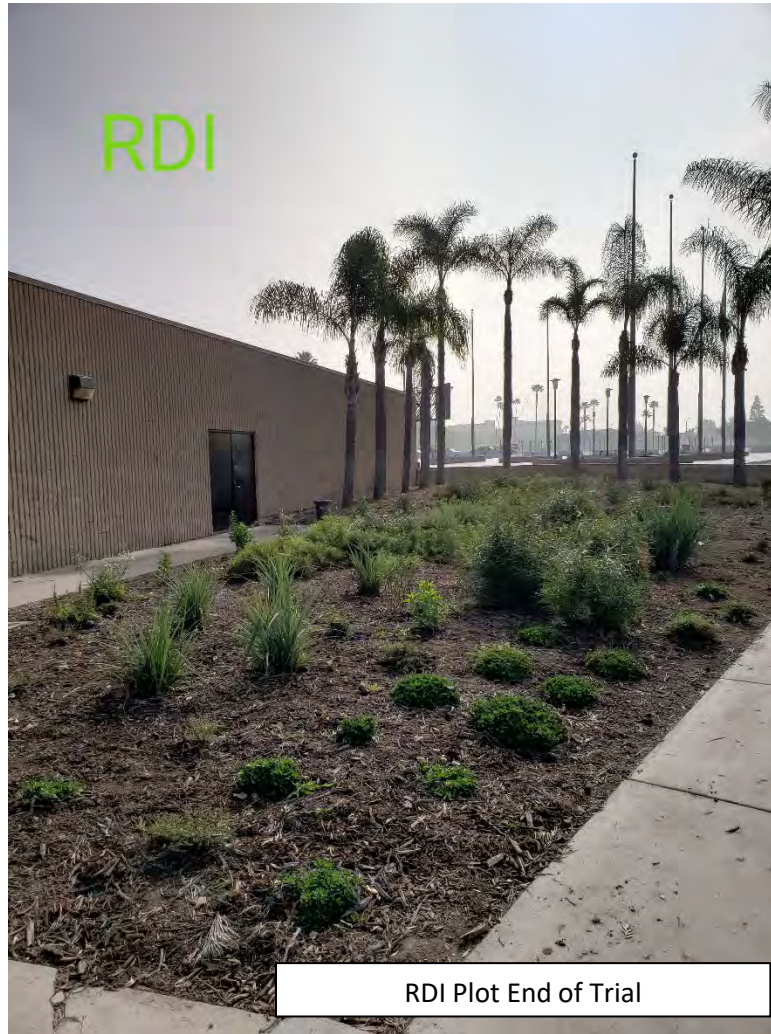
The RDI garden displays good growth. Most areas are thriving and doing well, looking full and lush. The plants have adapted well to GrowStream™, the plant-responsive irrigation system. There are a few small areas showing stress due to the amount of foot-traffic in the garden, due to the events at OC Fair & Event Center (i.e., OC Fair in July and August, catering events, etc.). The following observations were made by Ms. Gregerson:

- The Amorpha has branched nicely with good growth. Some areas near heavy foot-traffic appear to be struggling.
- The Salvia and Eriogonum are growing well, with very nice blooms.
- The Solidago is growing well and blooming profusely.
- The Carex is growing quickly and filling out nicely.
- The Ceanothus is thriving and appears very healthy.
- The Penstemon is blooming with good growth. It looks healthy and is thriving in most of the areas of the RDI side.
- The Lobelia has growth that is spotty. Some areas are very lush and blooming, looking healthy. Other areas are struggling. Lobelia tends to like a lot of water.

Below is a picture of RDI's plot during the trial and at the end of the trial:

In addition, there was visibly less weed growth, which can be clearly observed in the pictures – 60%-70% less. The reason for this is due to the GrowStream™ system waters the root system, only upon demand where the plant is located. Netafim's standard drip irrigation system has emitters every 10 inches, whether there is a plant there or not. Therefore, the Netafim system is providing water where it is not needed, allowing weeds to germinate and grow profusely.

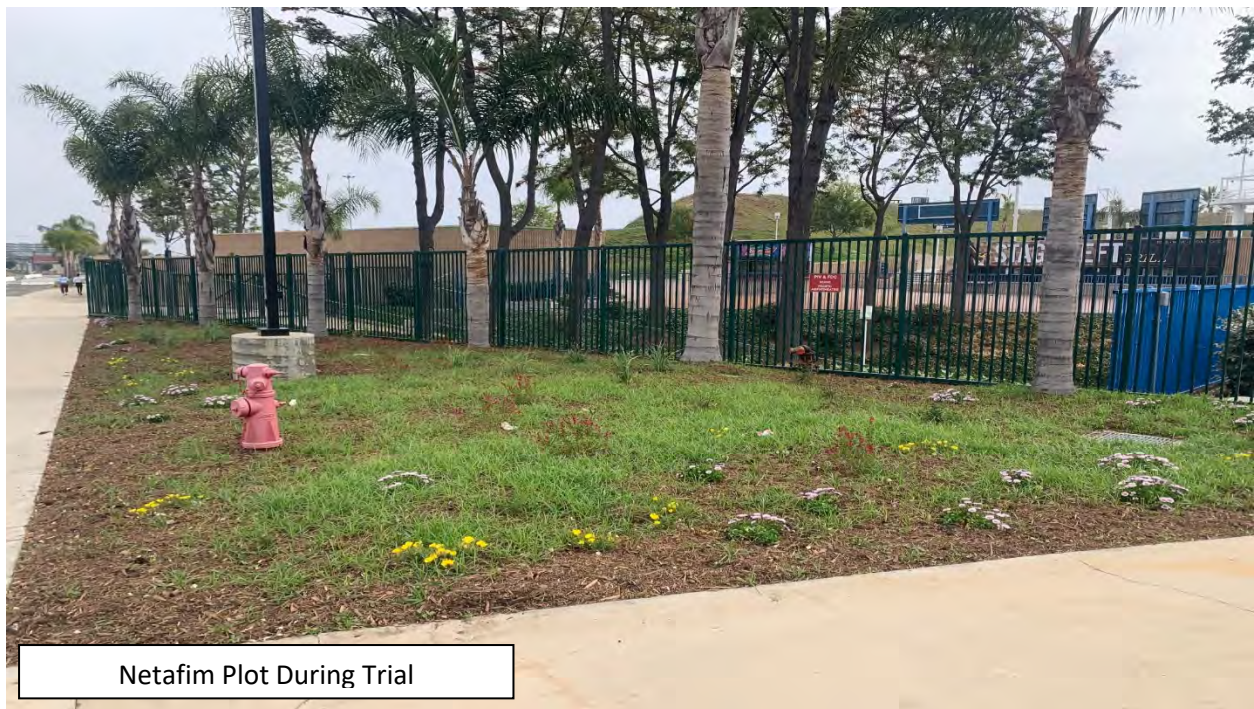
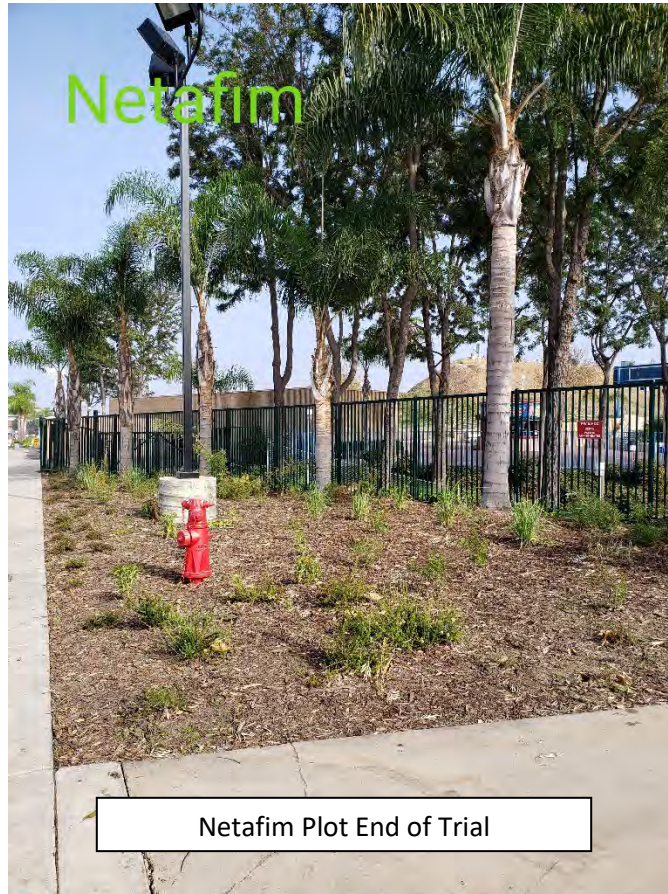
In comparison to RDI's GrowStream™, the Netafim side appears sparse in growth. While the plants look healthy, they appear to be growing much slower in this plot with considerable weed growth. The following observations were made by Ms. Gregerson:

- The Amorpha is full, branching nicely, and appears healthy.
- The Salvia appears healthy and has started to fill out.
- The Solidago is blooming well and appears healthy.
- The Carex appears healthy and appears to be growing well.
- The Ceanothus seems to be dying. It is yellow and is not growing. This could be from too much water, not enough water, or a plant disease that was unforeseen when it was planted. If a plant has a virus, it will usually appear when the plant is stressed.
- The Eriogonum is blooming nicely and has good but slow growth.

Below is a picture of Netafim's plot during the trial and at the end of the trial::

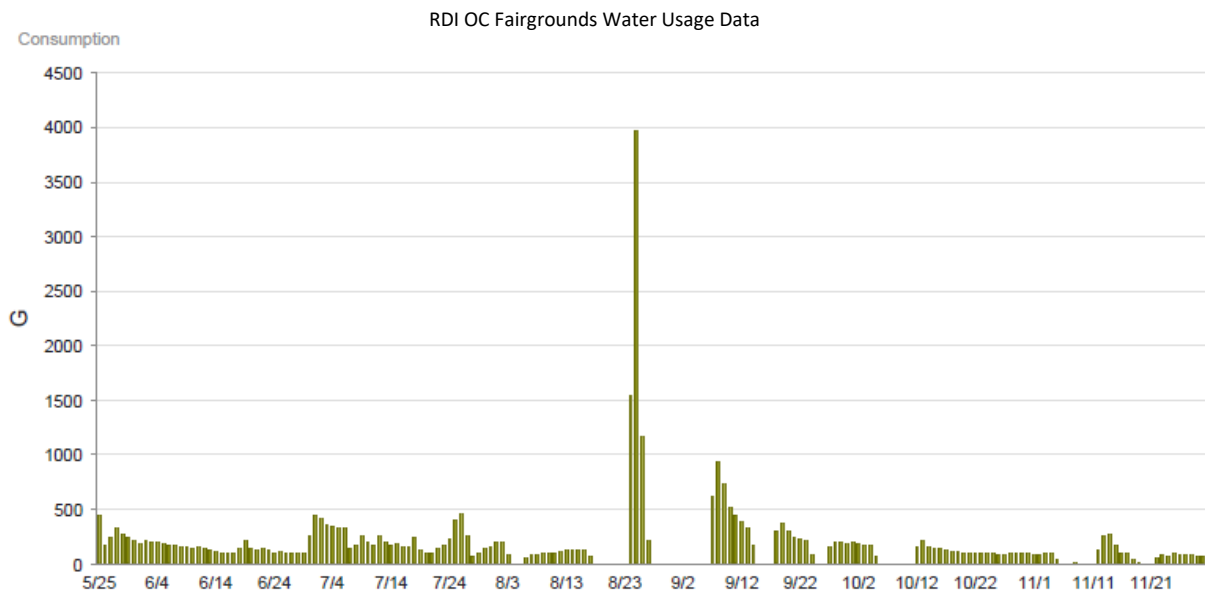
Below is a graph depicting daily water usage for the RDI Plot from 5/24/21 to 11/30/21:

The total amount of water used in the **RDI garden** was **32,611.6 gallons**. It's important to note that the spike in usage observed on August 23rd was due to a gopher biting a hole in the tubing, resulting in excessive water use. The system was turned off briefly and repaired.

**Rainbird ICWM series cellular water meters were installed on the header of each irrigation system. These meters uploaded the water readings daily to a database. Both graphs above were constructed based on these readings.*

<u>Square Footage</u>	<u>Water Usage</u>	<u>Water Usage Per Sq Ft</u>
RDI	3,500 square feet	32,611.6 gallons	9.32 gallons per square foot
Netafim	1,750 square feet	47,349.1 gallons*	27.06 gallons per square foot

Overall plant health with **RDI's GrowStream™ system** is notably better than Netafim's standard drip irrigation, displaying full and lush plant growth with more blooms – while using **65% less water**.
