DETECTING WATER LEAKS USING DRONE TECHNOLOGY

Deliverable #5 – Final Report

Report Agreement No. 180894

ManageWater Consulting, Inc.

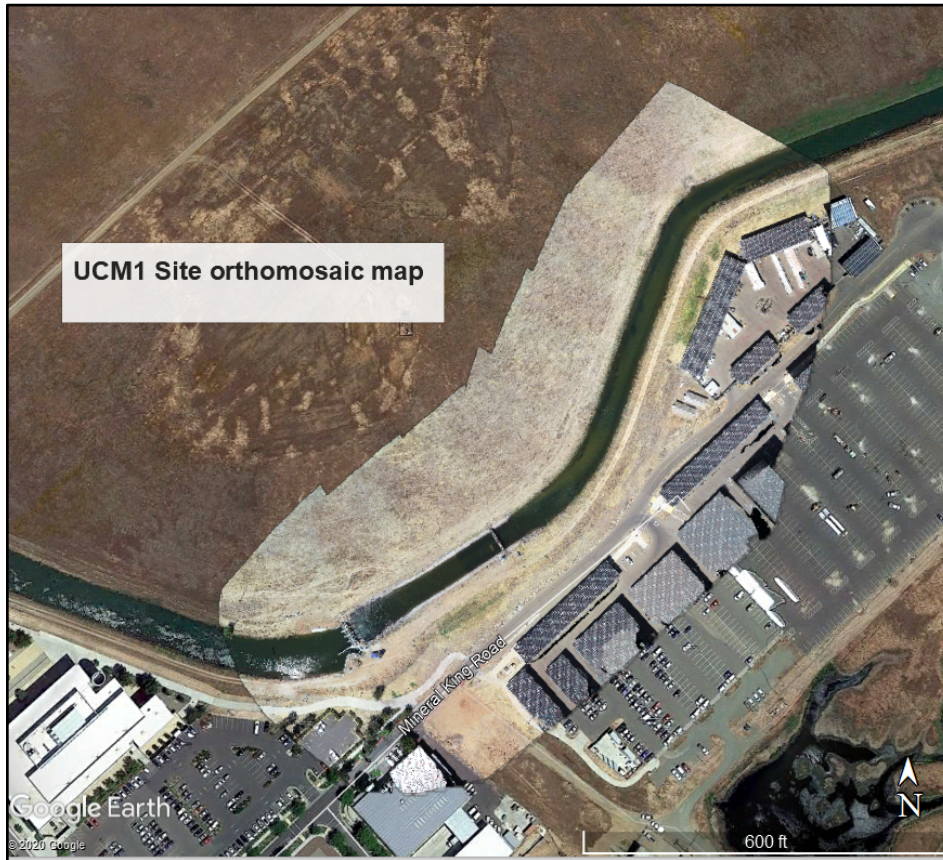
Figure 8. Orthomosaic map of UCM1 field site, generated using DJI P4P drone and Pix4D image Capture and Mapper processing software (lighter area). Surrounding area image uses Google Earth satellite view. Note the much higher resolution of the drone image, since it has a ground sampling distance (GSD) of approximately 1 inch and the satellite view has a nominal GSD of 50 feet.

At the UCM1 site, the earthen canal has several seeps through the earthen levee. The levee is mostly composed of native soil and rocky material. The canal water surface was approximately 4 feet below the top of the levee. Vegetation can be an indicator for water leaks. Grass and shrubs were visible on the campus site (Figure 8A), approximately 5 feet below the levee top. Clearly, this vegetation had access to water compared with adjacent vegetated areas that are dry. Lower temperatures were also observed in this area in the thermal images (Figure 8B).

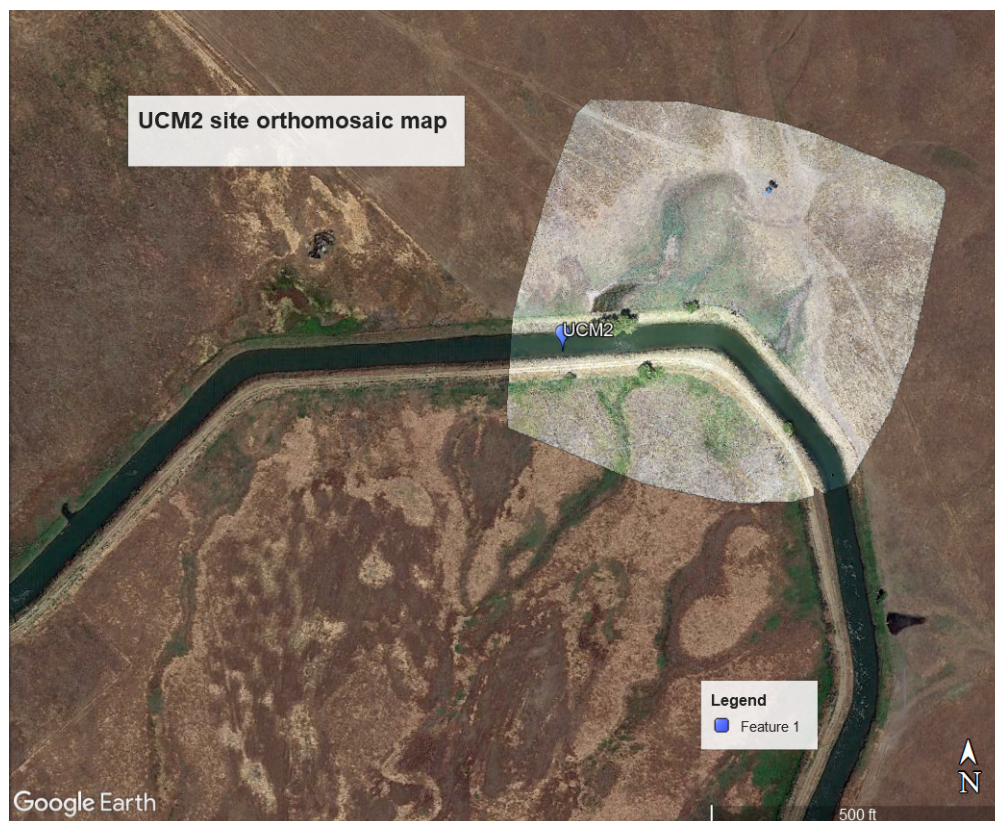
Figure 10. Map of UCM2 field site, generated using DJI P4P drone and Pix4D image Capture and Mapper processing software (lighter area). Surrounding area image uses Google Earth satellite view. Note the much higher resolution of the drone image, since it has a ground sampling distance (GSD) of approximately 1 inch and the satellite view has a nominal GSD of 50 feet.

This site is different from the UCM1 site because the area is hotter, more open, with shallow water ponded areas. The areas appear to be fed by leaking canal water. However, it was difficult to see specific leak locations from an on-the-ground perspective. The leak areas were more visible in visible light aerial surveys and even more apparent on the reflectance index maps.

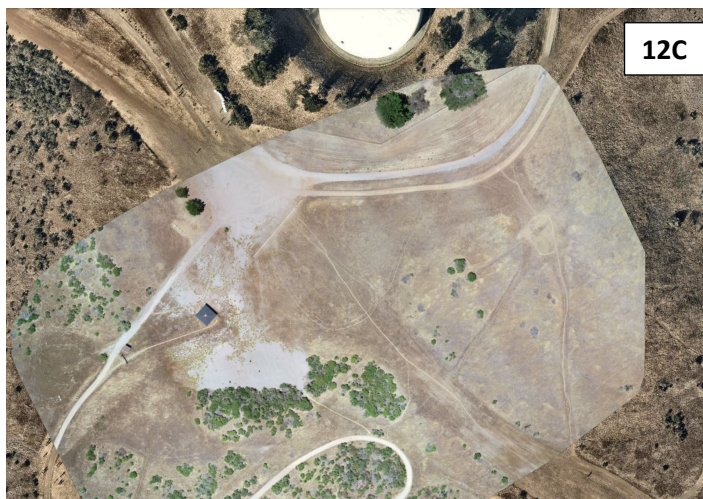
Figure 12B. Aerial views of MPWD1 site on March 19, 2019, with abundant grassy area due to recent and prolonged rainy season. The ground temperatures were too low due to the cooling effect of the green vegetation, resulting in insufficient contrast between the ground surface and water temperatures. The lack of contrasting ground to water temperatures resulted in no discernible temperature anomalies. Figure 12C. shows the aerial orthomosaic map for the MPWD1 site on July 26, 2019, almost two months after last rain event, with grassy areas dried out and ground temperatures (>100F) more than 40F higher than the water (60F). The orthomosaic map was developed using the P4P drone and Pix4D Capture and Mapper software.

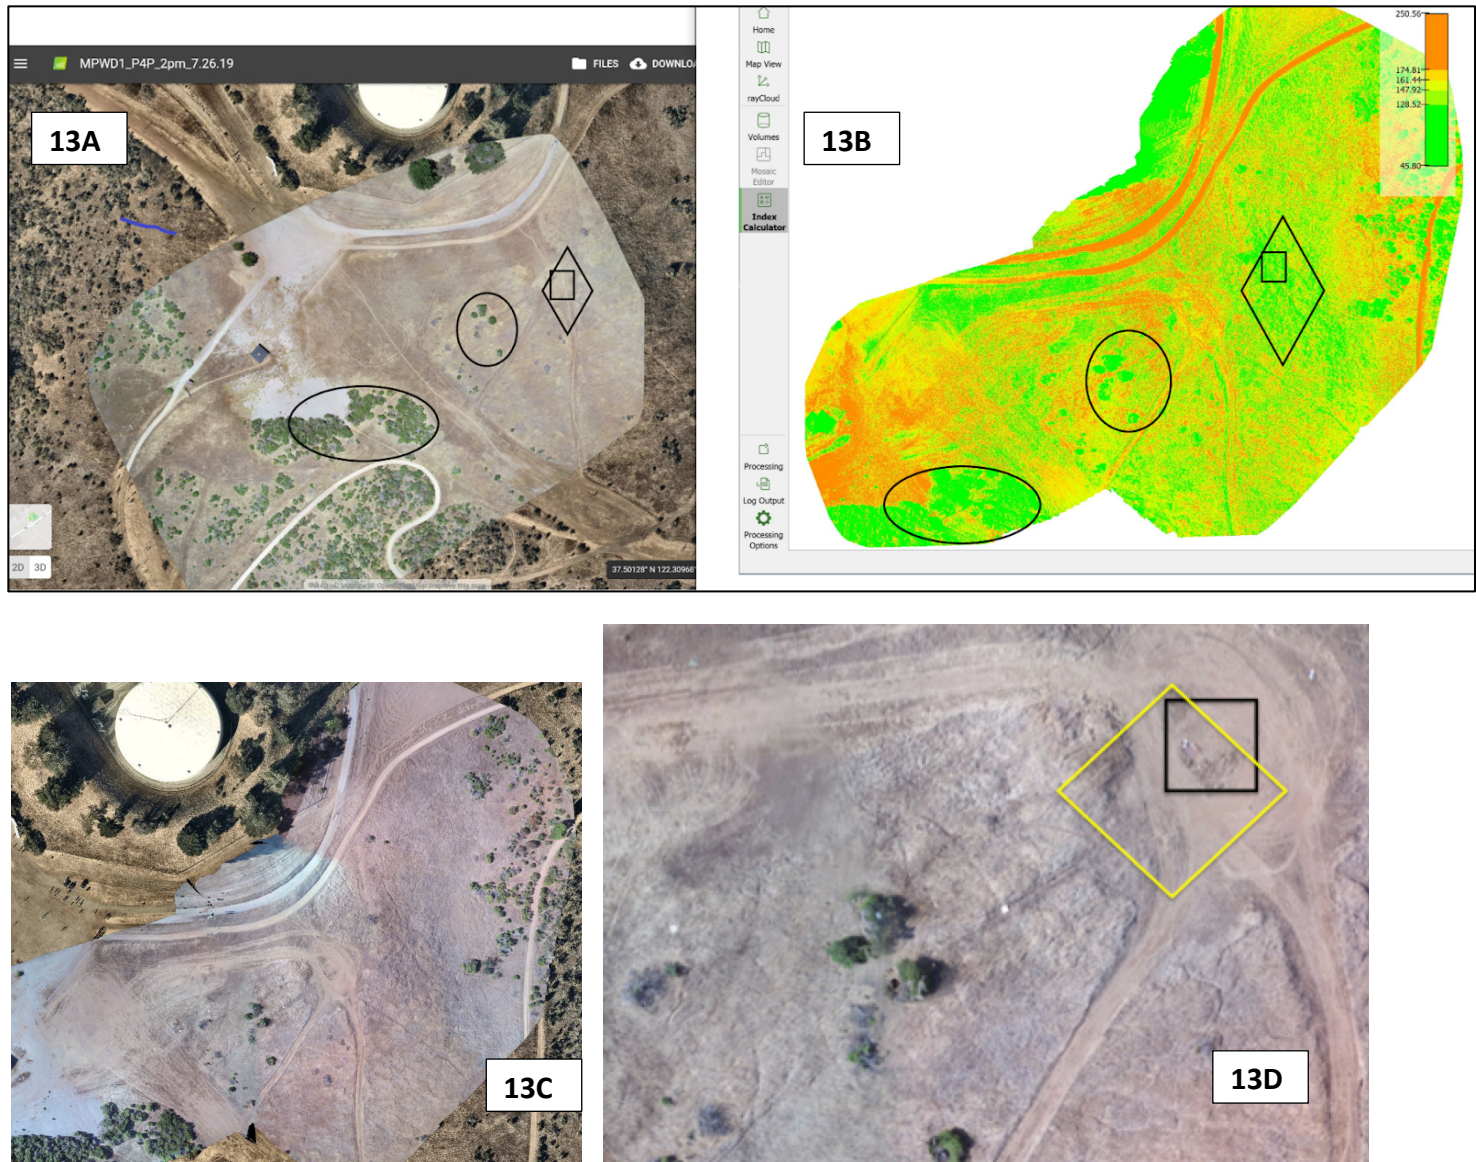
We used the reflectance index map to find the temperature patterns and anomalies. The area of the valve box (square: Figures 13A, 13B, and 13D), the lower temperature anomaly (diamond: Figures 13A, 13B, and 13D), and two vegetated areas (ovals: 13A, 13B) are outlined. Vegetation can be misinterpreted as a temperature anomaly due to leakage, but it is a result of cooling of the leaf surfaces from transpiration.

Figure 13E. M200 aerial visual image for reference to Figure 13F, showing the location of the valve box (square box) and approximate location of thermal image showing lower temperatures in figure 13F. This M200 aerial thermal image shows a closer view of the valve box with a metal cover (Sp1, upper center blue area) – the location of the subsurface simulated leak. The greenish mottled area, in the dirt road, to the left

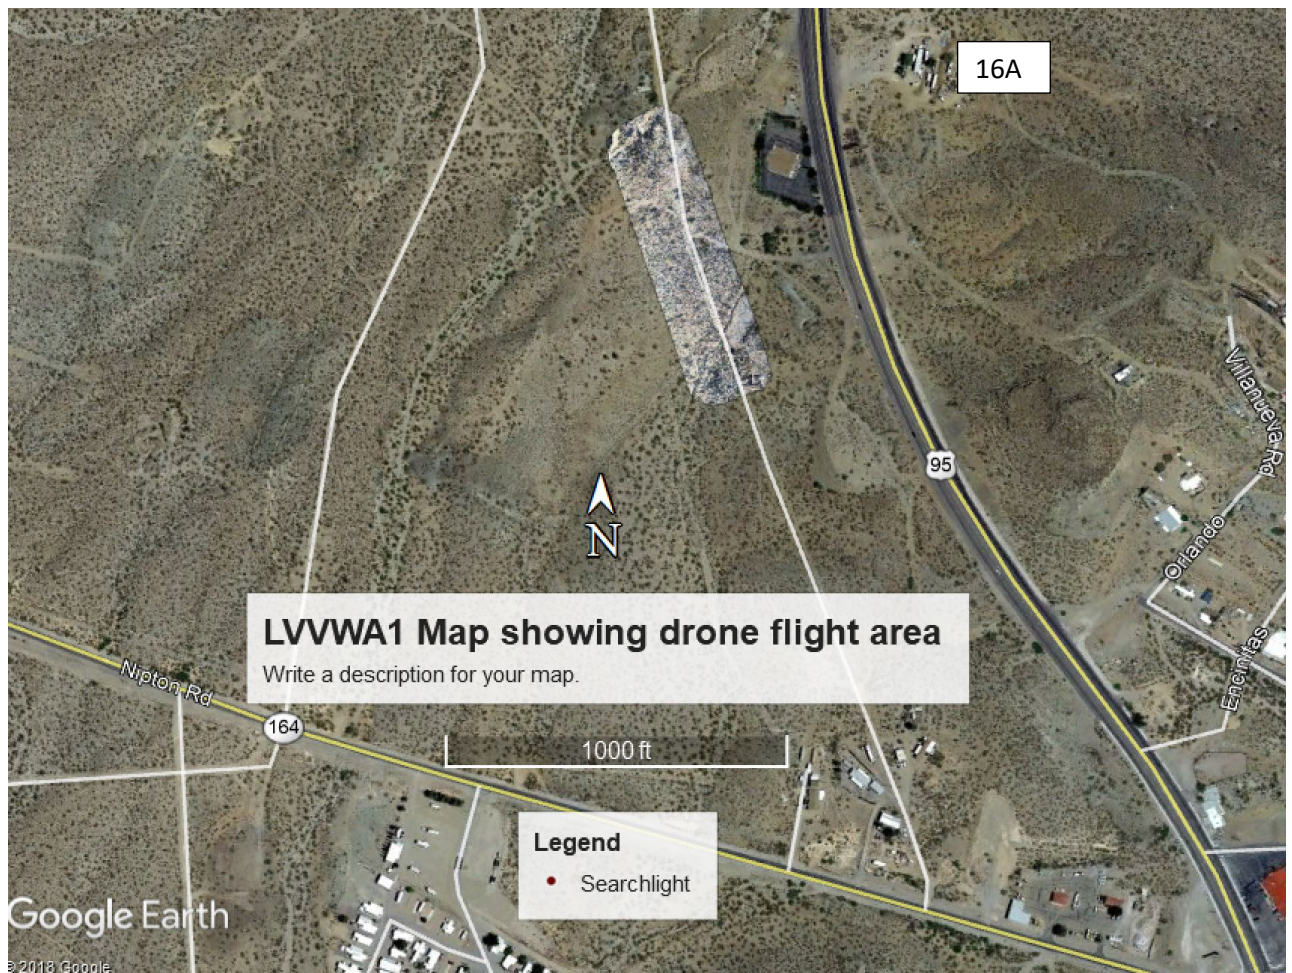
a reflectance index map and analyze it for thermal anomalies. No thermal anomalies were detected that could be interpreted as pipeline water leaks during fieldwork in May and October 2019.

Figure 16A. Flight map (lighter area), using sUAS DJI P4P and Pix4D Capture for LVVWA1.

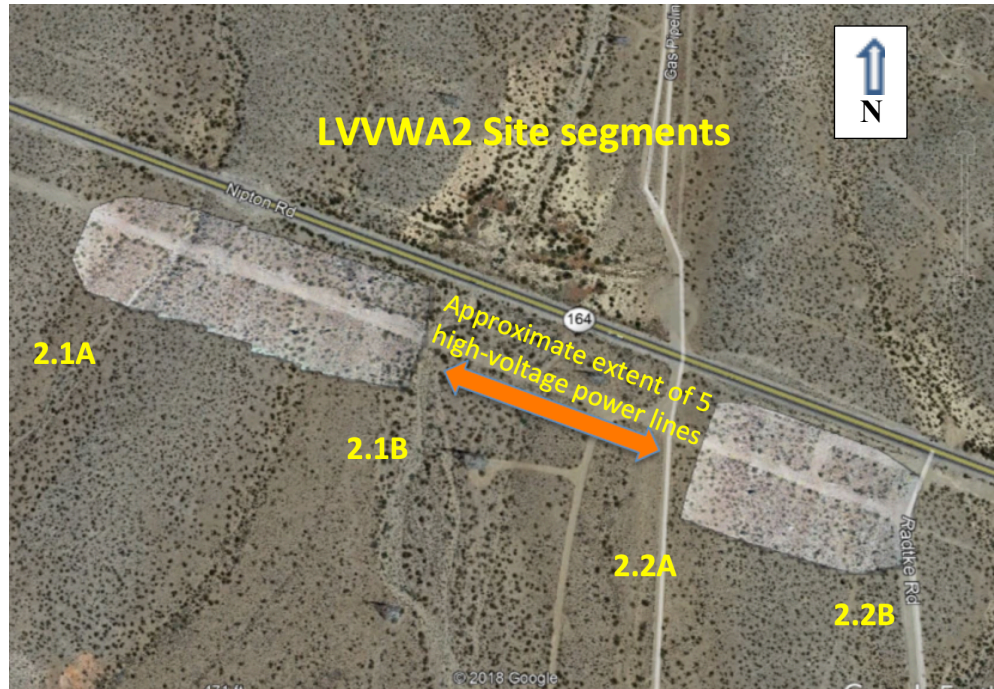
The LVVWA2 site water pipeline is located on the south side of the dirt road that runs north-west to south-east (Figure 17A). During the May site visit, LVVWA staff stated that this pipeline has a history of leaks and at the time of this site visit the pipeline was experiencing significant losses of pressure, likely due to water leaks.

Figure 17A. The LVVWA2 site water pipeline was considered to have a leak due to pressure losses when wells were turned off. LVVWA2 was mapped using the P4P drone in two segments (light areas) to avoid flying in the area where high voltage power lines are located.

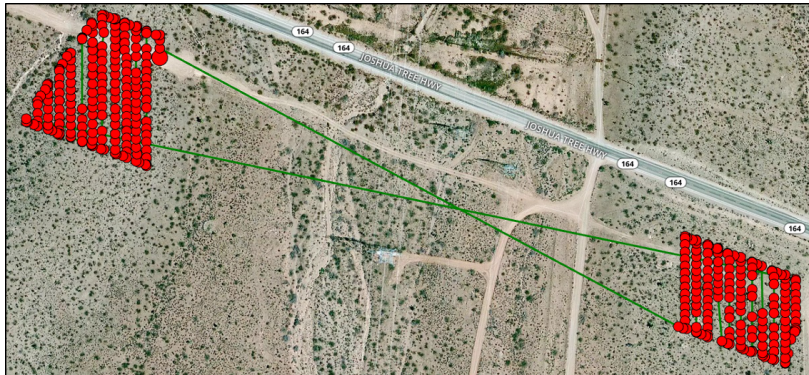
The LVVWA2 site was re-visited between October 29 and 31, 2019. The site representative indicated that the segment of pipeline with the suspected leak was shut down at this time. No other leaks were known. On October 29th and 30th the weather was unusually cold, rainy, and with wind gusts in excess of 30 MPH. Flights were suspended until environmental conditions were safe and suitable (no rain, wind <15mph). The goal of the visit was to develop a reflectance index map and analyze it for thermal anomalies.

Figure 19A. Aerial mapping using sUAS DJI M200 XT2 and DJI Pilot software for LVVWA2, sections 2.1A-B and 2.2A-B. The red dots represent the flight path and images taken during flight. (Source: MW, 2019).
