## ***DETECTING WATER LEAKS USING DRONE TECHNOLOGY***

Deliverable #5 – Final Report

Report Agreement No. 180894

ManageWater Consulting, Inc.

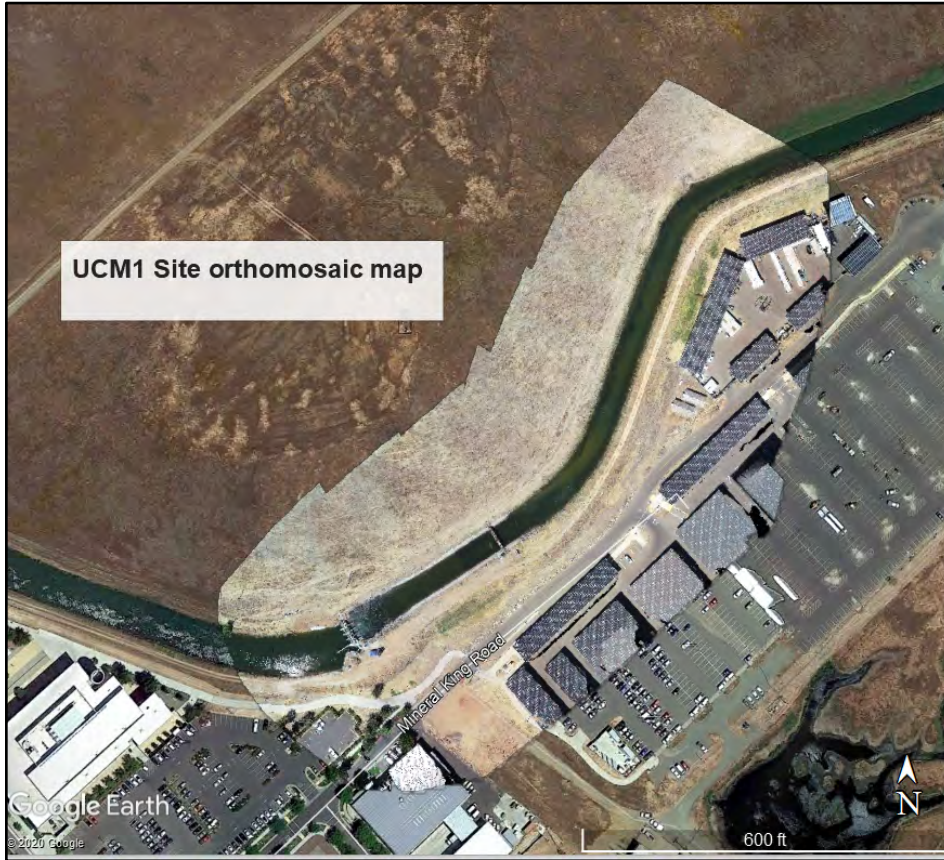
Figure 8. Orthomosaic map of UCM1 field site, generated using DJI P4P drone and Pix4D image Capture and Mapper processing software (lighter area). Surrounding area image uses Google Earth satellite view. Note the much higher resolution of the drone image, since it has a ground sampling distance (GSD) of approximately 1 inch and the satellite view has a nominal GSD of 50 feet.

At the UCM1 site, the earthen canal has several seeps through the earthen levee. The levee is mostly composed of native soil and rocky material. The canal water surface was approximately 4 feet below the top of the levee. Vegetation can be an indicator for water leaks. Grass and shrubs were visible on the campus site (Figure 8A), approximately 5 feet below the levee top. Clearly, this vegetation had access to water compared with adjacent vegetated areas that are dry. Lower temperatures were also observed in this area in the thermal images (Figure 8B).

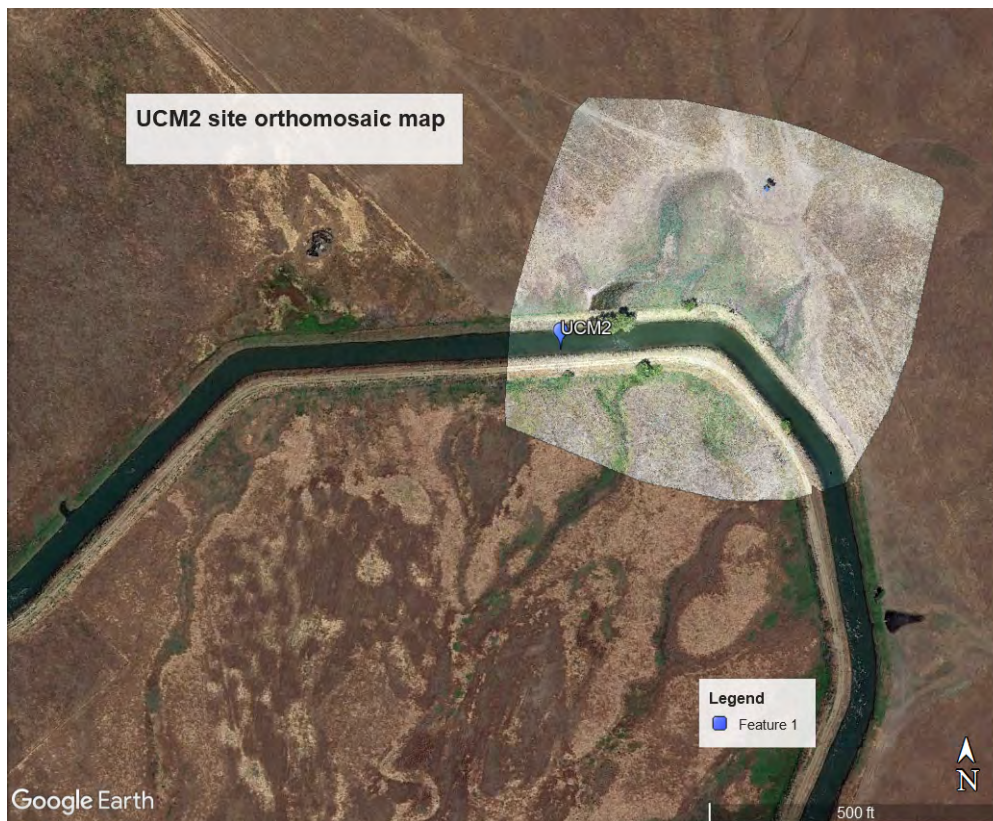
Figure 10. Map of UCM2 field site, generated using DJI P4P drone and Pix4D image Capture and Mapper processing software (lighter area). Surrounding area image uses Google Earth satellite view. Note the much higher resolution of the drone image, since it has a ground sampling distance (GSD) of approximately 1 inch and the satellite view has a nominal GSD of 50 feet.

This site is different from the UCM1 site because the area is hotter, more open, with shallow water ponded areas. The areas appear to be fed by leaking canal water. However, it was difficult to see specific leak locations from an on-the-ground perspective. The leak areas were more visible in visible light aerial surveys and even more apparent on the reflectance index maps.

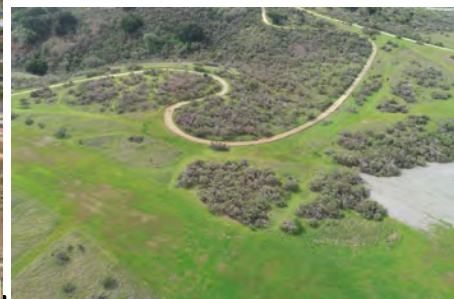
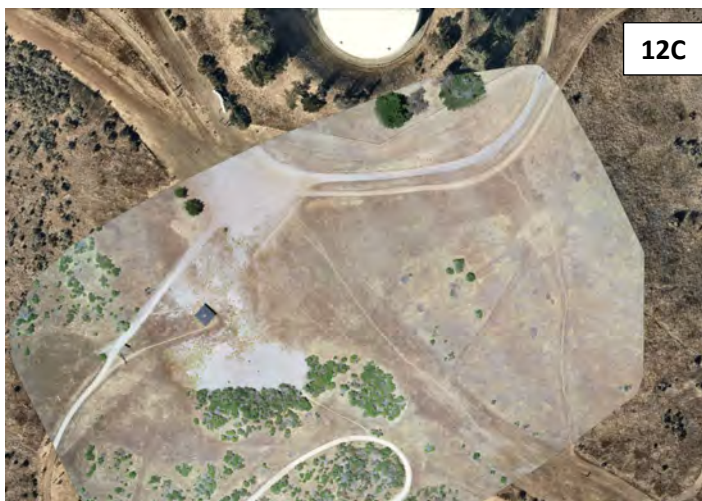
12C Figure 12B. Aerial views of MPWD1 site on March 19, 2019, with abundant grassy area due to recent and prolonged rainy season. The ground temperatures were too low due to the cooling effect of the green vegetation, resulting in insufficient contrast between the ground surface and water temperatures. The lack of contrasting ground to water temperatures resulted in no discernible temperature anomalies. Figure 12C. shows the aerial orthomosaic map for the MPWD1 site on July 26, 2019, almost two months after last rain event, with grassy areas dried out and ground temperatures (>100F) more than 40F higher than the water (60F). The orthomosaic map was developed using the P4P drone and Pix4D Capture and Mapper software.

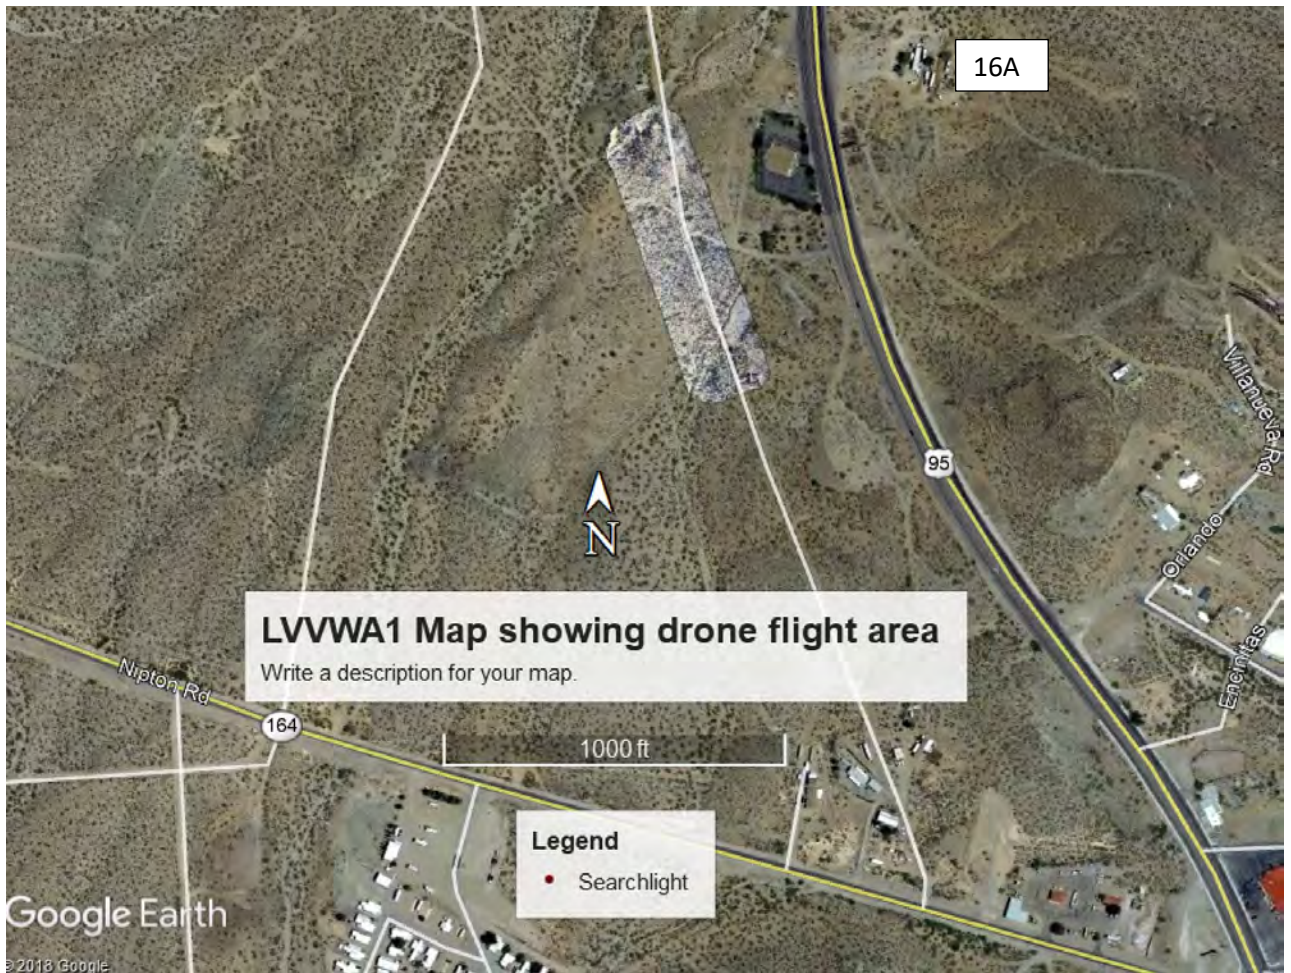
a reflectance index map and analyze it for thermal anomalies. No thermal anomalies were detected that could be interpreted as pipeline water leaks during fieldwork in May and October 2019.

Figure 16A. Flight map (lighter area), using sUAS DJI P4P and Pix4D Capture for LVVWA1.

Figure 16B. Aerial orthomosaic map of LVVWA1 using DJI P4P imagery and Pix4D Capture and Mapper software.  
 Figure 16C. Reflectance index map images were collected in October 2019 using DJI Pilot software. Pix4D Mapper software was used to develop the reflectance index map (the orange depicts cooler ground surfaces and the green represents vegetation that reflects warmer temperature compared to the ground. The water pipeline runs north-south along the west side of the dirt road. (Image source: MW, 2019.)

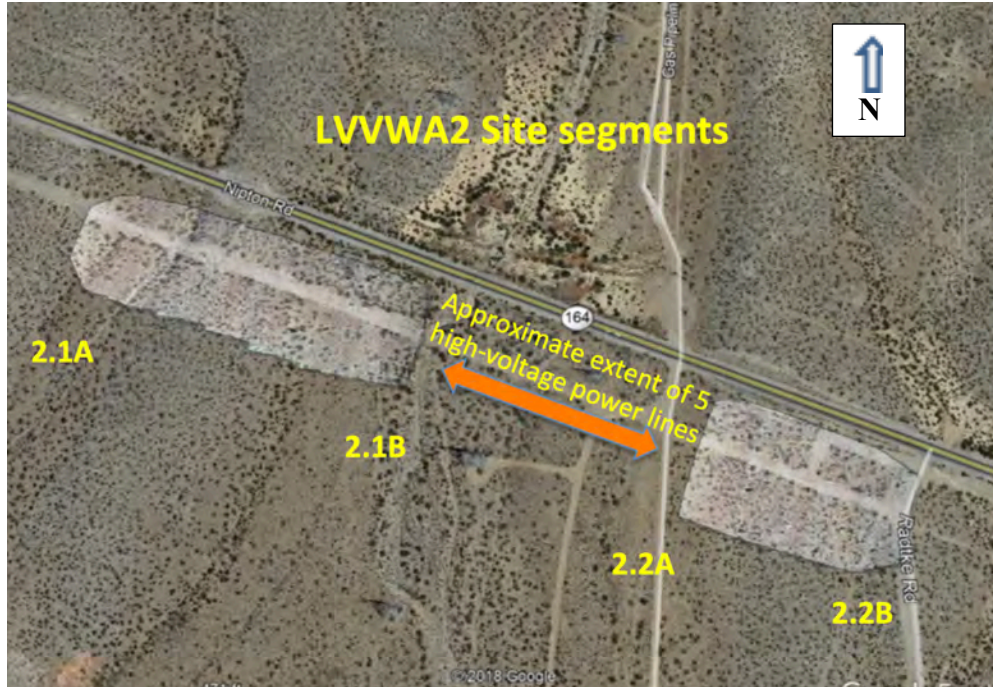
The LVVWA2 site water pipeline is located on the south side of the dirt road that runs north-west to south-east (Figure 17A). During the May site visit, LVVWA staff stated that this pipeline has a history of leaks and at the time of this site visit the pipeline was experiencing significant losses of pressure, likely due to water leaks.

Figure 17A. The LVVWA2 site water pipeline was considered to have a leak due to pressure losses when wells were turned off. LVVWA2 was mapped using the P4P drone in two segments (light areas) to avoid flying in the area where high voltage power lines are located.

During the May 2019 fieldwork, hundreds of thermal images were collected from drone flights. On May 27 at 6:50 am, the aerial thermal sensor detected a pattern of apparent thermal anomalies. That morning was chilly, with ground temperature in the low to mid-50s F, while water temperature was about 70F. Near the north-west end of 2.1A (Figures 17A, 18A, 18B), the temperature increased consistently about 10F, to mid and high 60s F (Figures 18A, 18B). This apparent thermal anomaly was visible in this area for about 45 minutes.

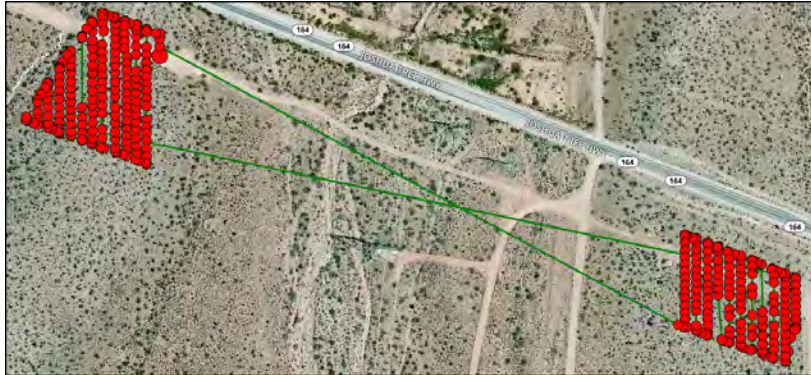
The LVVWA2 site was re-visited between October 29 and 31, 2019. The site representative indicated that the segment of pipeline with the suspected leak was shut down at this time. No other leaks were known. On October 29<sup>th</sup> and 30<sup>th</sup> the weather was unusually cold, rainy, and with wind gusts in excess of 30 MPH. Flights were suspended until environmental conditions were safe and suitable (no rain, wind <15mph). The goal of the visit was to develop a reflectance index map and analyze it for thermal anomalies.

Figure 19A. Aerial mapping using sUAS DJI M200 XT2 and DJI Pilot software for LVVWA2, sections 2.1A-B and 2.2A-B. The red dots represent the flight path and images taken during flight. (Source: MW, 2019).
