City of Fullerton Meter Health Analytics Pilot Project

Deliverable #2: Final Report

City of Fullerton

July 11, 2024

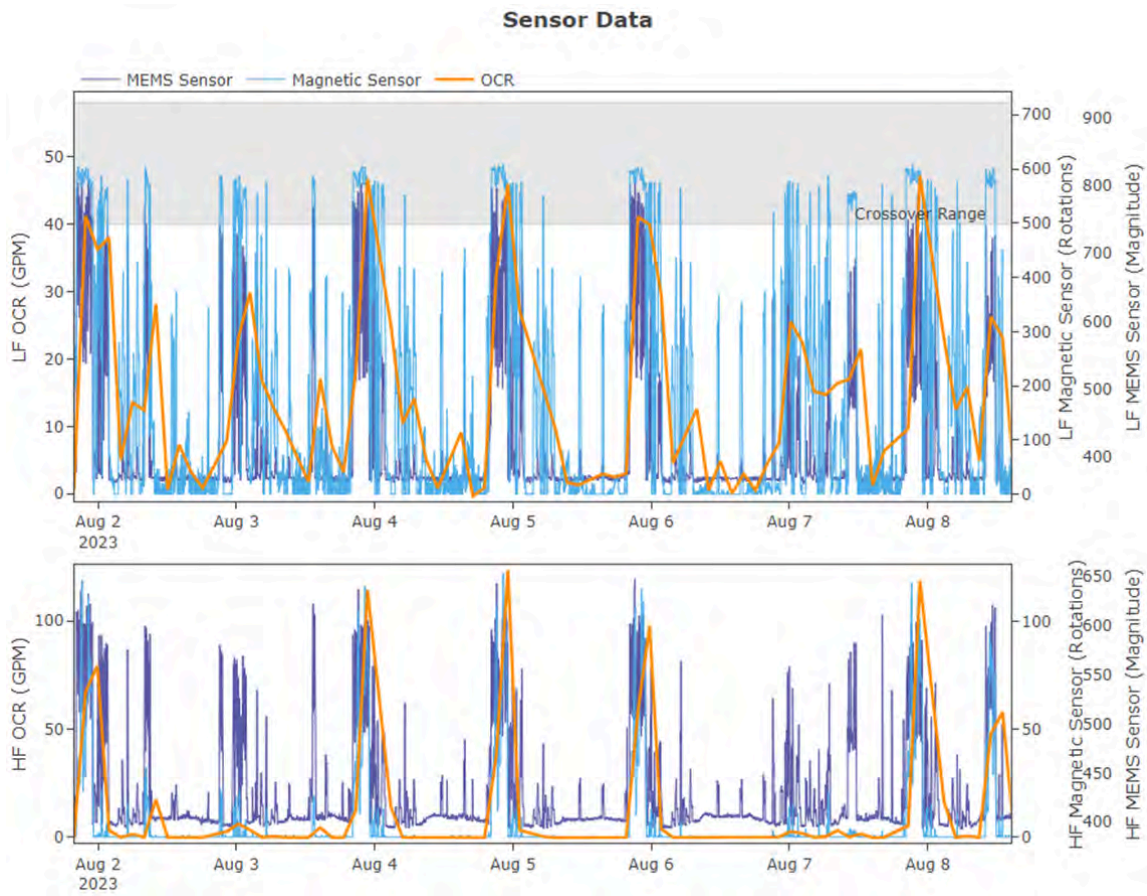
Figure 5 - 'No Problem Found' meter

Meter: Compound, Sensus, W Compact FireLine 2" x 6"

Meter Health Status: No problem found

- This is a compound meter (Figure 5), with the low flow meter represented in the upper graph and high flow meter on the lower graph. The sensor data (flow - orange, magnetic rotations - blue, vibration - purple) is in harmony, and the flow is crossing over from the low flow meter to the high flow meter correctly (crossover range in gray on the low flow meter graph). Analysis reveals that the meter is operating within the manufacturers specifications (Figure 6) and no problem is found.

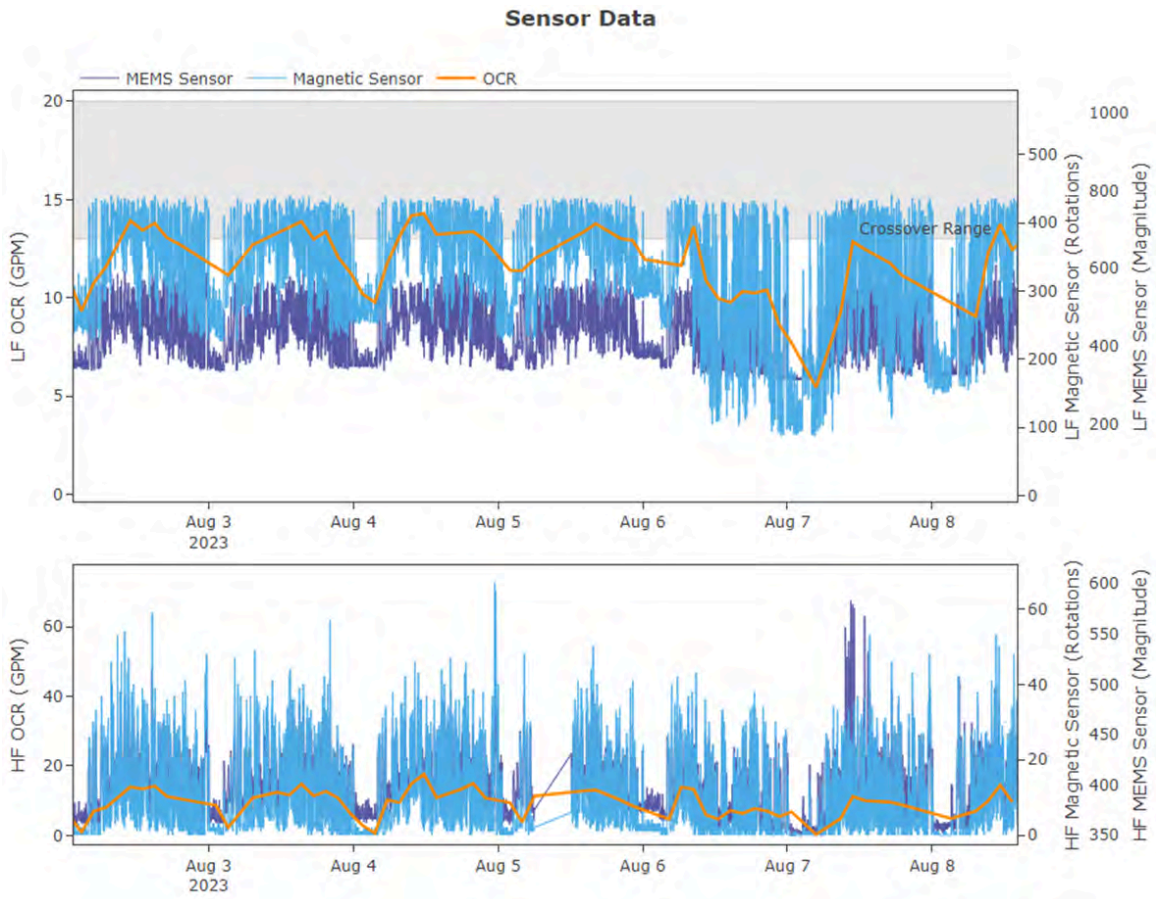
Figure 7 - 'No Problem Found' meter

Meter: Compound, Hersey, MCTII Compound 1" x 4"

Meter Health Status: No problem found

- This is a compound meter (Figure 7), with the low flow meter represented in the upper graph and high flow meter on the lower graph. The sensor data (flow - orange, magnetic rotations - blue, vibration - purple) is in harmony, and the flow is crossing over from the low flow meter to

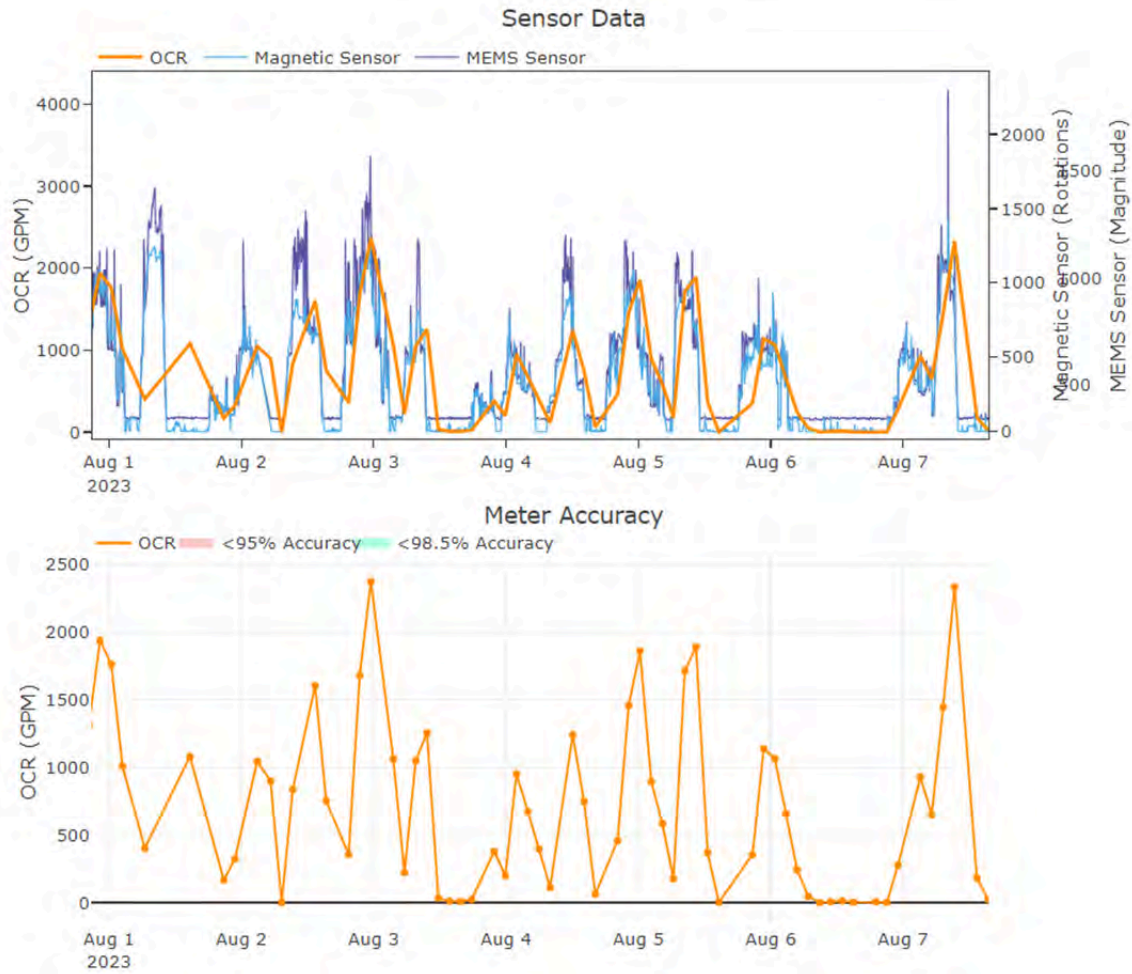
Figure 9 - 'No Problem Found' meter

Meter: Single, Sensus, W Turbo DR 3"

Meter Health Status: No problem found

- This is a single meter (Figure 9). The sensor data (flow - orange, magnetic rotations - blue, vibration - purple) is in harmony. Analysis reveals that the meter is operating within the manufacturers specifications (Figure 10) and no problem is found.
